An Roinn Tithíochta,  
Rialtais Áitiúil agus Oidhreachta  
Department of Housing,  
Local Government and Heritage

# Conservation Architect's Report on St. Mary's Cathedral, Elphin, Co. Roscommon.

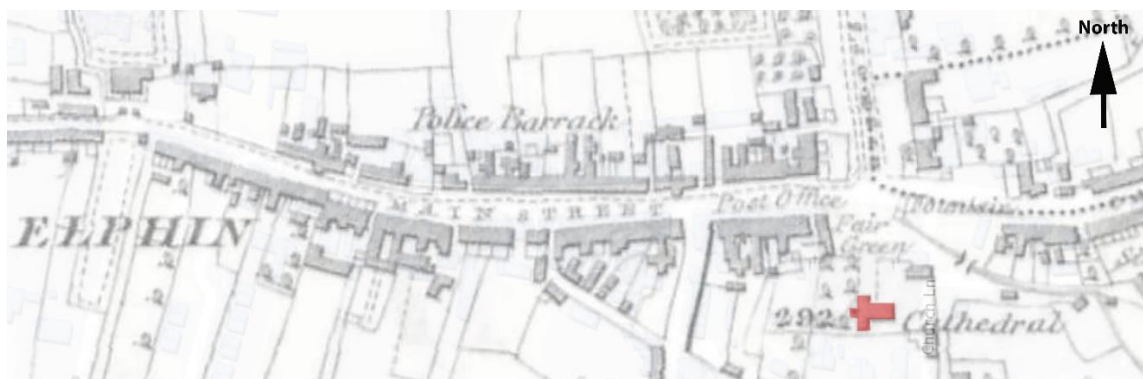
Fig. 1 First Edition Ordnance Survey Map (1837-42) – St. Mary's Cathedral is highlighted in red (not to scale)

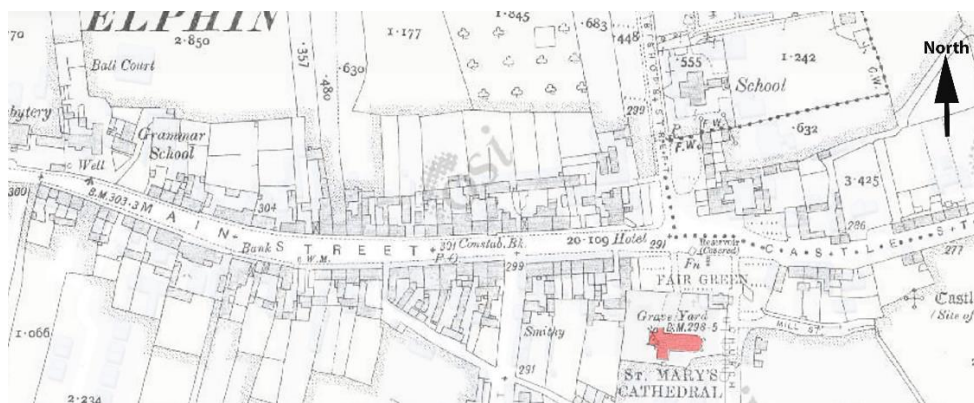
Fig. 2 Extract from 25" Ordnance Survey Map (1888-1913), with cathedral shaded red (not to scale)

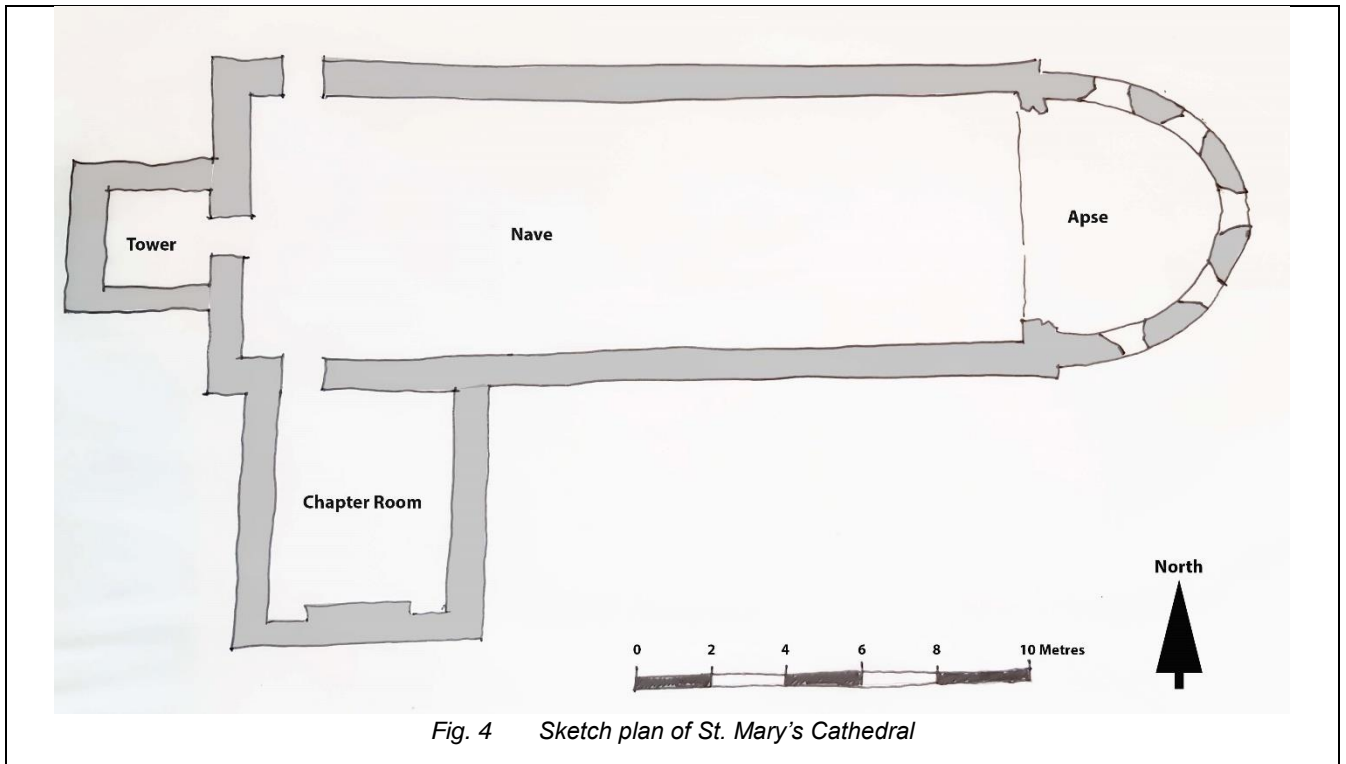
Fig. 4 Sketch plan of St. Mary's Cathedral

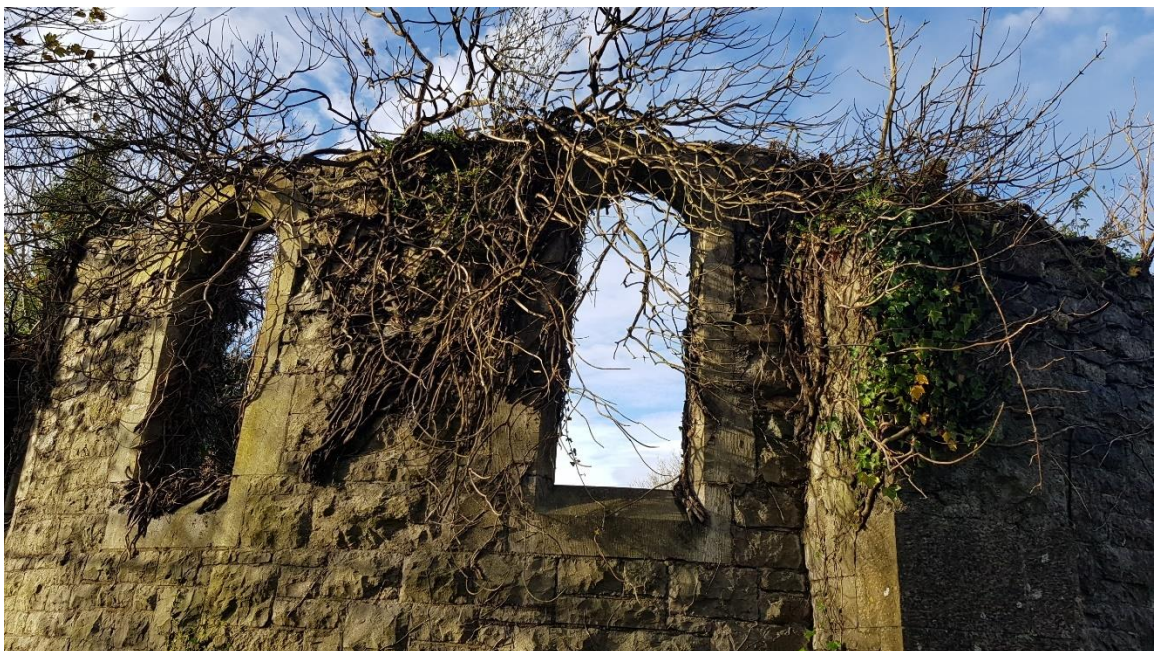
Fig. 5 Mature vegetation embedded into the top of the wall within the apse

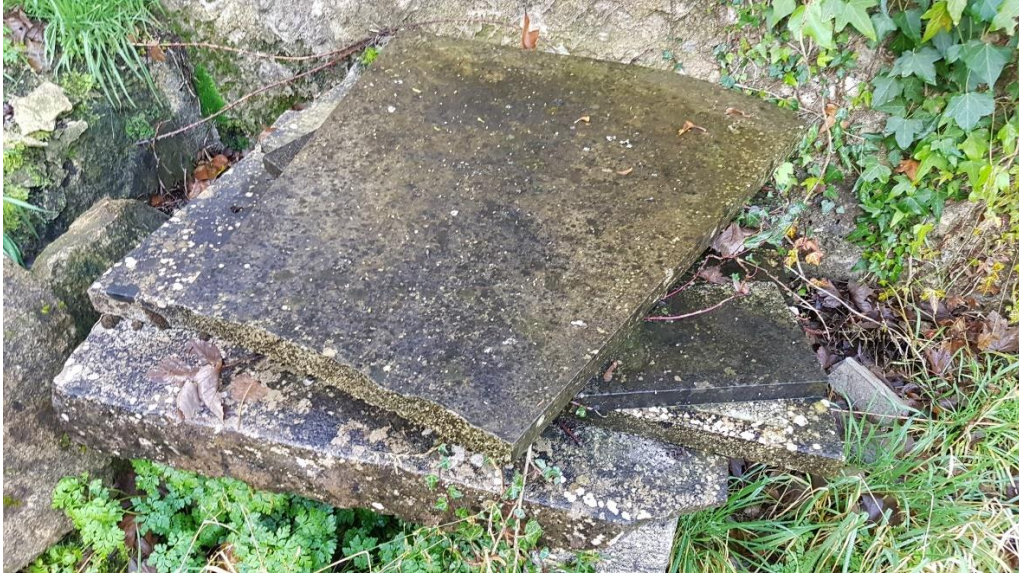
*Fig. 6 Broken and displaced memorial stones within the cathedral ruin*

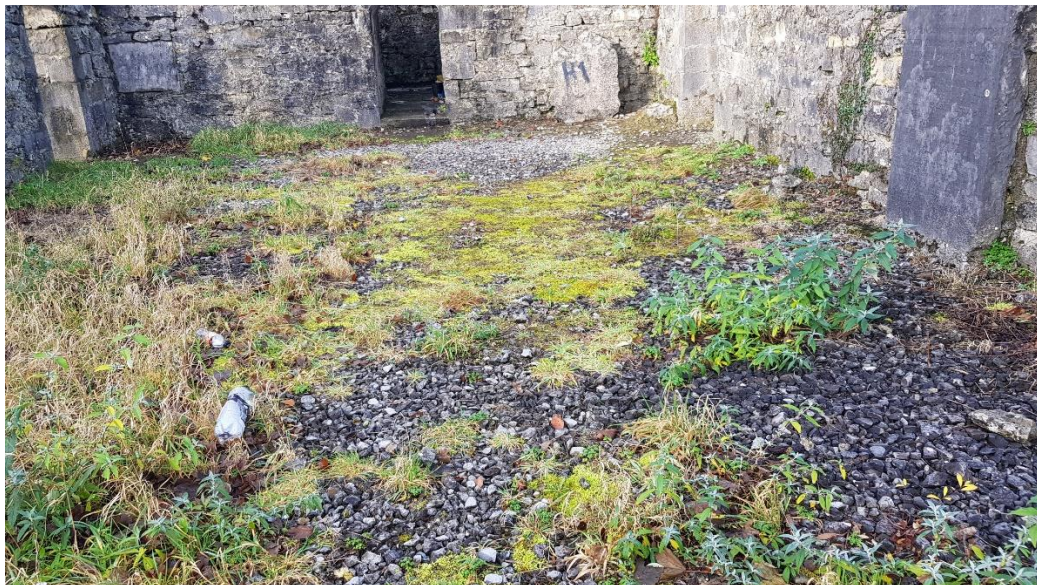
*Fig. 7 View of interior of cathedral ruin (looking west to tower) showing uneven floor surface*

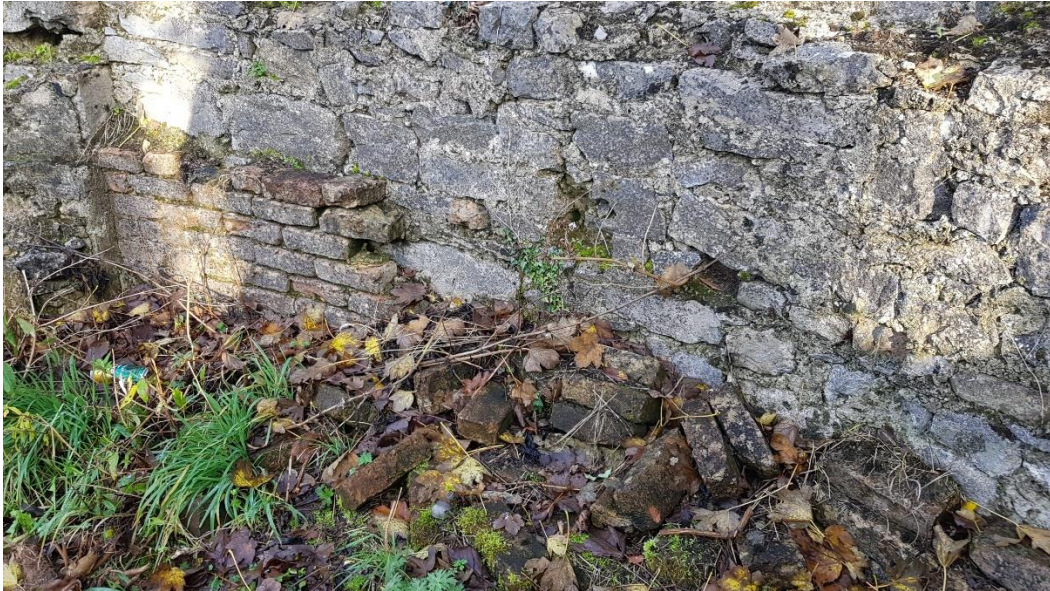
*Fig. 8 Brick lining within apse*

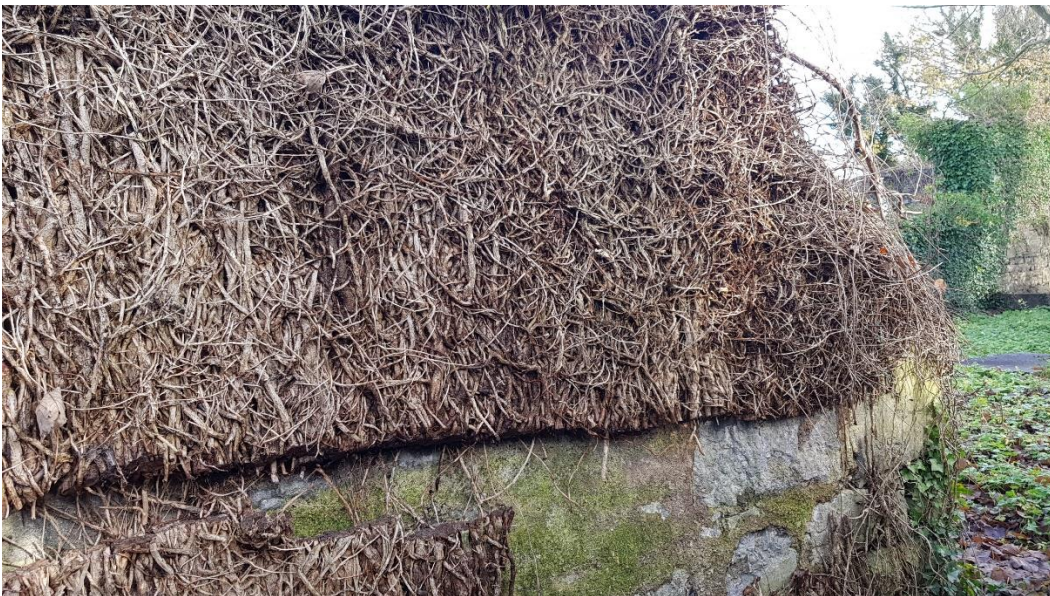
*Fig. 9 Cut ivy on exterior of cathedral ruin.*
