Conservation Architect's Report on Rahara Medieval Church, Co. Roscommon.

Prepared by
Michael O'Boyle B.Arch MUBC FRIAI
RIAI Grade 1 Conservation Architect
on behalf of
Roscommon County Council

Date: 19th November 2020

Ref.: P20-033 (01)

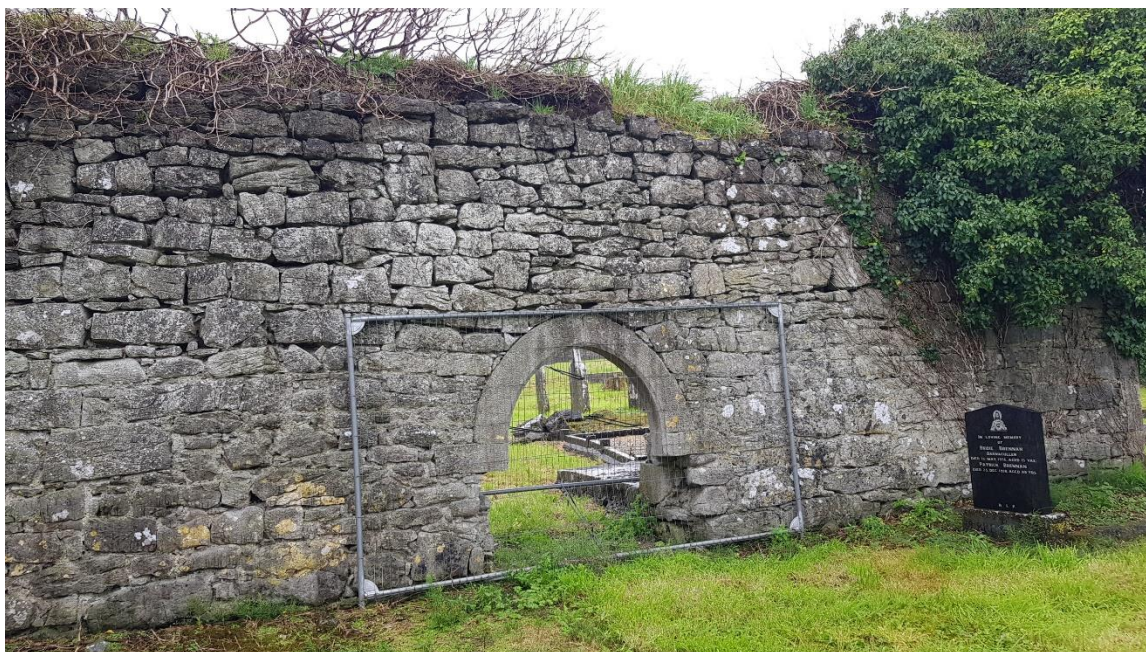
Fig. 4 Pointed arch door with cut limestone head on north exterior face of Rahara Church. The cut stone surround below this arch is missing.

exterior face of the opening should be reinstated through the introduction of replacement cut limestone underneath the intact cut stone arched head.

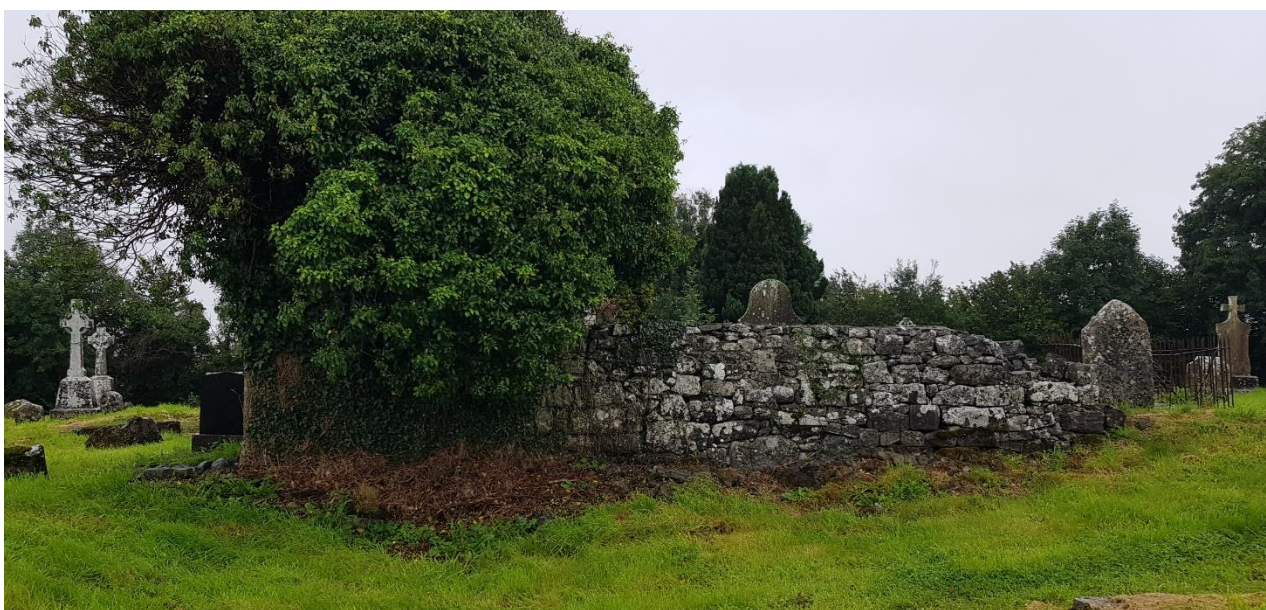
The north-west corner of the ruin is heavily overgrown with ivy (Fig. 7) and was not fully visible. This west gable wall drops in height from 4 metres, approximately 2.5 metres from this corner, to circa 1.4 metres. This lower wall appears to have been at least partly rebuilt and has a twentieth century cement-based render on part of its internal face. The cut stone quoins of the north-west corner include a carved head, which was not visible due to the heavy ivy growth.

Fig. 7 Exterior face of west gable wall.

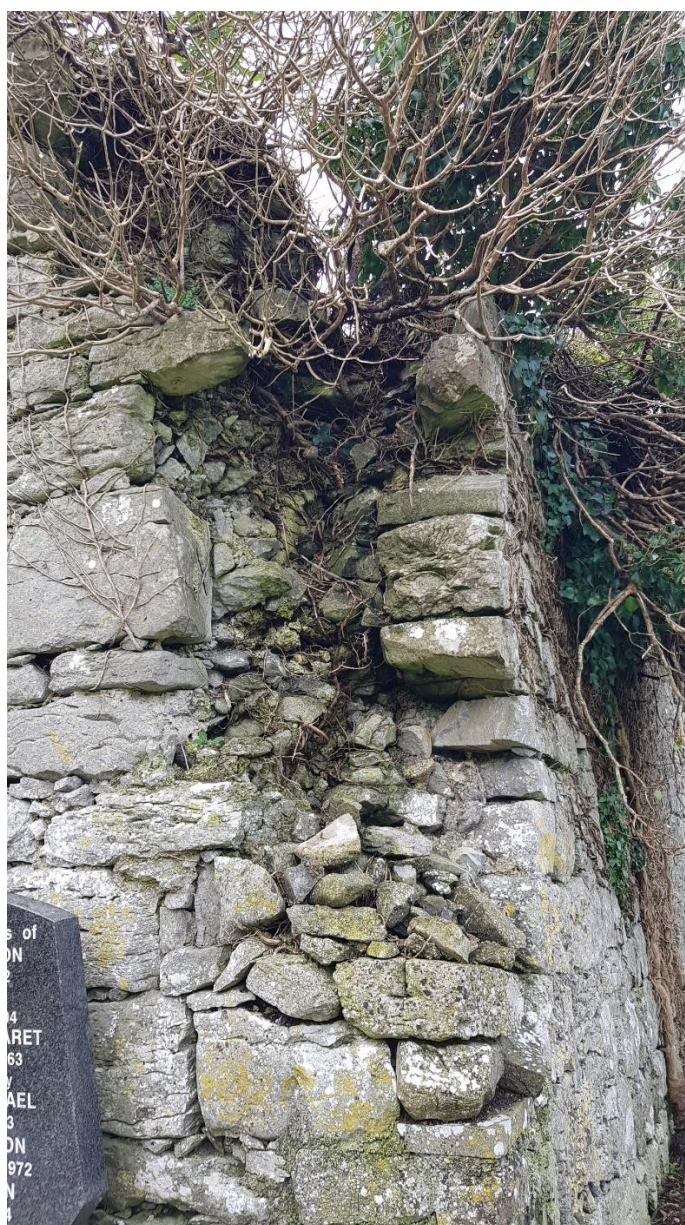
There is a substantial area of missing stone on the exterior face of the north-east corner of the church. The missing area of stone is approximately 2.5 metres high and extends c.500mm in both directions from the corner. It is possible that the outward movement of the east gable (see b) below) may have contributed to the failure of the masonry in this corner. There are dead ivy branches at the top of the wall, which appear to have been cut off close to the root. The core of the wall is exposed at this corner. The stone around the perimeter of this missing corner appears to be unstable and there is potential for the corner to unravel further.

Fig. 8 Missing stone on north-east corner

The consolidation and repair of the north-east corner should be carried out prior to any works to address the outward lean at the top of the east gable. These works will reinstate and consolidate the structural connection between the east gable and the north wall of the church, and will optimise the structural integrity of the ruin prior to the works to the vulnerable gable. The reconstruction of the corner should be carried out using the salvaged limestone from the site. The replacement stone should be selected to fit with the configuration of the stone in the corner, with particular emphasis on the inclusion of longer stones to reinforce the corner of the ruin. The replacement stone should be bedded in lime mortar to the specification noted below. The core of the wall (i.e. between the inner face and the reconstructed outer face) should be filled with a compacted dry mix of medium-size limestone gravel, sand and lime. Allowance should be made for the use of helical flexible stainless steel reinforcement bars and stainless steel ties, to act a stitch reinforcement - both between the retained inner leaf and the reconstructed outer corner; and to provide reinforcement to the masonry around the corner. This reinforcement should comprise a series of stitched connections in multiple locations. The introduction of more invasive structural supports would be harmful to the integrity of the structure and is not recommended. Where there are wide joints or gaps between the stones, these should be packed at with smaller stone gallets (flat stones) and pins (pointed stones). The stability of the east gable should be regularly monitored throughout this work.

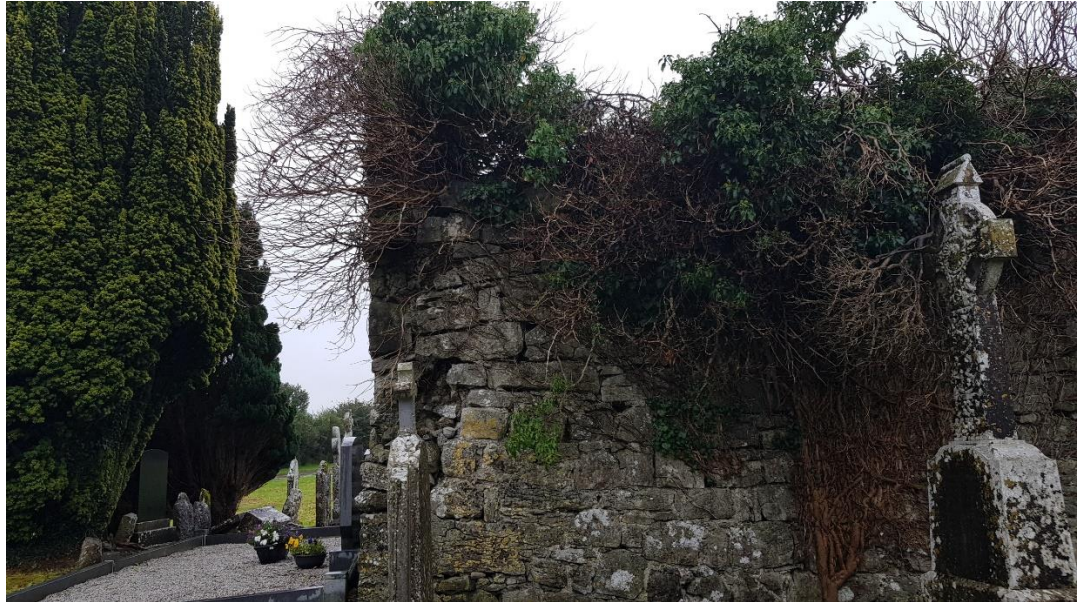
The east gable is off-plumb, with the uppermost part of the masonry leaning outwards by at least 300mm. This outward movement in the wall appears to have contributed to the loss of masonry at the north-east corner of the ruin (see a) above). It is not possible to determine from a single inspection whether the movement in the wall is actively deteriorating. The extent of this outward lean is such that the gable must be regarded as unstable and at potential risk of collapse. There are dead ivy branches at the top of the wall, which appear to have been cut off close to the root.

Fig. 9 Outward lean on east gable wall of Rahara Church. The dislodgement of stones at the corner appears to be linked to the movement in this wall.

The outward lean of the east gable will require significant work. The introduction of buttresses or permanent supports on the east side of the gable is not a viable option as this would dramatically alter the appearance of the ruin and would interfere with the relatively recent graves at the exterior base of the wall. For this reason, the preferred option would be to carefully dismantle and reconstruct the upper part of the gable, to a depth of about 1.5 metres from the apex. This will require the numbering of each stone and the preparation of a detailed drawing of the gable from both sides, which should capture the slope of the wall and the location of the stones. The dismantled stone should be numbered with chalk (or similar removeable marking) and stored on the scaffolding platform to minimise double-handling. The reconstruction of the stone should focus on correcting the outward lean so that the upper part of the wall is plumb and to relocate the centre of gravity of the wall so that the risk of collapse is greatly reduced. As part of this work it will be necessary to consolidate the base of the wall, where there are a large number of gaps and open joints. In particular, the gap at the base of the wall which has been filled with loose stone, will need to be consolidated with stone bedded in lime mortar. Once the stone on the gable has been re-pointed, a lime-based liquid grout, to the specification noted below, should be slowly introduced to the wall – to fill and consolidate any gaps in the wall. A rounded haunch should be formed at the top of the gable (to specification) to facilitate water run-off from the ruin.

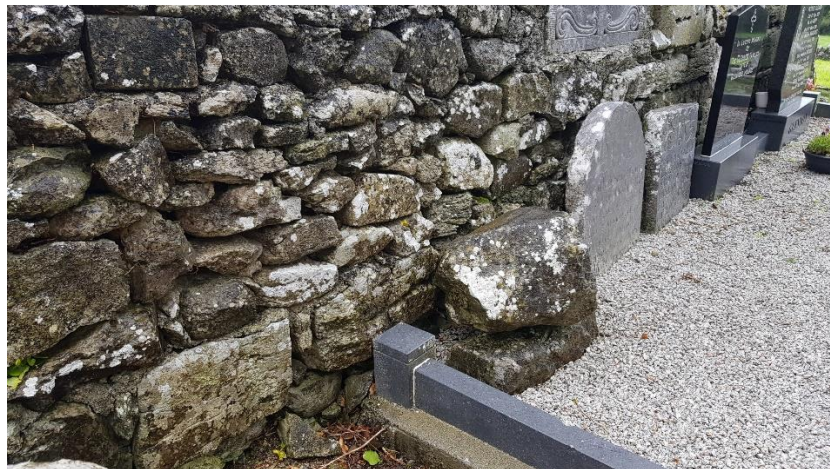
There are open joints without visible mortar at the base of the exterior face of the east gable (Fig. 10). These deep open joints appear to be linked to the loss of aggregate from the core of the wall. There is a gap at the base of the external face of the wall (c.500 x 500mm) approximately 1 metre in from the corner, which has been filled with loose stone that is not bedded in mortar. The missing masonry and open gaps are contributing to the lack of stability in this wall.

Fig. 10 Deep open joints in the stone rubble at the base of the east gable (exterior face)

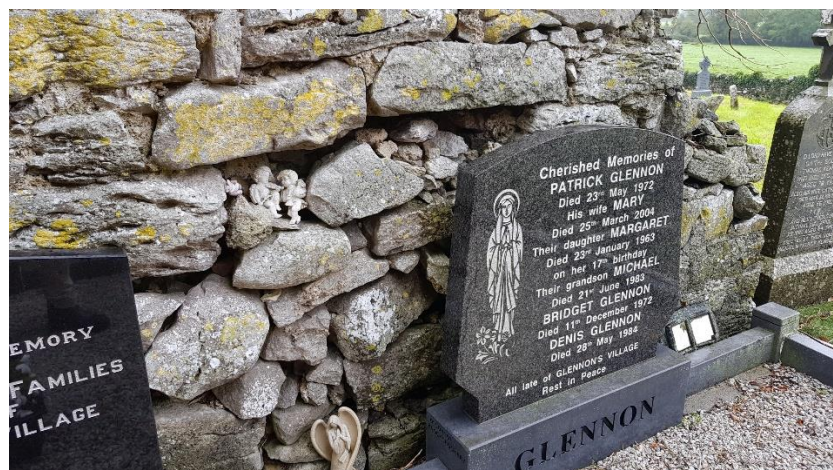
Fig. 11 Substantial gap at base of east gable (exterior face) that has been filled with loose stone.

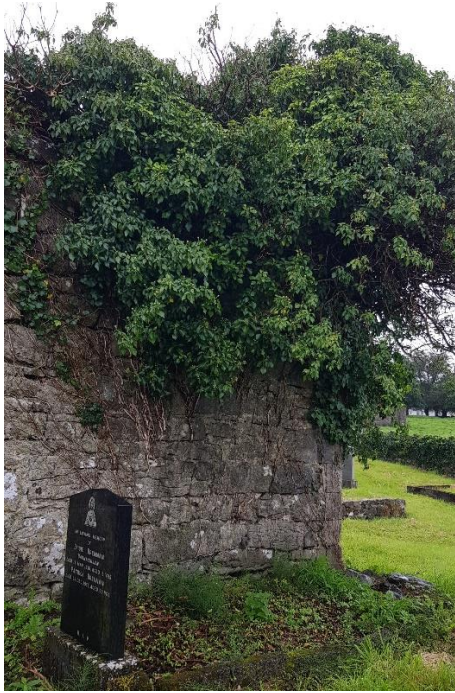
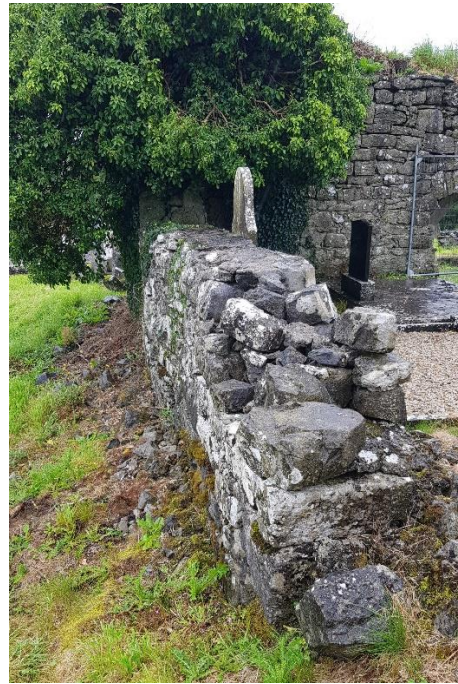
There is a substantial cluster of mature ivy, which completely obscure the interior and exterior face of the wall at the north-west corner (*Fig. 12 & 13*). It was not possible to visually inspect the face of the wall in this corner on the date of inspection and it is not possible to comment on the condition of the stone.

Fig. 12 Ivy growth on north wall (exterior face) at north-west corner

Fig. 13 View from south-west corner looking towards north-west corner, which is heavily overgrown with ivy.

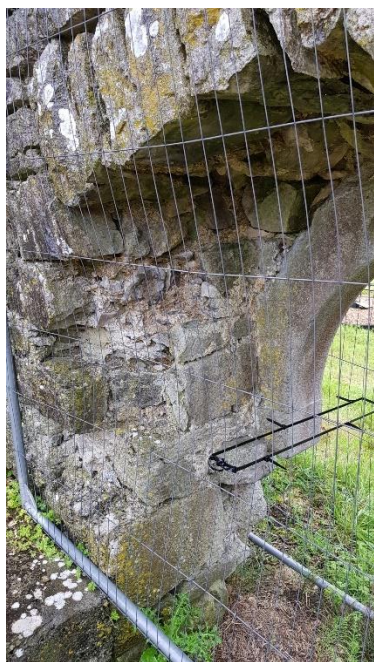
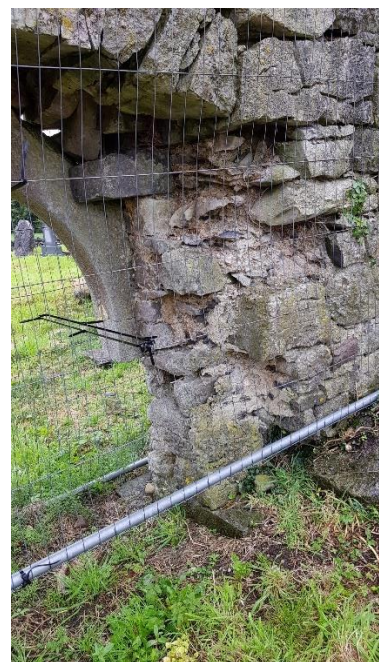
The cut stone surround to the pointed-arch opening on the north external wall is an important survival. The cut stone reveals beneath the arch do not survive. The masonry rubble reveal to the inside of the arch is in poor condition, with missing stone on both sides (*Fig. 14 & 15*). The stone rubble inner arch is not adequately supported. It is possible to see through the wall at the gaps between the stones at the head of the arch. The stone arch is not stable and consolidation is urgently required to the reveals. Protective fencing is in place to prevent public access to the arch.

Fig. 14 West reveal of arched opening

Fig. 15 East reveal of arched opening

The loose and missing masonry around the reveal and head on the interior of the wall should be consolidated and reconstructed using stone rubble, to be salvaged from the site where possible, bedded in lime mortar (to the specification noted below). The reinstatement of the missing reveals under the internal flat arch is urgently required to ensure the structural integrity of the opening. The

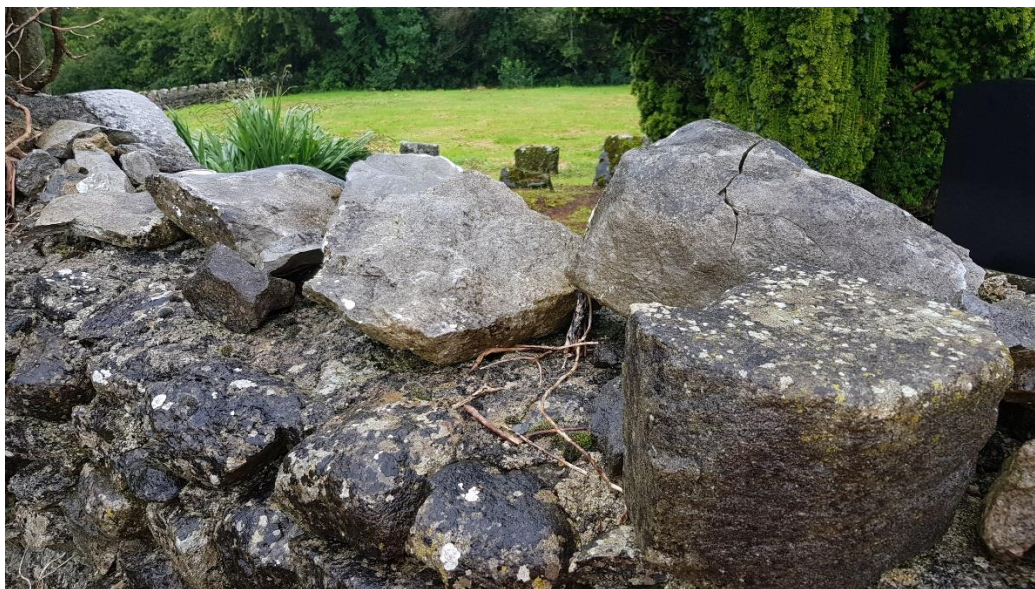
With the exception of the west wall, which has been partly re-built, the tops of the walls are not finished with a haunch or capping. There are open gaps in the stone rubble along the top of the wall, which have allowed water to drain through the stone rubble. This has caused much of the aggregate to leach out of the wall, leaving substantial voids which have weakened the core of the wall. If left unchecked, the root systems of the embedded vegetation will extend into the voids within the core, causing a further weakening and deterioration of the ruin. The use of a hard cementitious mortar in local twentieth century repairs is contributing to the instability at the top of the wall.

Fig. 16 Open gaps along the top of a truncated section of wall at the south gable. The individual stones at the top of the wall have been re-bedded in a cement mortar (during the twentieth century), which is significantly harder than the historic masonry and is contributing to instability in the wall.

The wall tops of the church ruin will be subjected to water penetration and weathering stresses far in excess of those experienced by the wall face, and a different mortar formulation for haunching will be required. All vegetation and any existing wall top haunching should be removed prior to application of the new haunching. It should be noted that one of the most common problems with past cement-rich haunching is deterioration of the original work immediately below it; and the failure of new haunchings is often due not to incorrect formulation or poor workmanship, but the poor condition of the wall-core substrate. On removal of the vegetation and any past haunching, it is crucial to consolidate the wall-core at the wall top prior to applying a new haunching²¹. The new haunching should be a natural hydraulic mortar (NHL 3.5). The limestone used to build the wall is a durable limestone and NHL 5 would bond with this stone. However, NHL 5 is stronger, less elastic and less permeable than a NHL 3.5, and while durable, should be expected to be less able to cope with any future wall movement or failure(s) within the original weathered material in the wall core. For this reason NHL 3.5 is preferred. The recommended mix of for the haunching is NHL 3.5: Sand aggregate in the **ratio 1:2½**. The sand aggregate should be sharp, coarse limestone sand (10mm down, gauged with a fraction of fine limestone aggregate to improve workability).

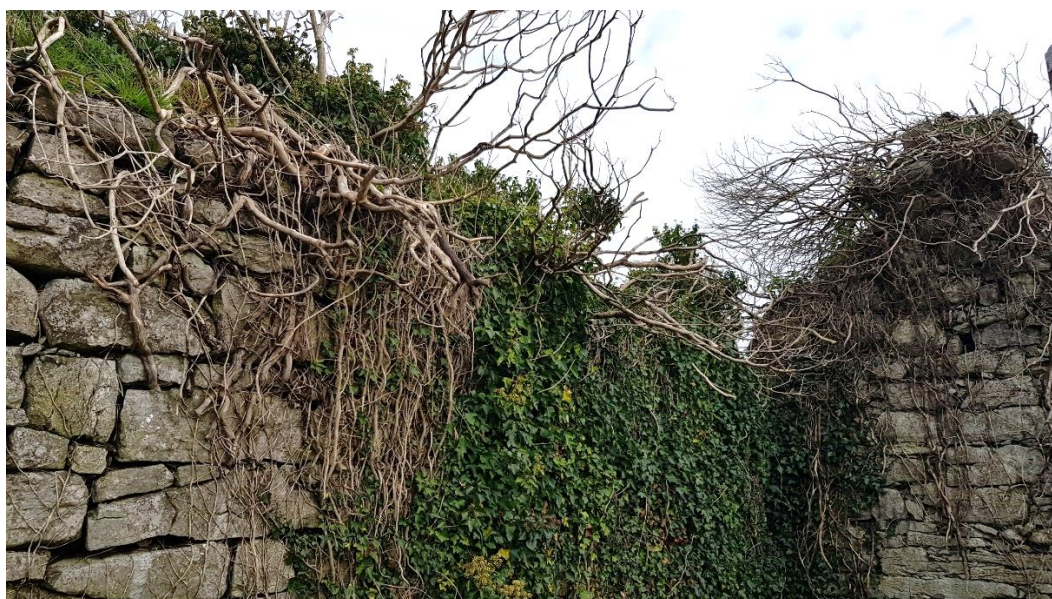
The open gaps and absence of a haunch at the top of the wall has facilitated the growth of vegetation from the top of the walls of the church ruin. Much of this growth comprises woody vegetation. During the course of my inspection I noted ivy, whitethorn and buddleia at the top of the ruin. These plants can grow to be relatively large with substantial root systems embedded into the wall. There is evidence of recent efforts to cut back some of the ivy growing in and over the ruin. This approach may not kill the plant and can cause the embedded roots to expand, which can further weaken the wall.

Fig. 17 Interior of Rahara Church looking towards north-east corner. There is dead ivy on the east gable and on the north wall (foreground, with cut branches)

The biocide treatment of this vegetation should be carefully targeted on killing the plant from the root upwards. This method involves the application of a biocide treatment under the bark close to the root of the plant. This approach differs from the more-commonly used application of a biocide treatment to the leaves, which will kill the foliage but cause the living plant to retreat into the root system. This can result in expansion of the roots, which can in turn destabilise the ruined structure. The slow and gradual process of killing back the plant will take several months and avoids any expansion or shrinkage of the root system. The approach involves the peeling back of a section of the bark about 50mm high to expose the substrate. A biocide (roundup or similar) is applied in paste form to the open section of the trunk and is then sealed with clingfilm and duct tape. The optimal time to carry out this treatment is in the spring, with allowance for 2-3 repeated applications on each trunk/branch at monthly intervals heading into the summer.

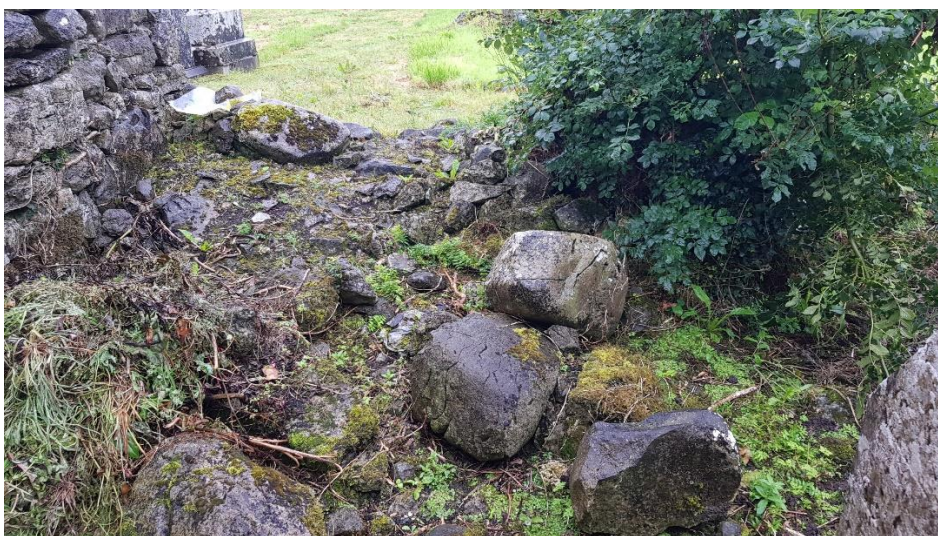
The surviving below ground remains of the south external wall are likely to be relatively undisturbed and do not give cause for concern. There are a number of loose stones along the top and on both sides of the wall line. It is likely that these are stones that have detached and rolled away for the wall.

Fig. 18 Loose stones along line of south wall of church ruin.

The killing back of the ground vegetation will facilitate further investigation of any above ground fabric along the line of the south external wall of the church. Where the top of this wall is visible, it should be consolidated with a limecrete haunch and any loose rubble in the vicinity should be bedded onto the top of the wall. The potential for the wall to form a trip hazard should be assessed in conjunction with Roscommon County Council, along with the potential to introduce soil covering as protection over the top of the wall line.

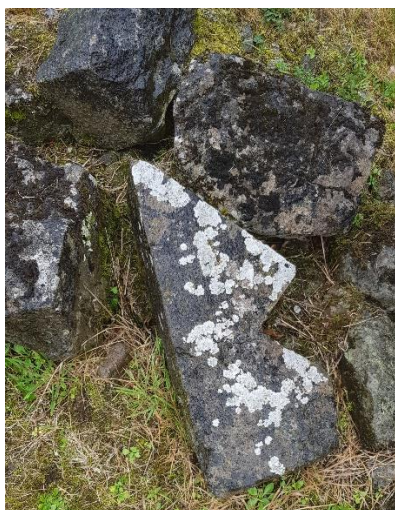
Fig. 19 Fragment of cut stone

The grass and weed ground cover within the church ruin is to be treated with a herbicide. Once the vegetation cover has died back, any cut stone fragments are to be photographed, identified by number, inventorised, and safely stored. The stone fragment pieces that go together to form an identifiable plaque or memorial stone are to be labelled and retained. Any decision in relation to the storage or reassembly and presentation of these stones shall be taken in consultation with the National Monument Service.

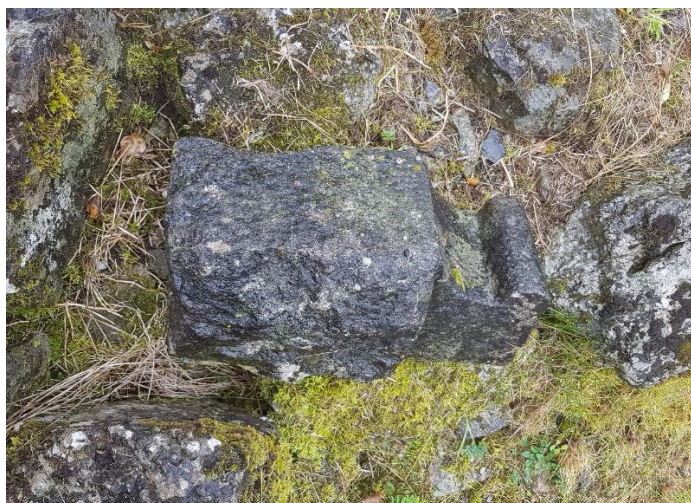
Fig.20 Cut stone fragment on line of south wall
