**ROSCOMMON COUNTY COUNCIL**

**NOTIFICATION OF DETERMINATION**

Reference Number: DED 912  
Application Received: 1<sup>st</sup> July, 2025  
Name of Applicant: Sean Ned Mulready  
Agent: N/A

# **BUILDING CONDITION ASSESSMENT**

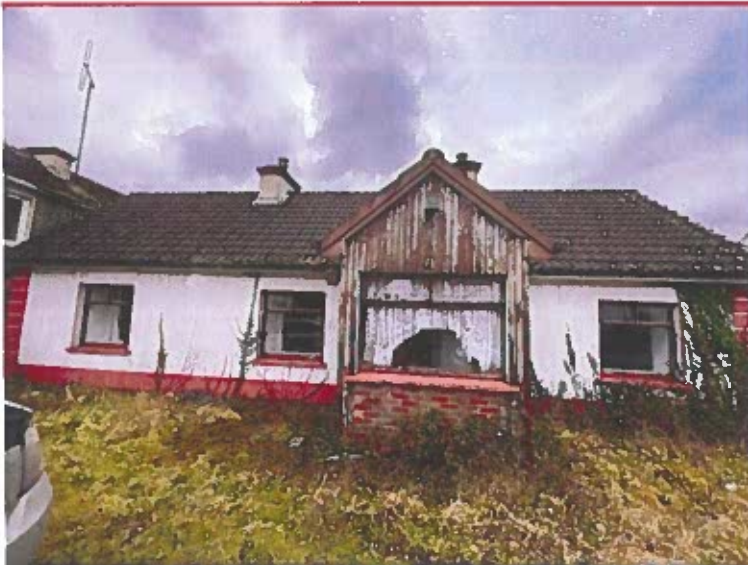
#### 6.01

Location Front Elevation

External walls in good structural condition. Roofing structure in good condition. Works to be completed to flashings, staining evident.

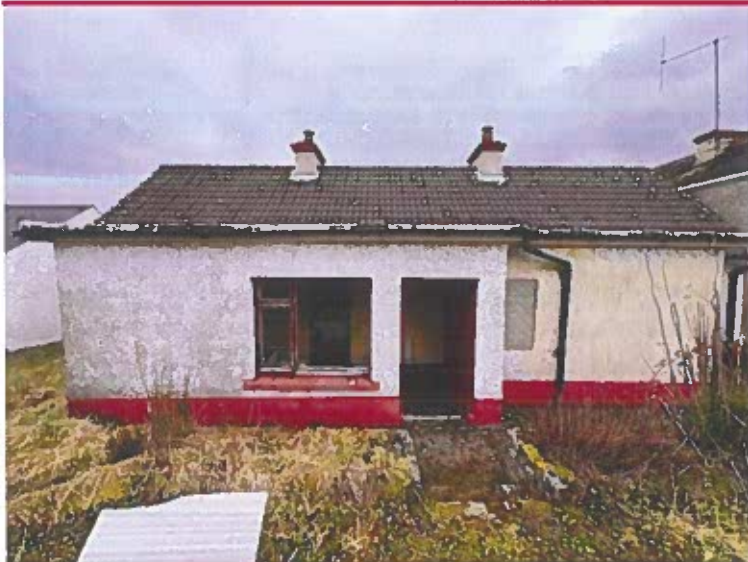
#### 6.02

Location Rear Elevation.

External walls in good structural condition. Roofing structure in good condition. Works to be completed to flashings, staining evident.

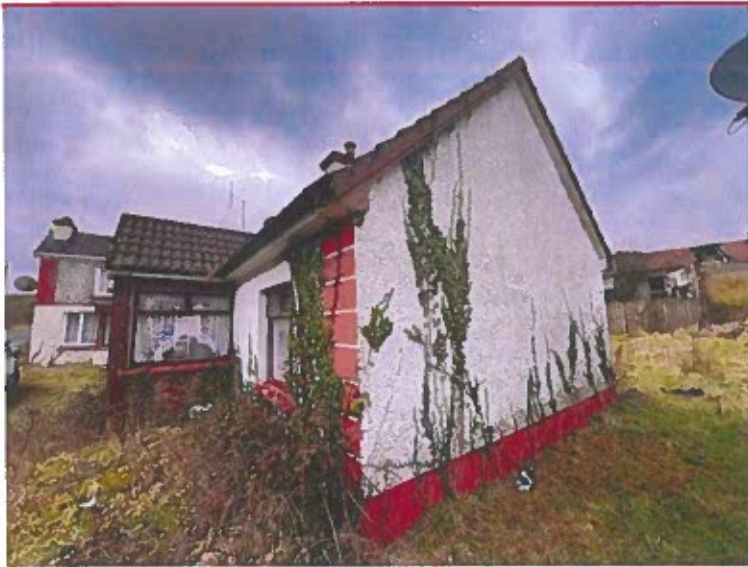
**6.03**

Location Right Elevation

External walls in good structural condition. Roofing structure in good condition. Works to be completed to flashings, staining evident.

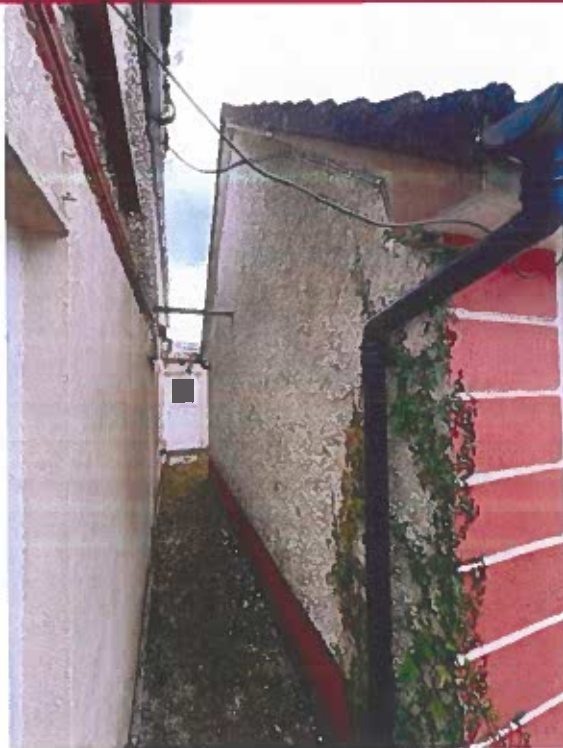
**6.04**

Location Left Elevation

External walls in good structural condition. Roofing structure in good condition. Works to be completed to flashings, staining evident.

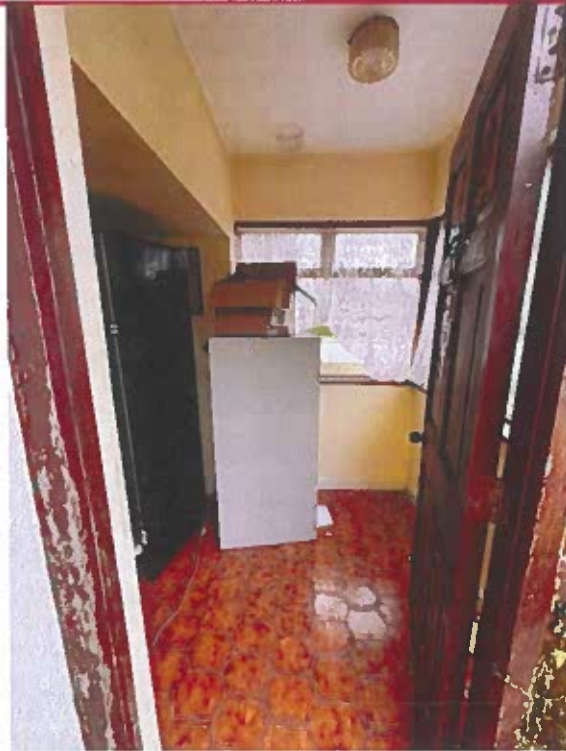
**6.05**

Location Entrance Hallway

Leaks and mould present throughout the property. Damp proofing works required to make this property habitable.

Recommended to be gutted. All Internal completions required.

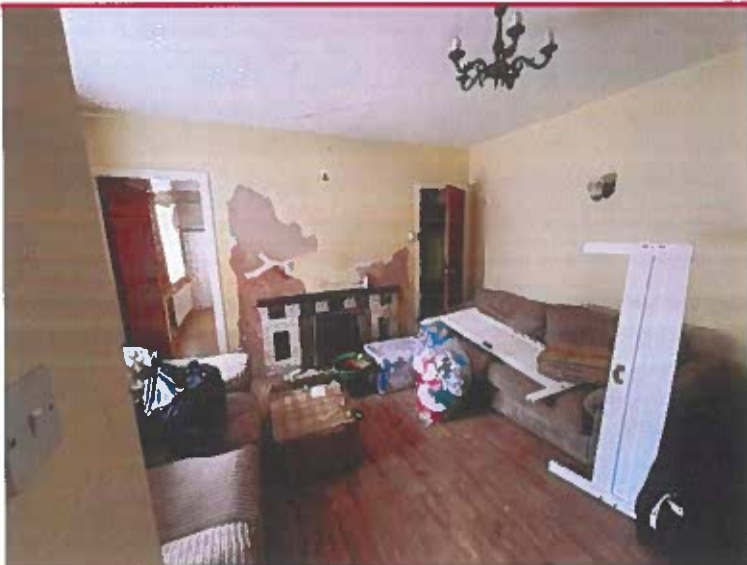
**6.06**

Location Living Room

Leaks and mould present throughout the property. Damp proofing works required to make this property habitable.

Recommended to be gutted. All Internal completions required.

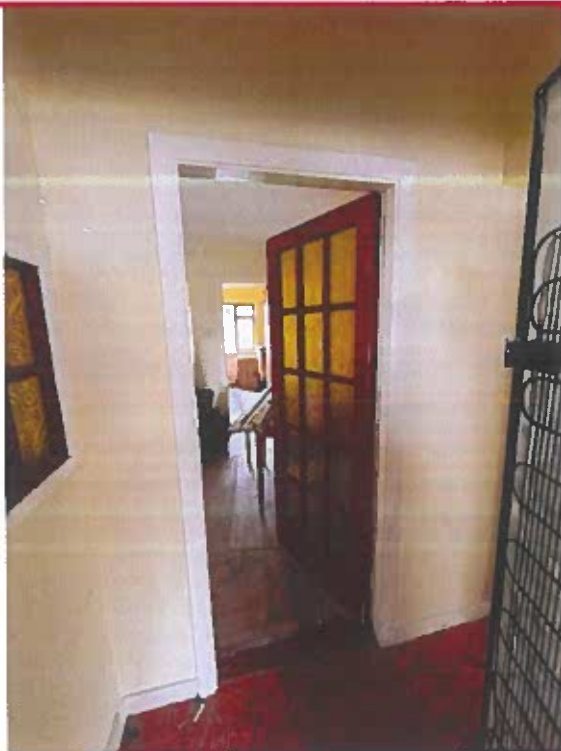
**6.10**

Location Hallway

All finishes in poor condition. Recommended to be gutted. All Internal completions required. Leaks and mould present throughout the property. Damp proofing works required to make this property habitable.

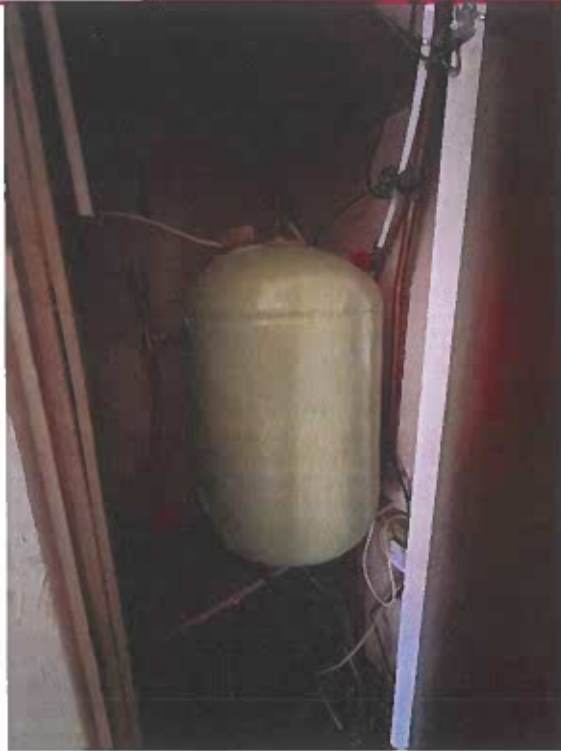
#### 6.11

Location Hot Press

Leaks and mould present throughout the property. Damp proofing works required to make this property habitable.

Internal completions required.

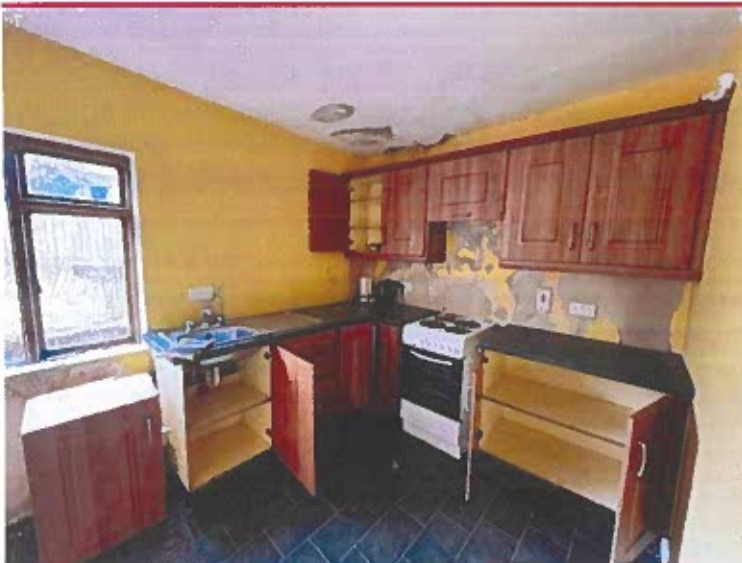
#### 6.12

Location Kitchen

Leaks and mould present throughout the property. Damp proofing works required to make this property habitable.

Internal completions required.

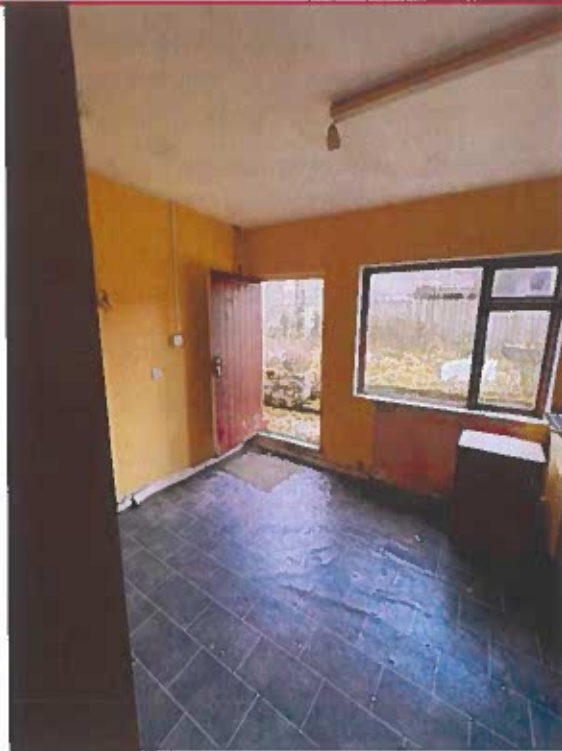
#### 6.13

Location Kitchen

All finishes in poor condition. Recommended to be gutted. All Internal completions required. Leaks and mould present throughout the property. Damp proofing works required to make this property habitable.

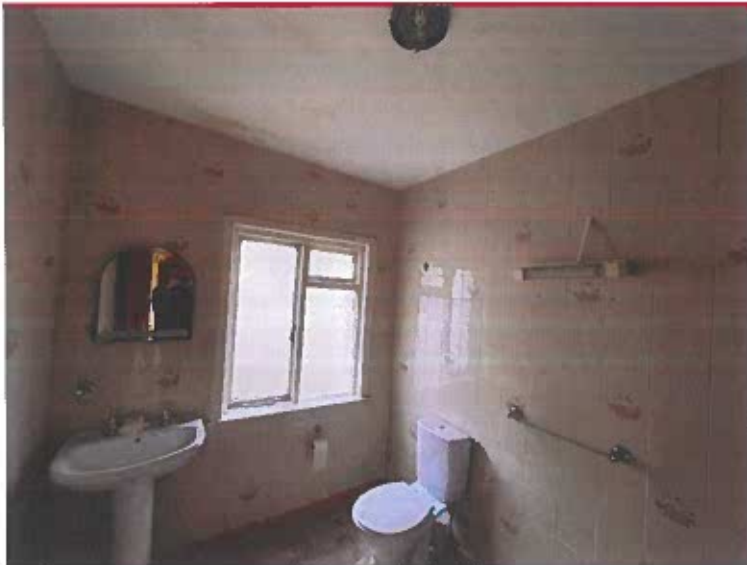
#### 6.14

Location Bathroom

Settlement cracking noted, various finishes throughout property, All in poor condition. Recommended to be gutted. All Internal completions required. No provisions for ventilation.

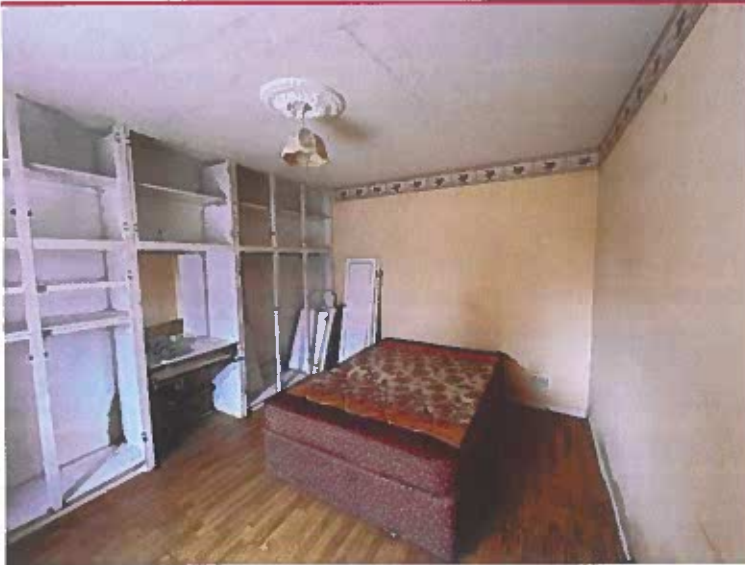
**6.15**

Location Bedroom 2

All finishes in poor condition.  
Recommended to be gutted. All  
Internal completions required.  
Leaks and mould present  
throughout the property. Damp  
proofing works required to make  
this property habitable. Have boiler  
serviced

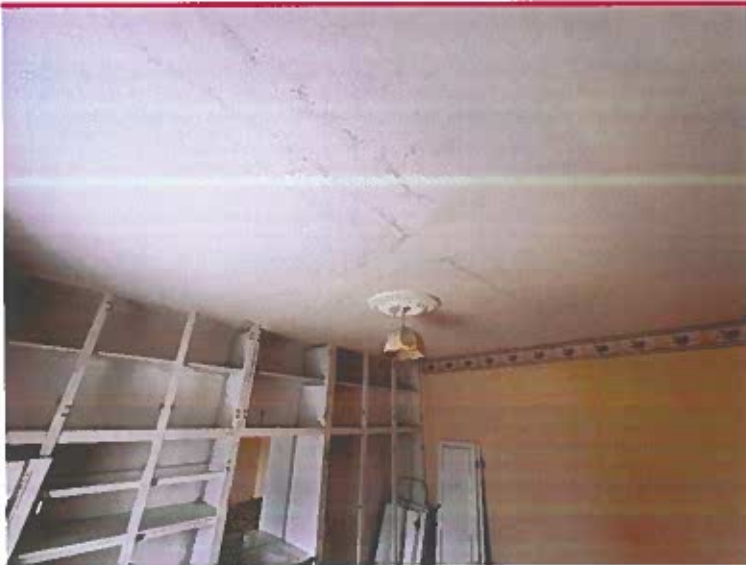
**6.16**

Location Bedroom 2

All finishes in poor condition.  
Recommended to be gutted. All  
Internal completions required.  
Leaks and mould present  
throughout the property. Damp  
proofing works required to make  
this property habitable.

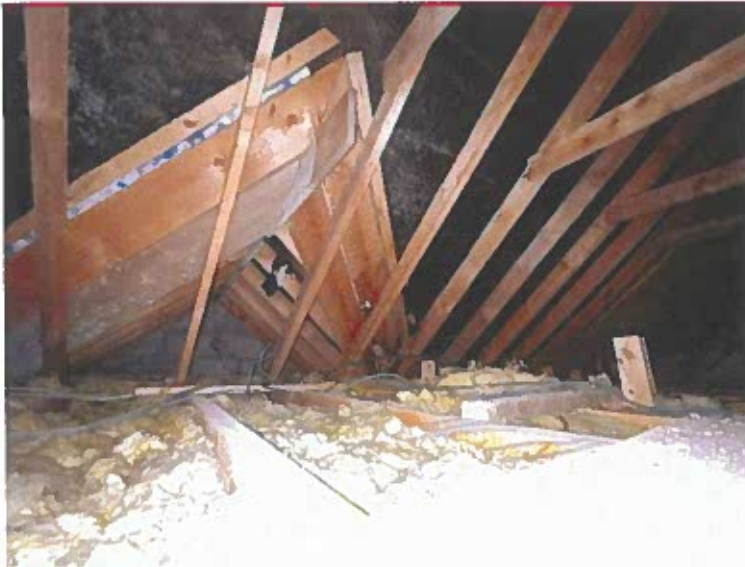
#### 6.19

Location Attic Space

Roof well covered with tiles felt layer needs attention due to coverage. Felt layer deteriorated over time. Flashings suspected to be allowing water into roof structure. Water tank in attic space to be insulated. Attic space overall recommended to be fully insulated with 400mm minimum Rockwool.

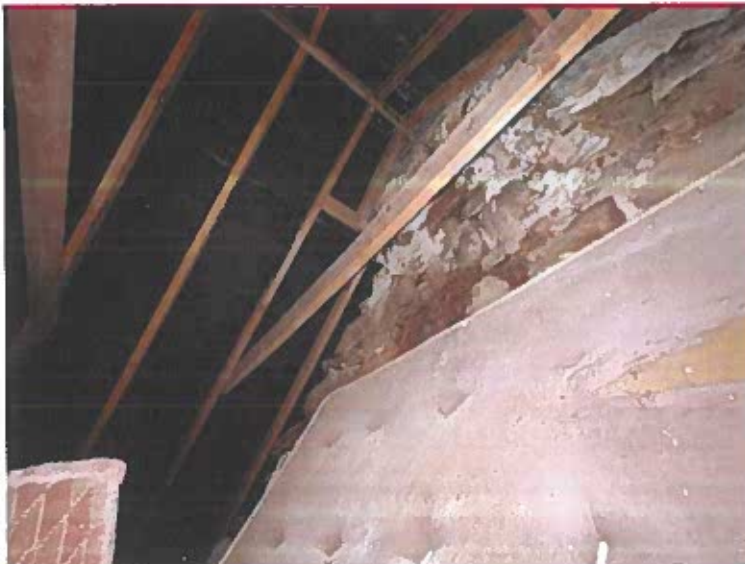
#### 6.20

Location Attic Space

Roof well covered with tiles felt layer needs attention due to coverage. Felt layer deteriorated over time. Flashings suspected to be allowing water into roof structure. Water tank in attic space to be insulated. Attic space overall recommended to be fully insulated with 400mm minimum Rockwool.

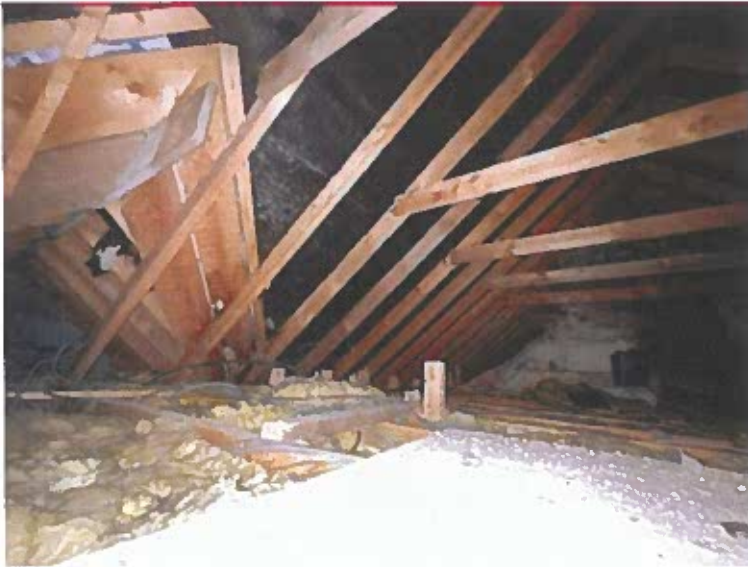
#### 6.21

Location Attic Space

Roof well covered with tiles felt layer needs attention due to coverage. Felt layer deteriorated over time. Flashings suspected to be allowing water into roof structure. Water tank in attic space to be insulated. Attic space overall recommended to be fully insulated with 400mm minimum Rockwool.

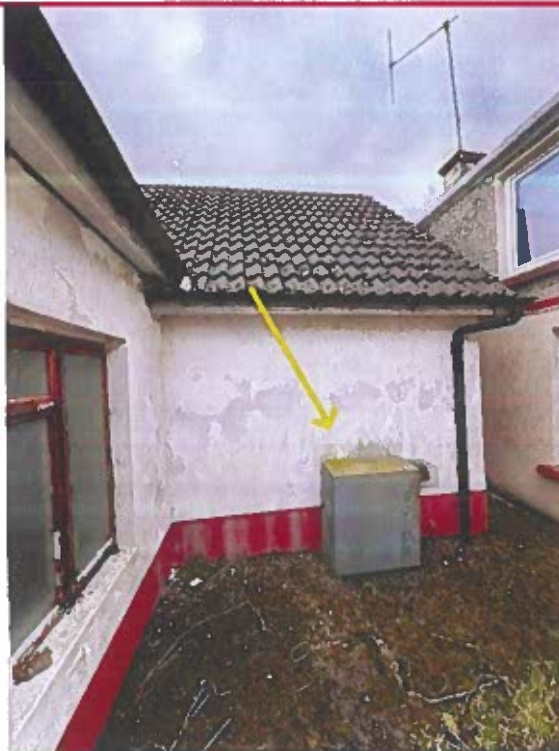
#### 6.22

Location Boiler To Rear

Recommend to have system upgraded. Recommend to have tank and boiler min 1.8 M apart. System has been inactive for a number of years.

Oil central heating system present in the dwelling hasn't been active in several years it would be recommended to upgrade the heating system.

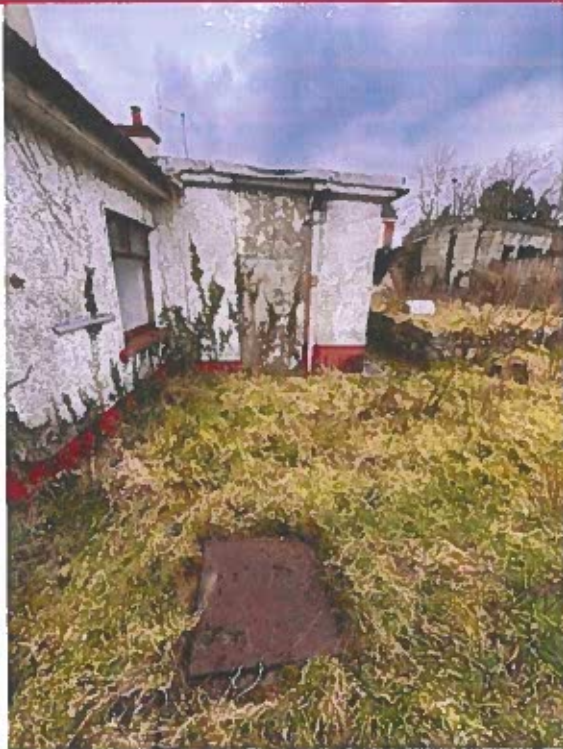
**6.23**

Location Septic Tank Rodding Point

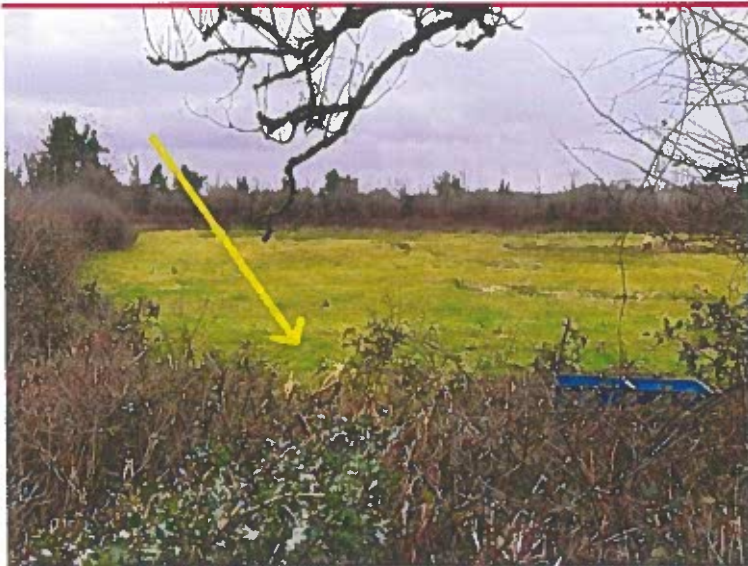
**6.0 24**

Location Septic Tank Location  
Estimated location. Unable to find  
covers. Client has registration  
papers from 2014.

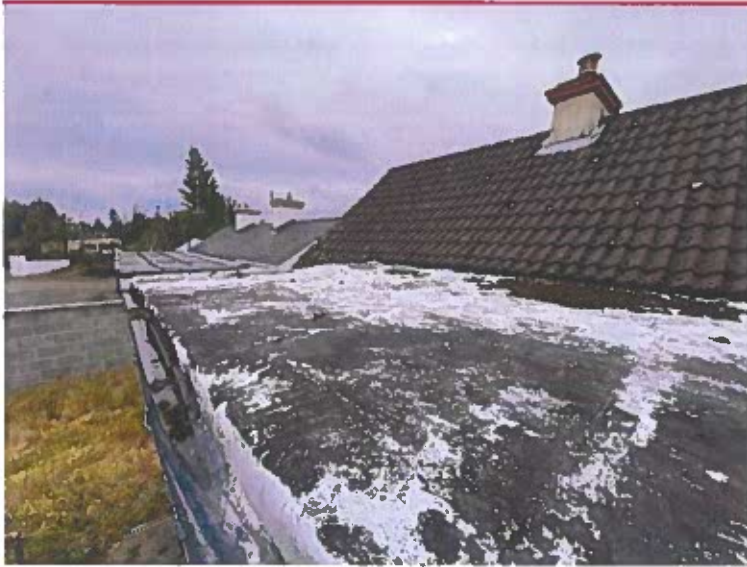
**6.0 25**

Flat roof on the rear of the property in poor condition. This will need to be replaced during the process of renovation and replaced with a warm deck system, Water proofing layer on this is seen as end of life.

Location Flat Roof To Rear

Finished flat room in extremely poor condition. Recommended to completely strip and replace with warm deck system.

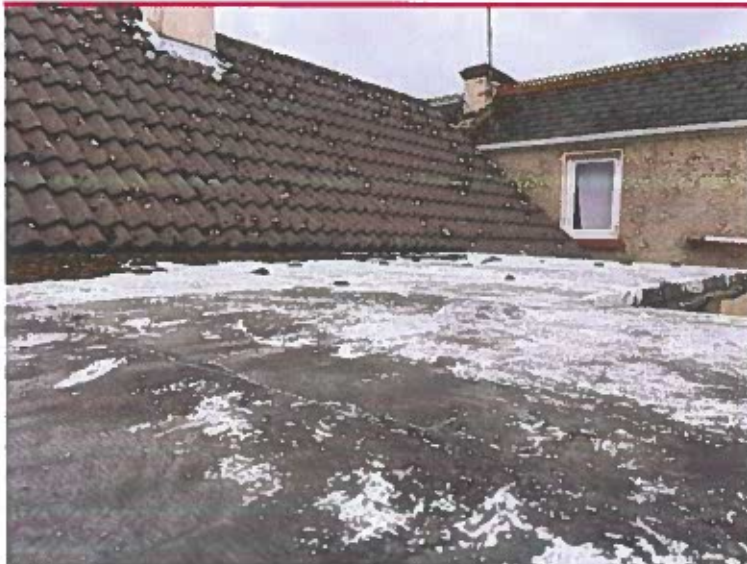
**6.0 26**

Location Flat Roof To Rear

Finished flat room in extremely poor condition. Recommended to completely strip and replace with warm deck system.

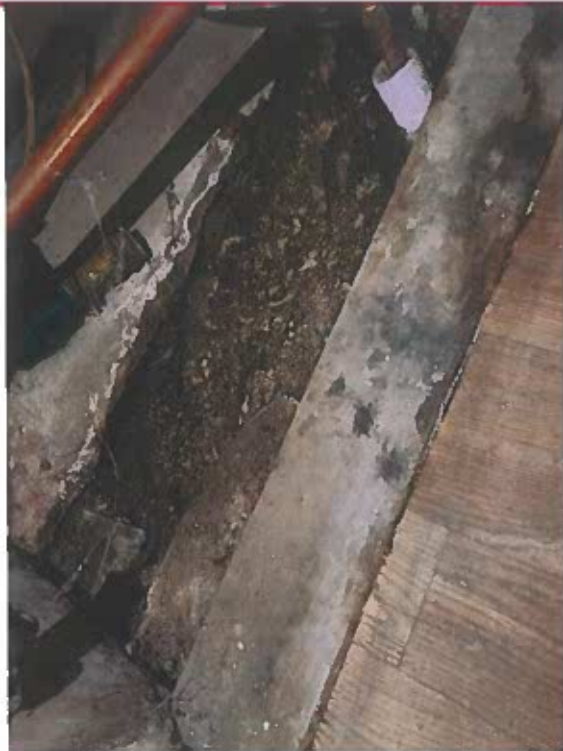
**6.0 27**

Location Floor To Hot Press

And replace with an insulated screed.

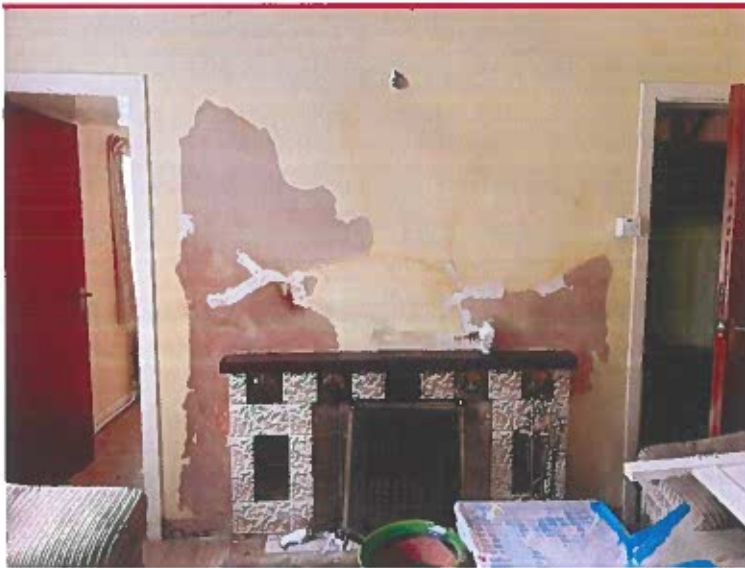
**6.0 28**

There are two chimneys in the house, both in fair condition, works will be required to flashings and both flues. Cracks evident on the face of the living room chimney, soot is seen seeping through the cracks. Discussed with client regarding demolishing chimneys.

Location Chimney Breast

Filled cracks in chimney. Sut appearing on face of chimney through cracks. Discussed with client about demolishing chimney in entirety.

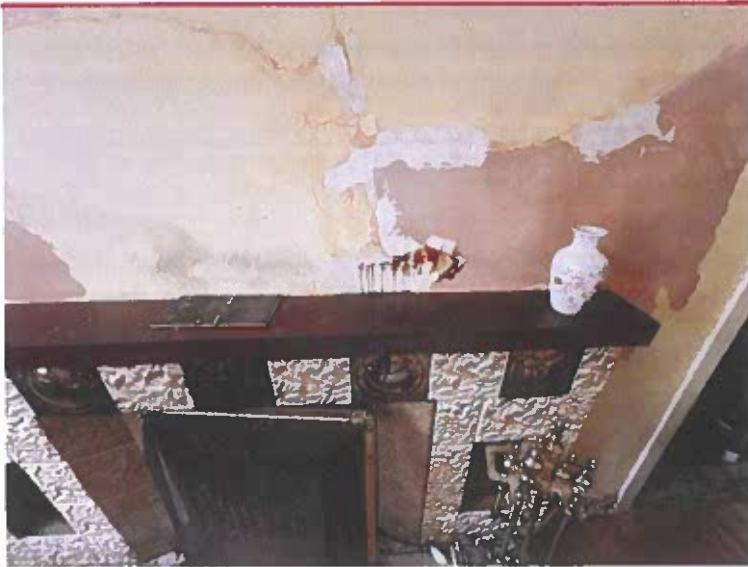
**6.0 29**

Location Chimney Breast
