Hedgerow Translocation

Documenting the successful
translocation of a mature Hedgerow

Croghan, Boyle Co. Roscommon
October 2007

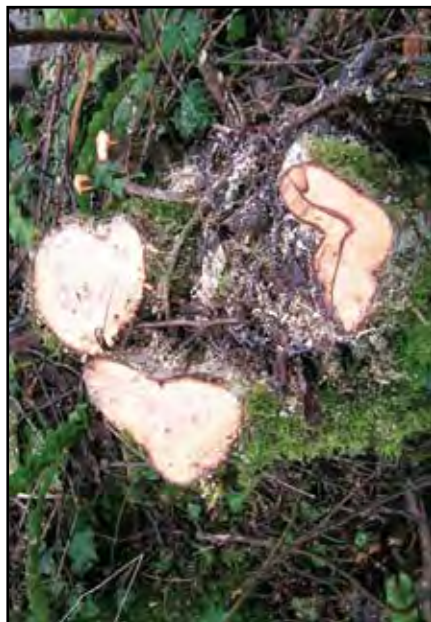
Photo 11: Healthy plant

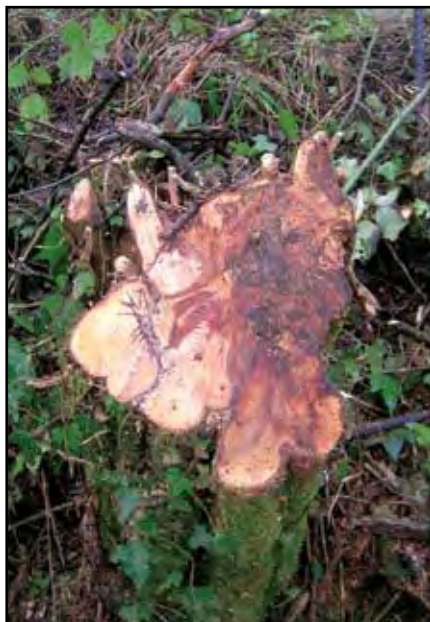
Photo 12: Severe decay

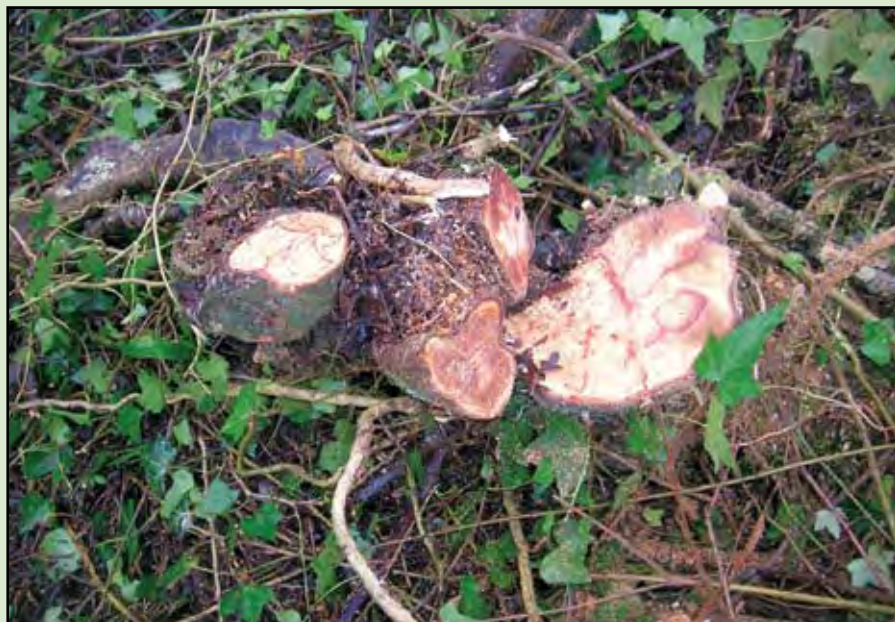
Photo: 13 Moribund plant

It is recommended that gaps caused by failures be planted up with whitethorn quicks of Irish (preferably local) provenance.

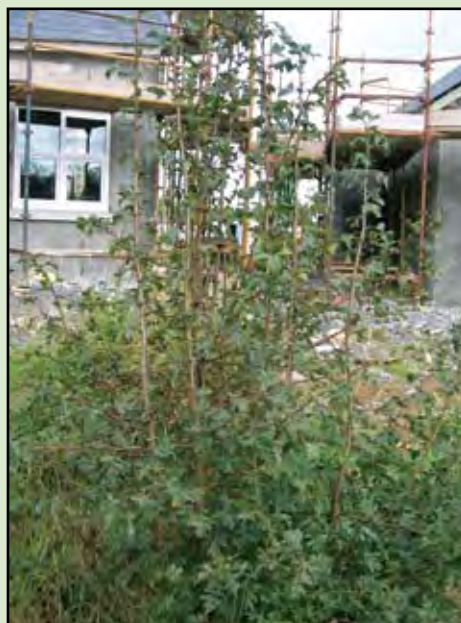
Photo 14: Strong growth from healthy plant

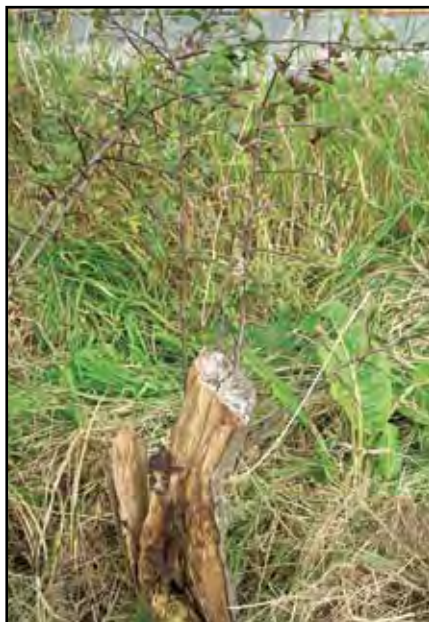
Photo 15: Weak growth from unhealthy plant

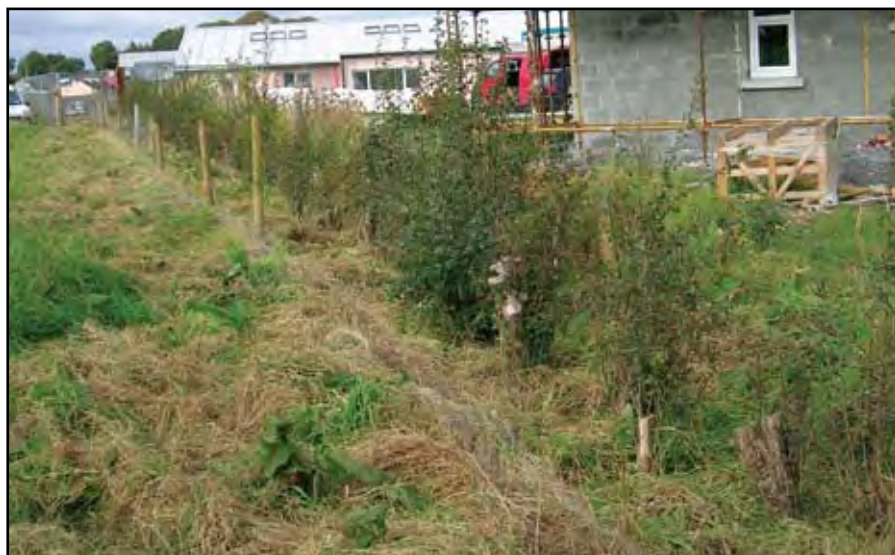
A final inspection of the Phase 1 hedge was made on 5th October 2007 by Neil Foulkes. The hedge had just been manually cleared of invasive grasses and weeds by the staff of Croghan Organic Garden. There was evidence of a few failures during the second year. These correlated with plants that had struggled during year one. However, the majority of plants were growing more than adequately well and a number of individual plants were thriving. The overall height of the hedge was approximately 1.25m, but individual plants had reached a height of 1.8m.

Photo 16: Phase 1 hedgerow at the end of its second growing season

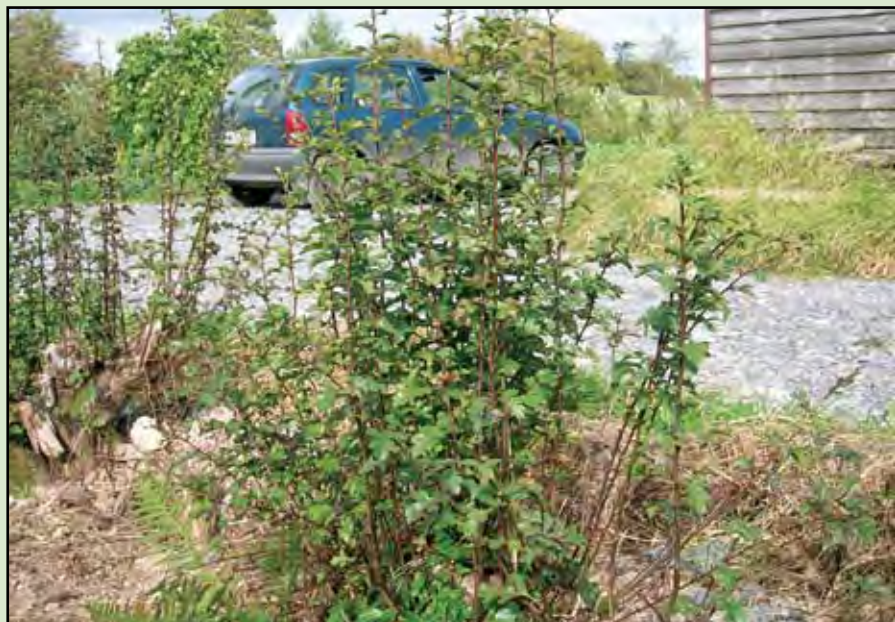
The hedge was inspected by Neil Foulkes on the 2nd August 2007. Survival rates were over 90% and growth rates were generally greater than those observed after a similar period of the Phase 1 hedge. This could possibly be due to the improved technique of cutting at the donor site but it could also have been influenced by the generally larger stems in the Phase 2 hedge; the warm wet summer of 2007 may also have been a factor, it being more beneficial to the plants than the very dry summer of 2006. Staff at the Organic Garden had used a mulch of compost to help control ground vegetation (particularly grasses) around the translocated plants. This appeared to have had an initial beneficial effect but at the time of inspection grasses were beginning to come through and encroach into the mulch. It was recommended that the mulch be topped up.

Photo 38: One years re-growth in Phase 2 hedge

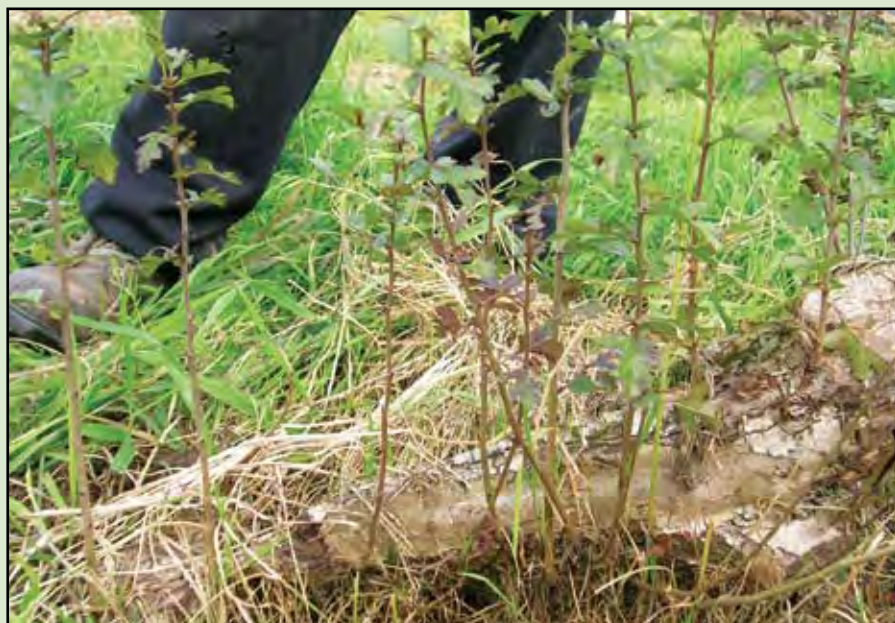
The laid stem had survived and grown well and had thrown up new sprouts of growth along its length. Use of this technique could result in a hedge with fewer gaps from an early stage as well as having a more immediate visual impact.

Photo 39: Laid stem showing multiple sprouts along its length
