## Exploring Roscommon Castle in Medieval Times

## Roscommon Castle: Two Archaeological Reconstruction Drawings

# Roscommon Castle as it may have appeared in 1307

# Roscommon Castle as it may have appeared in 1584

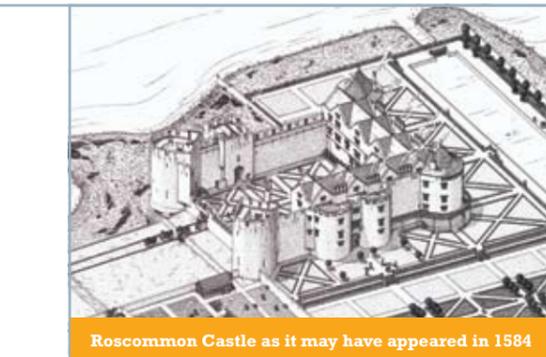
Roscommon Castle as it may have appeared in 1584

The main features of the late 16th century transformation are the replacement of the medieval accommodation in the castle with a large modern house and the modification of the towers and curtain walls to incorporate them into the house. With this went removal of the outer ward and moat and its replacement with a system of geometrical gardens. The new house built in the castle by Sir Nicholas Malby was big, as big as any of the great houses built in Ireland around this time.

With construction of a large new house to replace medieval accommodation that was to include the great gatehouse and the two northern towers, it is likely that the roofs of these towers were remodelled. In keeping with the fortified nature of the house, the reconstruction shows the gatehouse and the curtain walls capped by crenulated battlements, but in a more ornamental style than the relict medieval battlements on the rest of the castle. The gatehouse lies mostly within the new house, while the two northern towers project from it entirely.

In keeping with the remodelled castle's new role as a stately home, a long straight gravelled avenue was created about this time between the town square in Roscommon and the castle. To make the most of the stately new approach to the castle, it is likely that the south curtain was taken down and replaced with a lower wall. This would make the fenestrated upper storeys of the new house clearly visible to visitors as they approached up the avenue. The south curtain is shown replaced with a low wall, battlemented in the style adopted for the exterior walls of the new house and with, at its centre, a new ornamented gateway, complete with machicolated parapet over the gate.

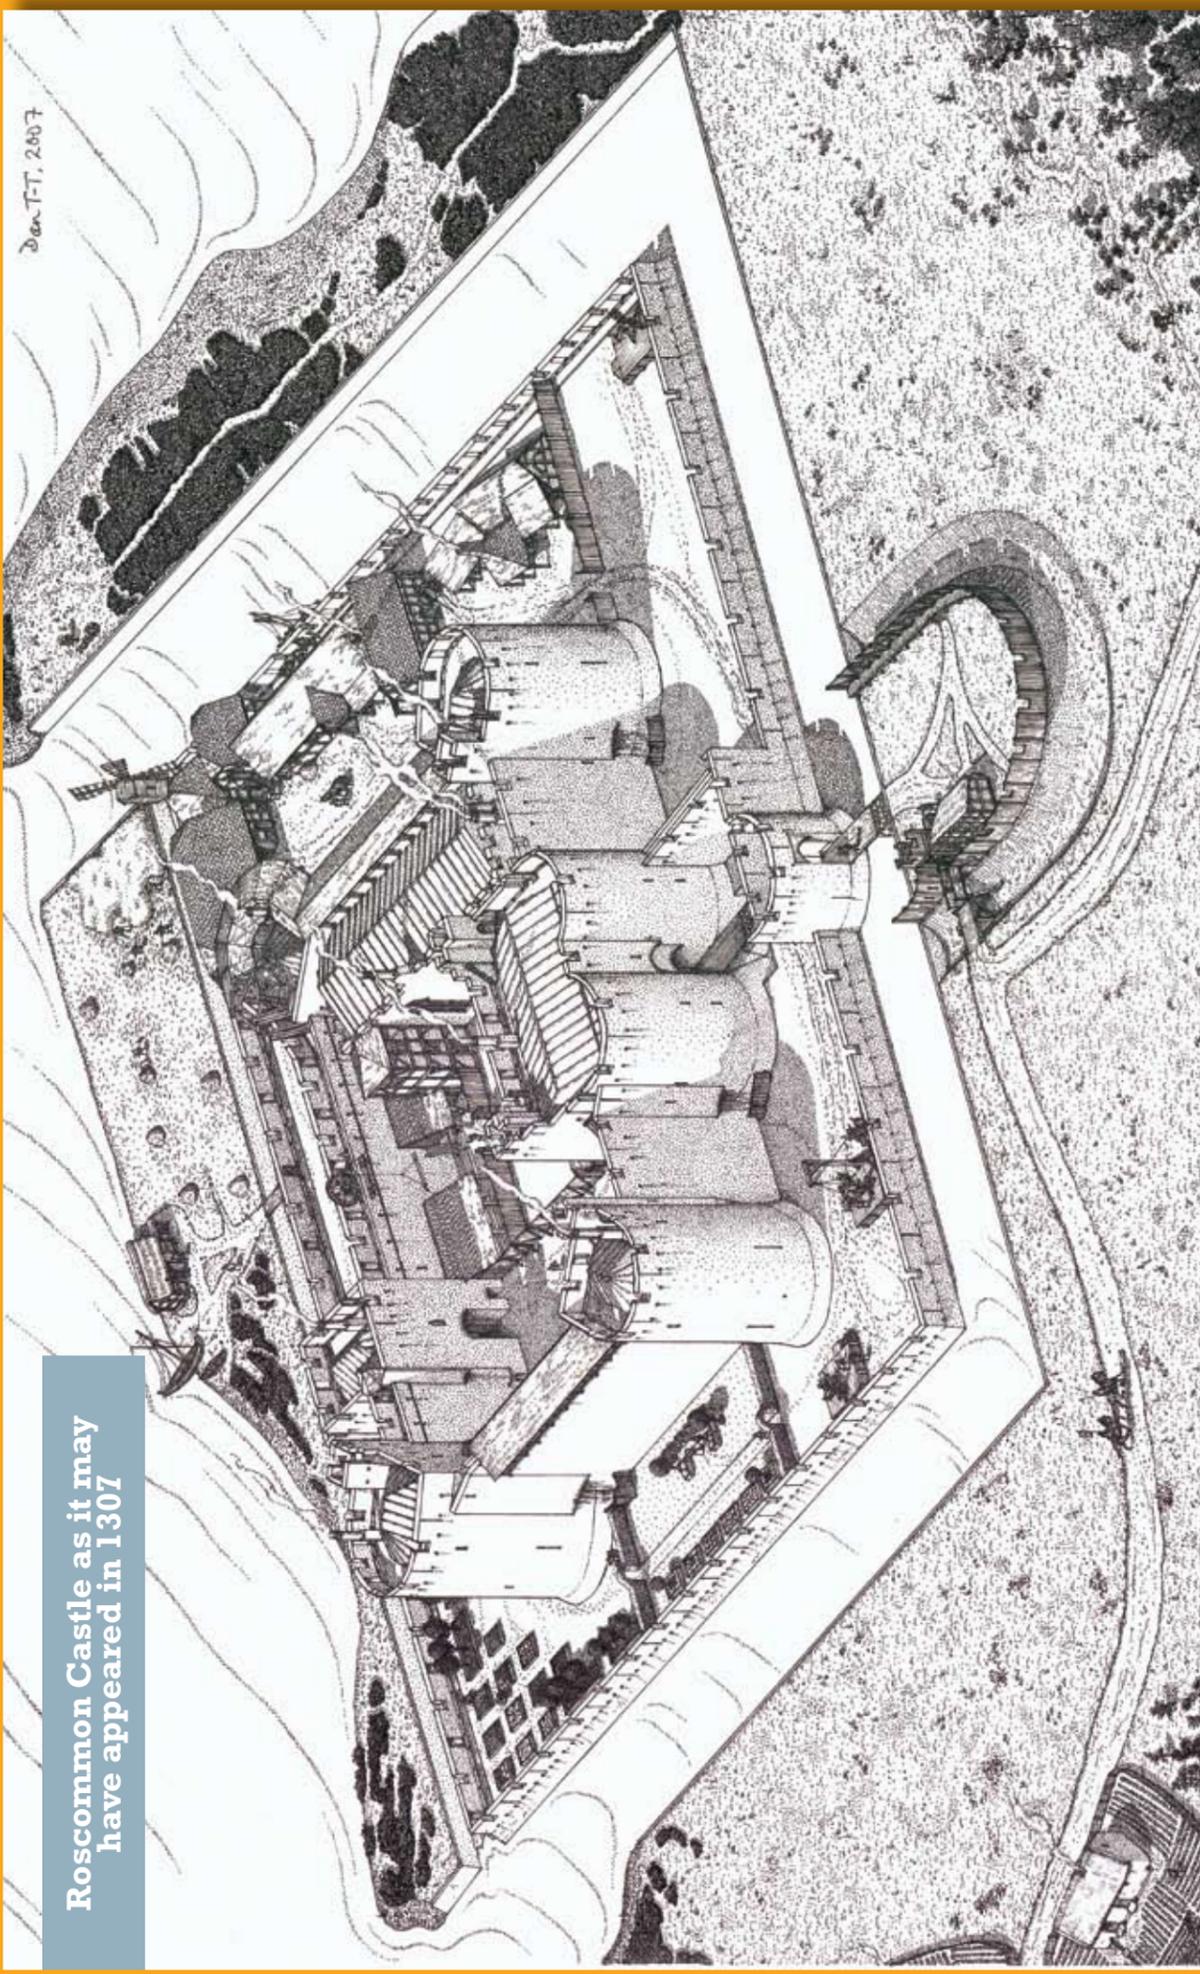
Roscommon Castle as it may  
have appeared in 1307

Work began on Roscommon Castle in 1269 and continued in several phases. The first phase included excavation of the moat around the castle, which would have had a timber palisade erected inside it. The foundations of the inner curtain wall and towers were probably begun during this stage. The second stage saw the building of the inner ward up to 8.8 metres at the wall walk. The third stage of building saw most of the curtain walls raised to about 11.5 metres at the wall walks. In the final stage, the two southern towers were raised by another storey.

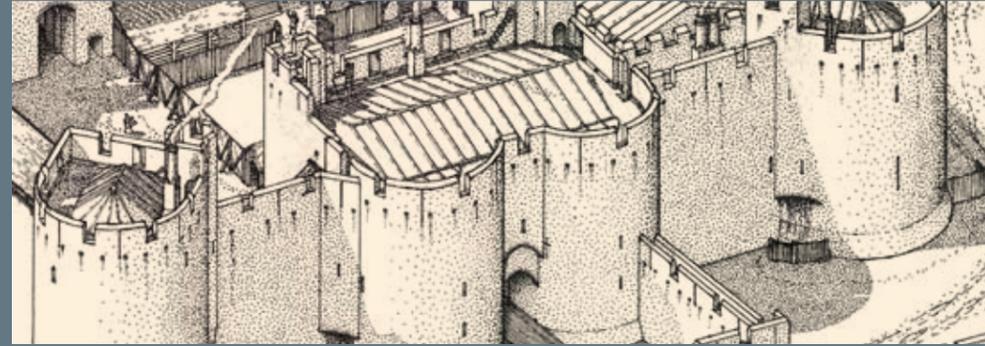
The castle was protected by high curtain walls. It is assumed that the castle walls were lime-washed throughout, both to protect and weatherproof the porous local limestone from which they are built and as a symbol of the castle's royal status, making it highly visible to the countryside around it. The battlement proportions adopted for the curtain walls and the towers of the castle are based on remnants still visible in the later-raised northwest tower. The southeast tower suggests the means of access to its former upper storey, via a spiral staircase. The lower stairways in all the towers are intramural stairs. On the evidence of the southeast tower, it is assumed that each tower once had spiral stair access to the roof, with a cap-house or a turret to keep rain out of the stairwell. The towers at Roscommon are all shown capped by a small turret. The great gatehouse is shown with a turret at each of its interior corners.

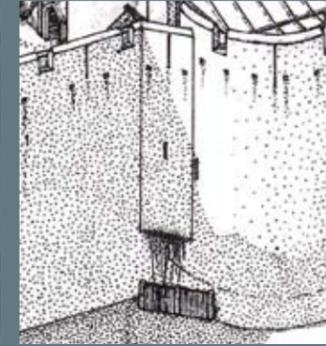
The garderobes hang on squinch-arches across the angles between the towers and the adjacent curtain walls. The open-air accumulation of human waste at the foot of the garderobes is shown hidden from general view by timber fences.

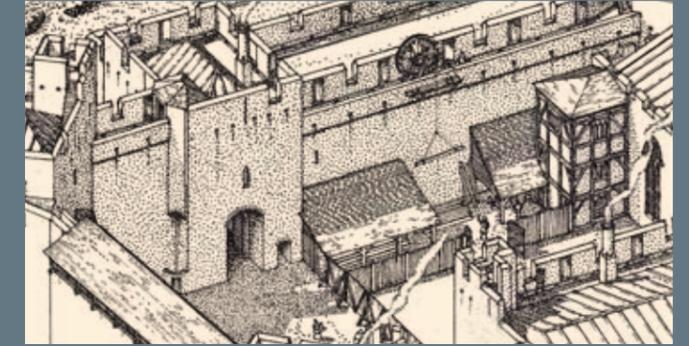
A fenced yard is shown against the west curtain wall in which material is being prepared for the ongoing construction of the wooden hoarding. As well as showing covered storage and workshops in the yard, timber is shown being winched up to the battlements using a large hand-turned wheel. Outside the yard, a timber fence further divides the ward into a ceremonial area enclosing the hall and great gatehouse, and a service area entered through the postern gatehouse. Half-timbered buildings for the servants and soldiers of the castle and perhaps a stable might have stood against the south curtain wall.

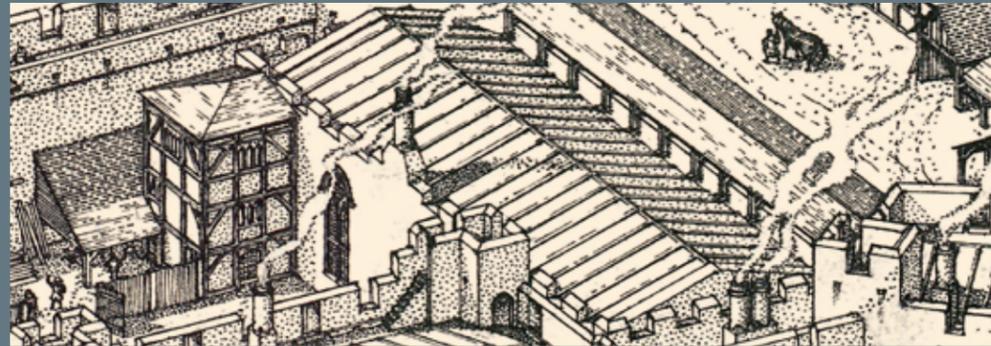
In the records for 1304 there is reference to a hall in the castle. The reconstruction shows the hall against the north curtain wall. This allows its large inward-facing windows to face south for maximum illumination. It also places it alongside the probable location for the medieval kitchens, up against the east curtain wall, north of the great gatehouse, where two large fireplaces suggest the later Elizabethan kitchens were also located. Between the kitchen and the lower end of the hall would have been a service passage flanked on opposite sides by a buttery and a pantry. Lead was the most likely roofing material. Expensive to buy in the first instance (less so if the sheeting was manufactured on site), lead was economical in the longer term because it could be stripped off when damaged or worn and simply melted down, reworked and replaced.

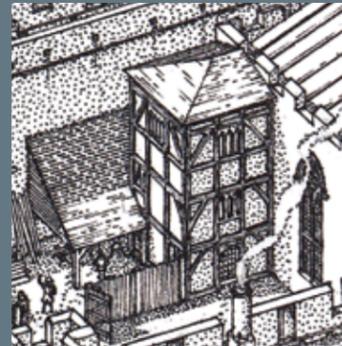
An oriel mentioned in 1304 as in need of repair was probably a projecting wing, most probably on the upper end of the hall. It is shown in the reconstruction as half-timbered with two storeys. The lower storey may have provided a private entrance to and antechamber off the upper end of the hall, perhaps with a stairs up to the second storey. The second storey is likely to have served as a chapel, as was common in medieval oriels.

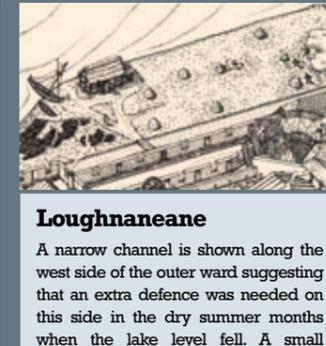
A narrow channel is shown along the west side of the outer ward suggesting that an extra defence was needed on this side in the dry summer months when the lake level fell. A small postern gate is shown in the west wall to give access across the moat to the ephemeral island just west of the castle, where boats are shown moored beside a temporary shed and also men cutting hay. A simple wooden bridge is shown accessing the island, but steps into the ditch from both sides are just as likely.

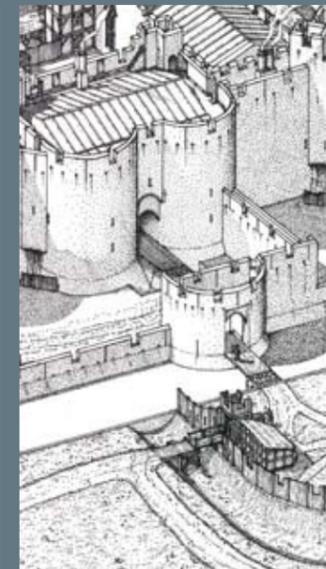
Roscommon Castle was capable of concentric defense, in which archers and crossbowmen on the higher walls of the inner ward could fire over the heads of defenders at the outer wall and, if the outer ward were captured, they could then also fire down on the enemy confined within its space.

Ballistae – crossbow-like siege engines that fired large arrow-like quarrels – are shown being erected on wooden platforms that will permit them an arc of fire over the battlements. The engines are mentioned in records from 1307 when artillerymen were assigned to repair them.

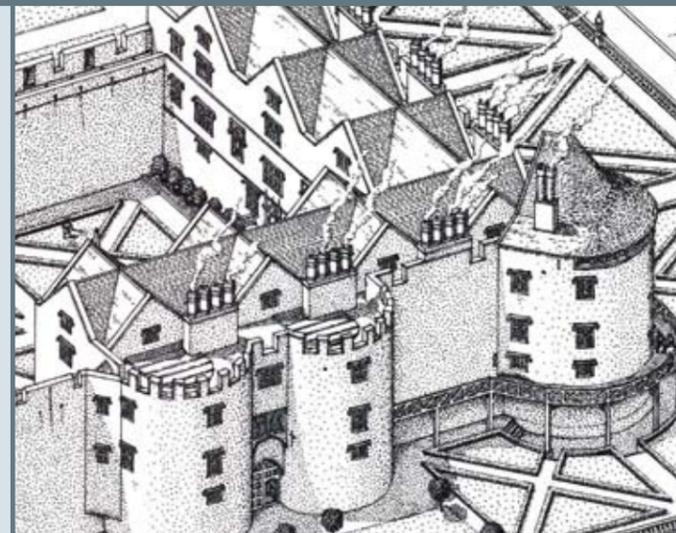
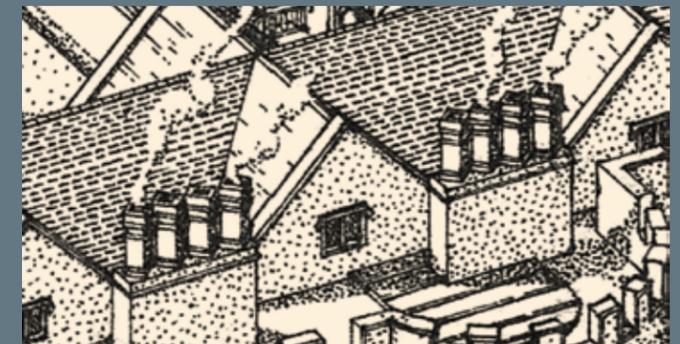
The house comprised four storeys capped by attic rooms in triangular-gabled roofs. In keeping with its continuing defensive role, the lowest storey is unlit by windows and access to storage rooms at this level was probably from the gatehouse passage. The position of windows in the new house is largely unknown except where new ones were opened up in the medieval walls. It is assumed that fireplaces and chimney flues were all within the thick outer walls of the house as we see them today in the east curtain wall of the castle. Towers were transformed internally to incorporate them into the new accommodation.

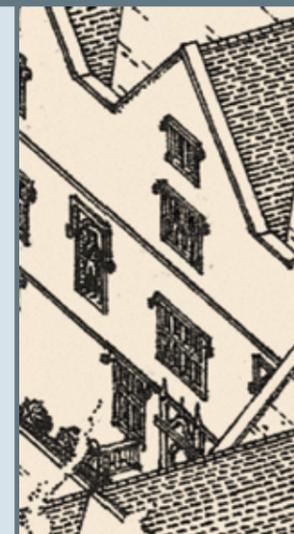
The lowest windows and the attic windows are simple two-light mullioned windows. Between these, the windows of the third and fourth storeys are either four-light or eight-light mullion and transom windows, diminishing in size from the third storey up to the fourth storey in a very elegant proportional arrangement. The full length of the third storey on both sides of the courtyard was framed above and below by two carved string courses.

Just visible at the centre of the second storey is an ornamented entrance. Also visible is one of two tall four-light windows placed either side of the entrance and a balustrade at the top of the staircase up to the entrance. Two round-arched semi-cylindrical niches with statues are shown on either side of the window above the entrance.

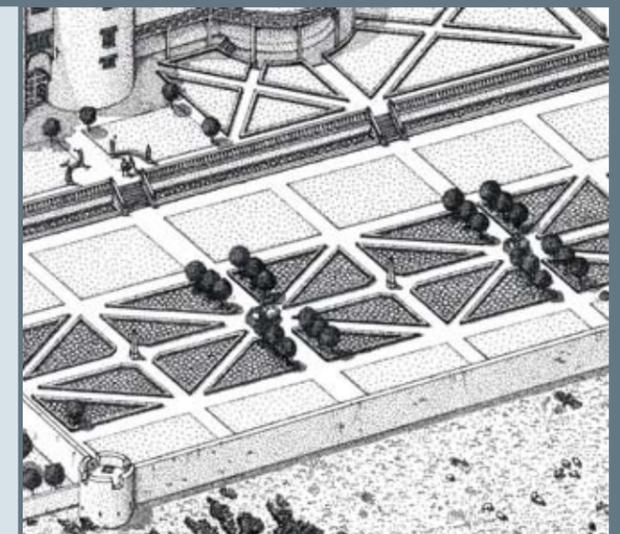
A couple of features of the ground outside the castle indicate that ornamental gardens were installed there to complement Sir Nicholas Malby's great house. One of these is the walled enclosure to the east of the castle. The wall is up to four metres tall and had a cylindrical flanking turret at its southeast corner, originally one of a pair with the other probably at the north end of the east wall. The southern stretch of this wall extends across the line of the medieval moat to join the southeast tower of the castle, indicating that the moat was filled in at this time.

The gardens are shown as simple design, while still trying to evoke the idea of a geometrically designed garden of the period. Thus, gravel paths divide the garden into squares or rectangles, themselves often subdivided by diagonal paths. The gardens as a whole are shown terraced on two levels to allow for the slope immediately outside the castle walls. Stone balustrades are shown at the edge of the upper terrace as well as along the garden edge facing the lake to the west. The upper terrace, which embraces the castle on three sides, is divided simply into hedged and un-hedged lawns except in front of the gatehouse, where some ornamental trees and statuary define the main avenue into the garden. The lower terrace is divided into two parts.

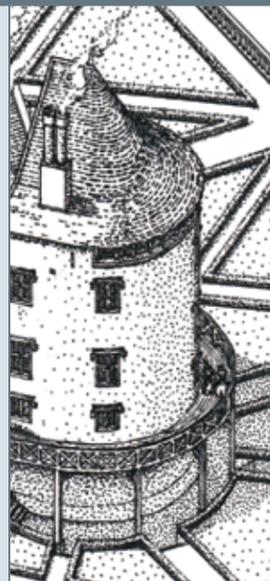
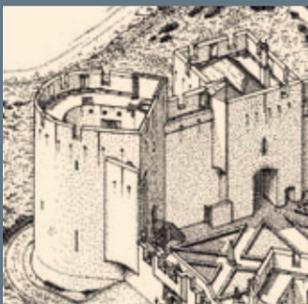
It is likely that the castle towers were capped with conical roofs in the French style. In light of Sir Nicholas's early military service in France, it seems reasonable that he would have done something similar at Roscommon, thus making the towers very much part of his modern new house.

The reconstruction shows the battlements of the northeast tower with an open viewing platform, the roof above supported on wooden posts. This would have provided long views out over the gardens and the surrounding countryside. There is a second storey door in the east curtain wall just north of the gatehouse, this door has no useful purpose other than to open onto a platform running along the outside wall. This is interpreted as a wooden viewing balcony, and is shown to extend around the northeast tower and along the north face of the castle. From it, household members and visitors could view the gardens on both sides of the house.
