Conservation Architect's Report on Owen O'Connor Mausoleum, Ballintubber, Co. Roscommon.

Date: 19th November 2020

Ref.: P20-033 (02)

This report has been prepared on behalf of Roscommon County Council to record the condition of the ruins of the Owen O'Connor Mausoleum, Ballintubber, Co. Roscommon. Ballintober Old Graveyard is an important archaeological site, with interments dating back to at least the seventeenth century. The subject mausoleum is one of a group of four rectangular mausolea, of limestone construction with sloped stone roofs within the ruin of a medieval church on the southern boundary of the graveyard. These unusual structures are individually (and as a collection) of considerable architectural, artistic, archaeological, historical, technical, and social significance, and make an important contribution to this historic ecclesiastical site. The NIAH survey (Ref. 31815002) identifies the graveyard as having Regional Significance, noting the quality of the eighteenth and nineteenth century grave markers, its historic interest as the site of an earlier church, and the presence of a holy well, *Tober Brida*, from which the townland takes its name.

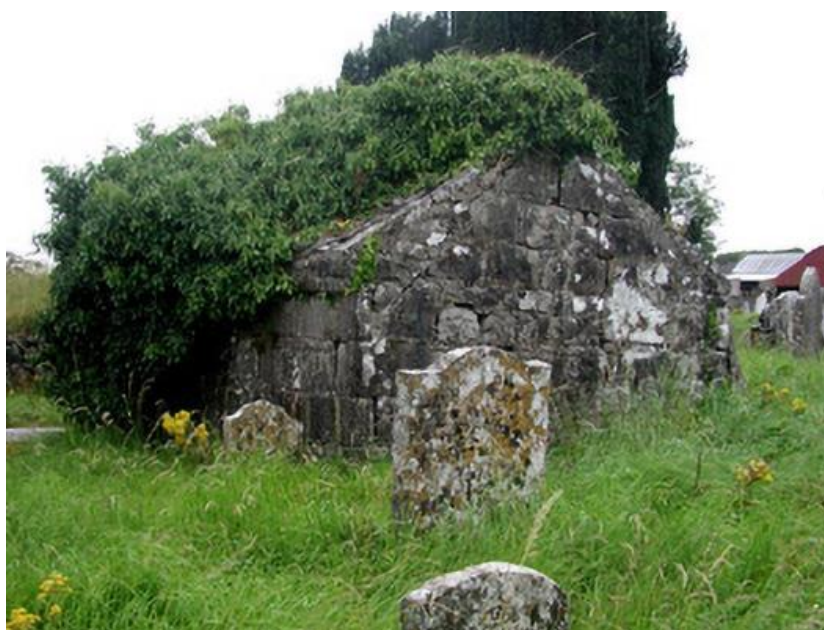
The subject mausoleum was built in 1762 by Owen O'Connor and his wife Catherine McDermot. There is evidence of some alteration following the initial construction of the structure, with photographs taken prior to the collapse of the east gable showing a change in the stonework that is suggestive of an alteration in the slope of the roof at the east end of the mausoleum. The west gable is dominated by a substantial memorial plaque and shows no signs of similar disturbance.

Fig. 3 Photograph of the east gable prior to the collapse of the stone facing, taken as part of the NIAH survey in August 2003 (NIAH ref. 31815002). The use of smaller stones under the barge is quite different to the cut stone lower down and suggests that the slope of the roof may have been changed.

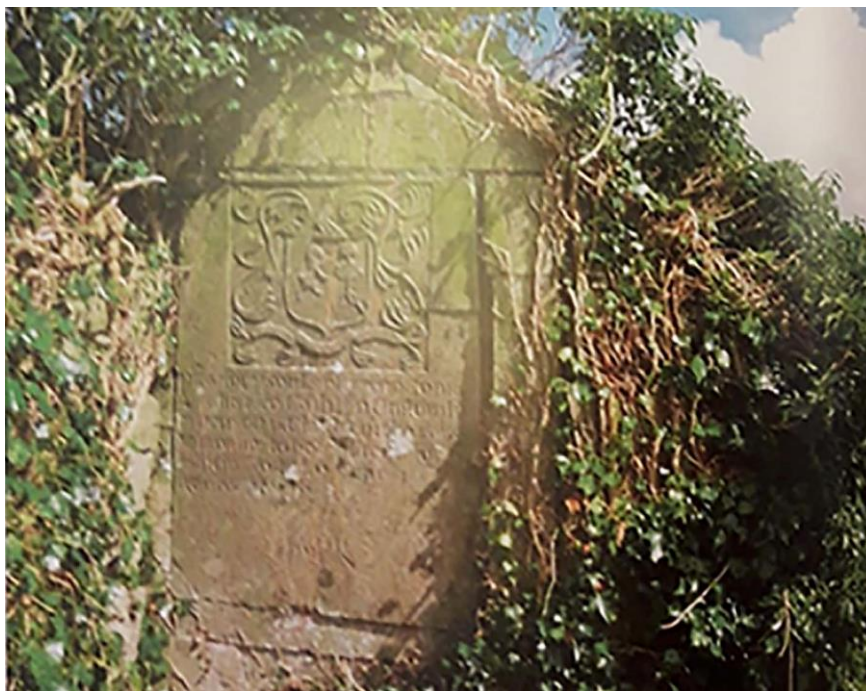
The mausoleum is a single storey east-to-west rectangular structure and is constructed of light grey limestone, with a double pitch roof. The external walls are made up of squared stone blocks, with the exception of the upper part of the east gable, where smaller and more irregular stones are used. Given the quality of the cut stone elsewhere on the external walls, it is probable that this more random stone is linked to a change in the slope of the roof following the initial construction of the structure. The apparent line of an earlier, more steeply-sloped, gable is visible where the stone changes (*Fig. 3*). The stonework on the west gable is more consistent, comprising squared limestone with a central (large) limestone memorial plaque, engraved with a coat-of-arms and text (*Fig. 4*) – *'Pray for the souls of owen o'connor & his wife Cathe O'Connor alias McDermott & Children who caused Y monument to be Erectd for them & their Posterity. June Ano Domine 1762. MK³*. It is possible that the introduction of this memorial plaque coincided with the change in the slope of the roof.

Fig. 4 Engraved memorial plaque on west gable (2018, reproduced from Timoney, P. 182)

j) Cleaning of engraved stone memorial plaque on west gable

The surface of the limestone memorial plaque should be sprayed with a biocide, kill back algae, lichen and other biological growth. Once this has been allowed to work the 2-3 weeks, the surface of the plaque should be cleaned using a mix of warm water and non-toxic washing-up liquid (such as 'Ecover'), to be worked with a soft nylon brush. The stone should then be rinsed with warm clean water.

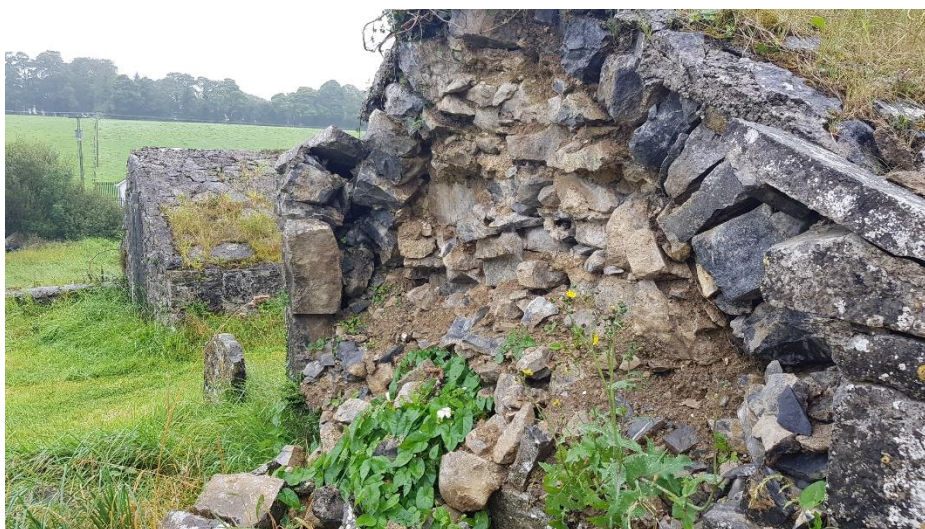
The construction of the mausoleum can be seen at the collapsed east gable (*Fig. 5*). The mausoleum chamber comprises a vault of roughly-hewn limestone, which was then faced with a squared limestone outer wall. The double-pitched roof is made up with flat limestone slabs, of random shape and size, bedded in a lime-based mortar (*Fig. 6*).

Fig. 5 Detail showing exposed inner vault construction at collapsed east gable of Owen O'Connor Mausoleum.

There was no access to the interior of the mausoleum. The inner leaf of the east gable wall, which is visible where the outer stone has collapsed, is of stone rubble construction.

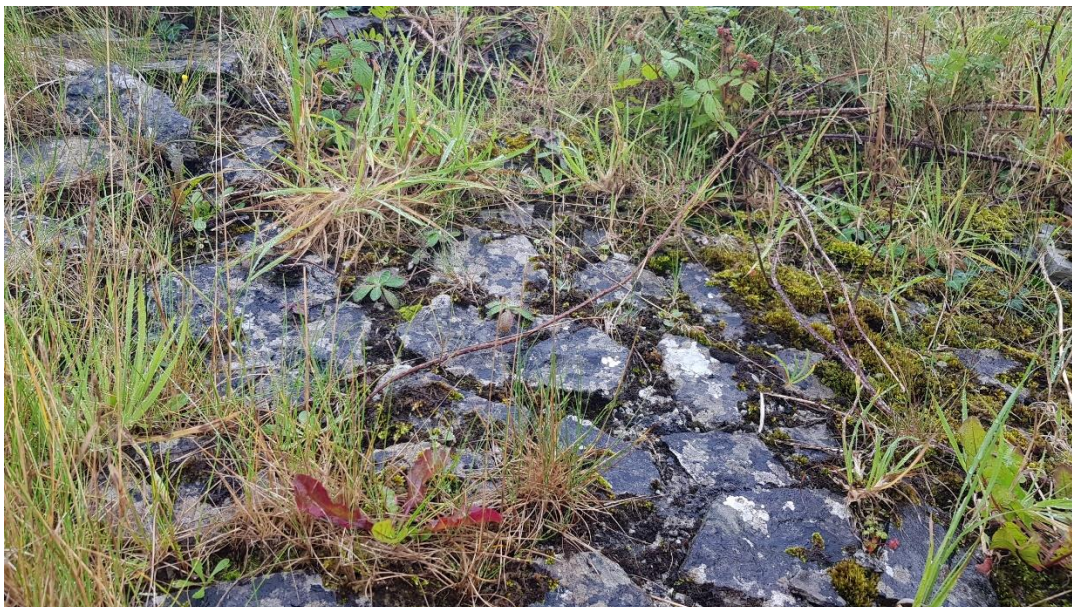
Fig. 6 Detail of flat limestone random slab finish to pitched roof of Owen O'Connor Mausoleum

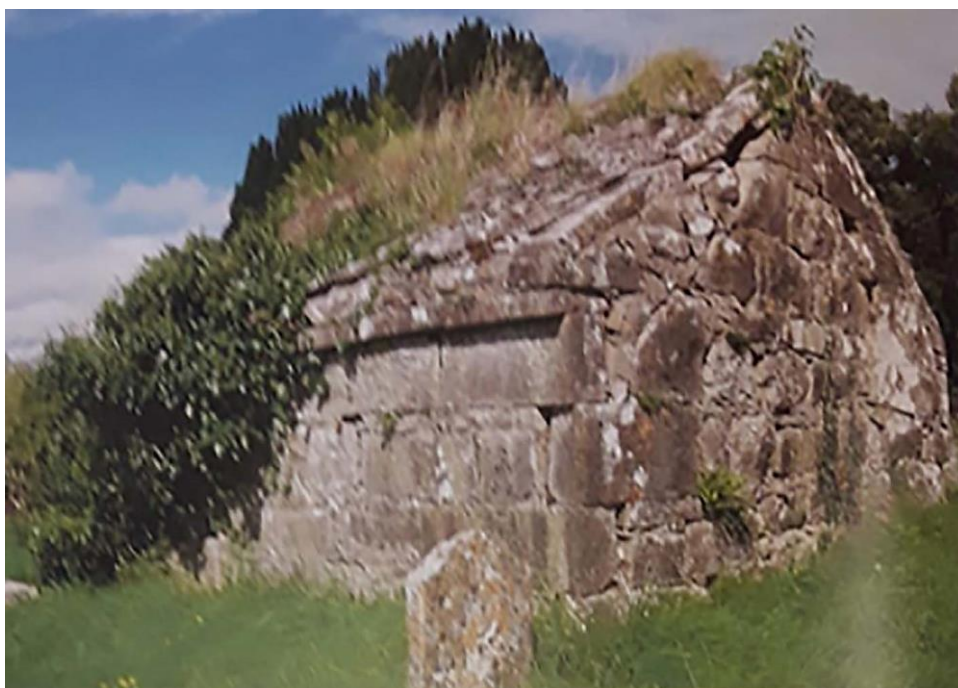
The squared stone outer face of the east gable has collapsed outwards. The stones for this gable remain on site and are lying in the grass in front of the mausoleum. This collapse is relatively recent and appears to have been primarily caused by water ingress through the roof and through gaps in the random stone at the top of the gable (*Fig. 7*) over a prolonged period of time. This facilitated a gradual erosion of the aggregate within the core of the wall (i.e. between the inner and exterior stone facing), with the loss of this material causing the bond between the two faces of the wall to weaken over time. The problems with the east gable may have been compounded by some settlement in the ground at the base of the wall.

Fig. 7 Photograph of east gable shortly prior to its collapse, showing large gaps in the stone rubble under the south barge (2018, reproduced from Timoney, P. 182)

e) Reconstruction of collapsed east gable

The reconstruction of the gable should be carried out using the salvaged stone from the site (see item c) above). The reconstructed stone should follow the layout and configuration of the numbered stones as agreed with the conservation architect. The core of the wall (i.e. between the inner face and the reconstructed outer face) should be filled with a compacted dry mix of medium-size limestone gravel, sand and lime. Allowance should be made for the use of helical flexible stainless steel reinforcement bars and stainless steel ties, to act a stitch reinforcement between the retained inner leaf and the reconstructed outer face of the gable; and to reinforce the masonry at the corners (i.e. junction of the east gable and the north and south walls) and at the barge (junction with the roof). This reinforcement should comprise a series of stitched connections in multiple locations. The introduction of more invasive structural supports would be harmful to the integrity of the structure and is not recommended. Where there are wide joints or gaps between the stones, particularly where there are smaller stones at the top of the structure, these should be packed at with smaller stone gallets (flat stones) and pins (pointed stones).

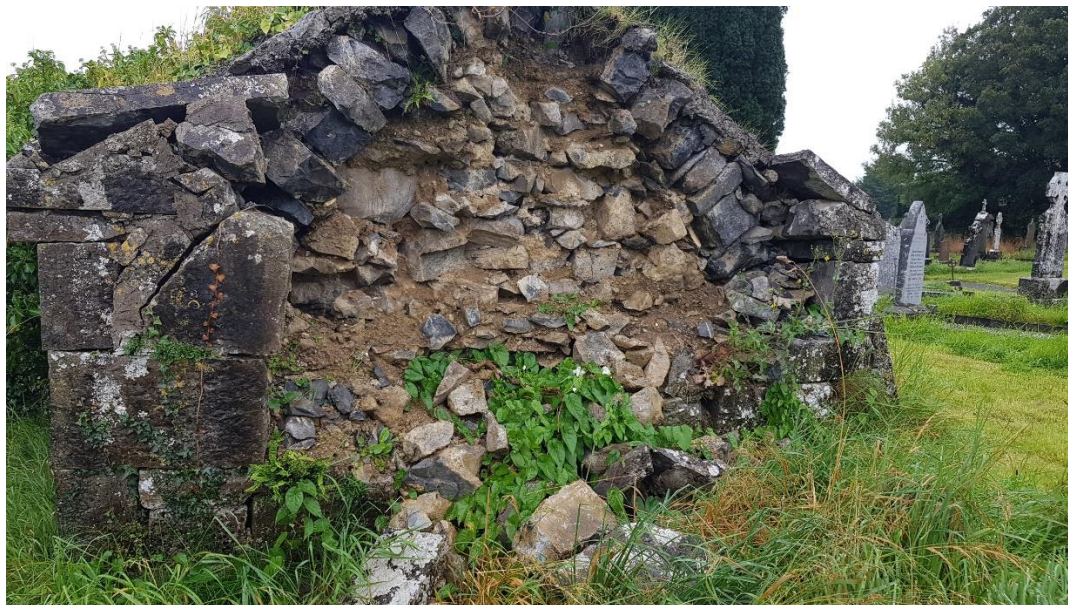
The inner wall of the east gable, which is of random stone rubble construction, is now exposed following the collapse of the outer face. This inner wall was not constructed to act as a single leaf wall or to be exposed to the elements. While the inner wall is not currently showing signs of imminent collapse, it is likely that the stone rubble will begin to break down over the short-to-medium term. The exposed core of the wall, which comprises a mix of aggregate and lime, had almost entirely washed away from the upper part of the stone rubble inner wall on the date of inspection and is likely to wash away from the base of the wall over a relatively short period of time (*Fig. 8*). The wall is also very vulnerable to damage from vandalism. The presence of bindweed and other vegetation, which is now rooted in the wall, is likely to further weaken the structure.

Fig. 8 Detail of collapsed east gable

c) Recovery of stone work from collapsed east gable

The loose stones from the collapsed gable, which are lying on the ground to the immediate east of the mausoleum, are to be carefully recovered. These stones are to be carefully sorted by size and shape, with particular care to be taken to identify the external face of each stone. The stone mason is to meet the project conservation architect, who should be a RIAI Grade 1 Conservation Architect with experience of comparable work, to loosely lay out the salvaged stone to match the configuration of the east gable prior to its collapse. Particular care is to be taken to replicate the sloped line, possibly associated with a earlier roof slope, which was a feature of the collapsed gable. Once this loose arrangement of stones has been reviewed and agreed, the stone mason is to chalk mark the face of each stone for identification purposes.

d) Investigation of base of the wall at the collapsed east gable

The base of the collapsed east gable is to be investigated by an engineer with comparable conservation experience, working in conjunction with the project conservation architect. The purpose of this investigation will be to establish if the lower portion of the gable is sufficiently robust to act as support the reconstructed outer face of the gable. Depending on the outcome of these investigations, it may be necessary to underpin or introduce a footing at the base of the wall. Allowance should be made for archaeological supervision of this investigative work.

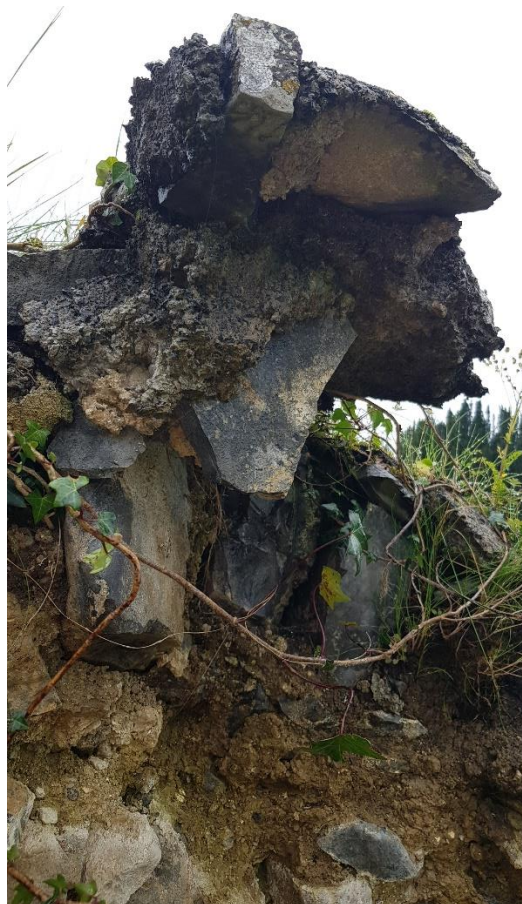
Fig. 9 Surviving stone from ridge of roof overhanging collapsed east gable

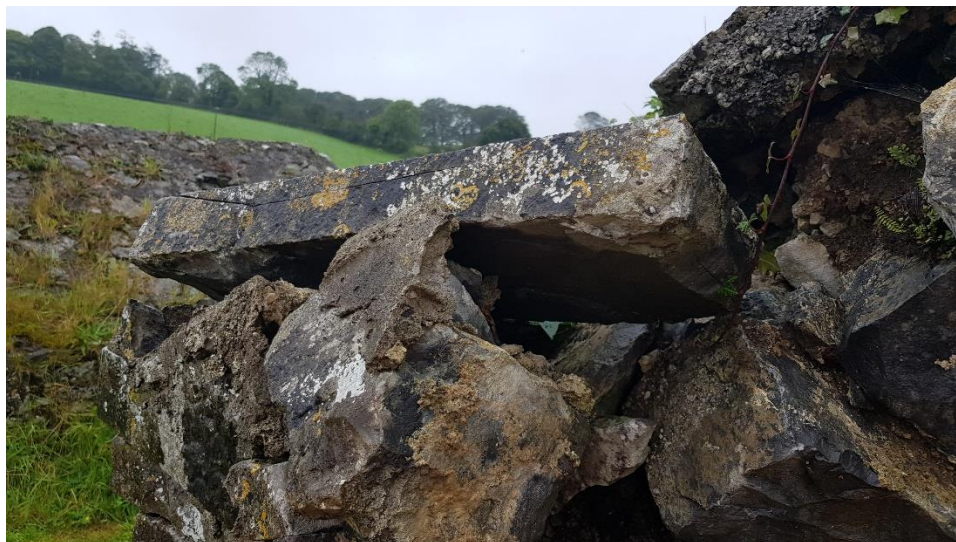
The composition of the roof comprises smaller stone slabs of random shape bedded in mortar onto the top of the wall. This roof construction remains relatively intact, with no signs of movement or delamination of the stone covering, apart from the section of the roof abutting the collapsed east gable. The relatively wide gaps between the stone slabs has facilitated water ingress through the joints and this has led to the growth of grass and other vegetation in the gaps between the stone. Some remedial work was carried out to the roof during the twentieth century, with modern cement mortar pointing evident between some of the joints in the stonework. The continuous growth of this vegetation will eventually cause significant deterioration in the composition of the roof over time. The covering of the roof nearest to the east gable is in a very fragile condition (*Fig. 9*). Part of the barge structure has begun to unravel and there are loose stones near the edge of the collapsed gable. It is likely that the surface of the roof will continue to unravel backwards (i.e. to the west) from this unstable edge (*Fig. 10*). The loss of this cover from the roof poses an imminent serious threat to the structure.

Fig. 10 Loose stones at edge of roof and east gable

h) Works to the roof

The roof of the mausoleum has been subject to water penetration and weathering stresses far in excess of those experienced by the wall face. All vegetation should be killed off and removed in tandem with the re-pointing and consolidation of the roof. Each of the mortar joints in the roof should be checked. Any loose or friable mortar should be carefully removed using hand tools to facilitate re-pointing. The roof includes areas of cement mortar pointing, which should be removed by an experienced stone mason using hand tools, taking particular care to avoid disturbance to the surrounding masonry. The contractor should notify the conservation architect, where larger pockets of cement mortar are identified, which are too large to remove without causing damage to the ruin. On removal of the vegetation and any past mortar pointing, it is crucial to consolidate the roof build-up prior to re-pointing. Any loose stones should be lifted and re-bedded. The lifting of stones should be limited to only those locations where the existing stones are loose. Any stones that are lifted should be re-bedded in the same configuration. Where there are wide joints or gaps between the stones, these should be packed at with smaller stone gallets and pins. Particular care should be taken to ensure that the slope of the roof is consistent, with no dips or hollows that would allow water to collect and seep into the structure. The new bedding mortar should be a natural hydraulic mortar (NHL 3.5). The recommended mix is NHL 3.5: Sand aggregate in the ratio 1:2½. The sand aggregate should be sharp, coarse limestone sand (10mm down, gauged with a fraction of fine limestone aggregate to improve workability). The mortar pointing should be finished flush with surface of the stones on the roof of the mausoleum, to facilitate water run-off.

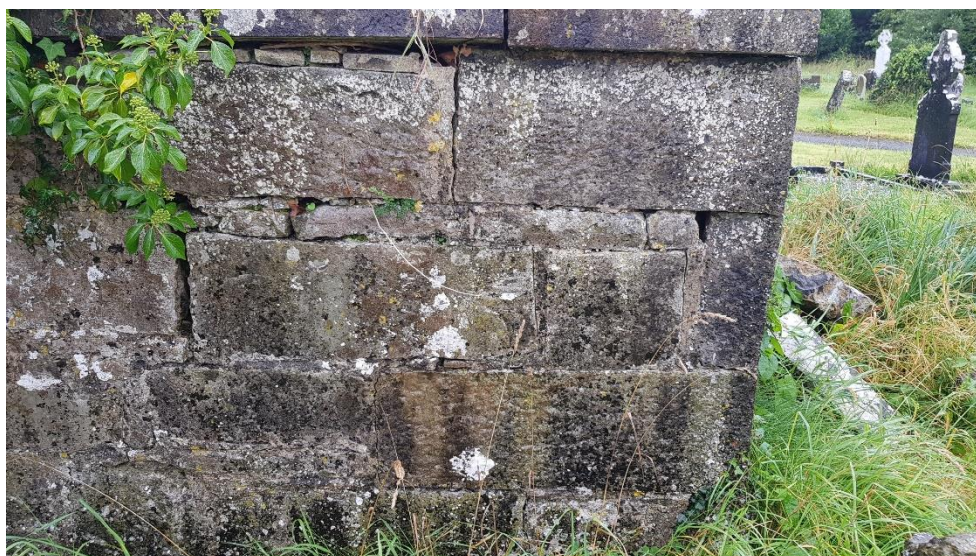
The walls on the remaining three sides of the mausoleum are extant and in reasonable condition. The south façade, which was visible at the time of inspection, comprises squared limestone. This stone facing is intact with some loss of mortar pointing between the stones. The west gable was heavily overgrown with ivy. This gable comprises squared limestone with a large engraved memorial plaque, as shown in the photograph above (*Fig. 7, dating from 2018*). It is likely that both of these external walls have suffered water ingress and possible leaching of material out of the central core, similar to that which preceded the collapse of the east gable.

Fig. 11 Detail of squared limestone on south exterior face of Mausoleum, at corner with collapsed east gable.

f) Works to north and south external walls and west gable

Each of the mortar joints in the existing (intact) stone walls should be checked. Any loose or friable mortar should be carefully removed using hand tools to facilitate re-pointing. If there are areas of cement mortar pointing, these should be removed by an experienced stone mason using hand tools, taking particular care to avoid disturbance to the surrounding masonry. These open joints should then be pointed to the specification noted at g) below. Where there are wide joints or gaps between the stones, these should be packed at with smaller stone gallets (flat stones) and pins (pointed stones). The stability of the larger stones should be checked as the works proceed. Where loose stones are identified, allowance should be made for the introduction of helical flexible stainless steel reinforcement bars and/or stainless steel ties. Any embedded branches or roots should be dug out and removed as part of this work. Allowance should be made for the introduction of a lime-based liquid grout (see g) below) to fill out any voids in the wall as part of this work.

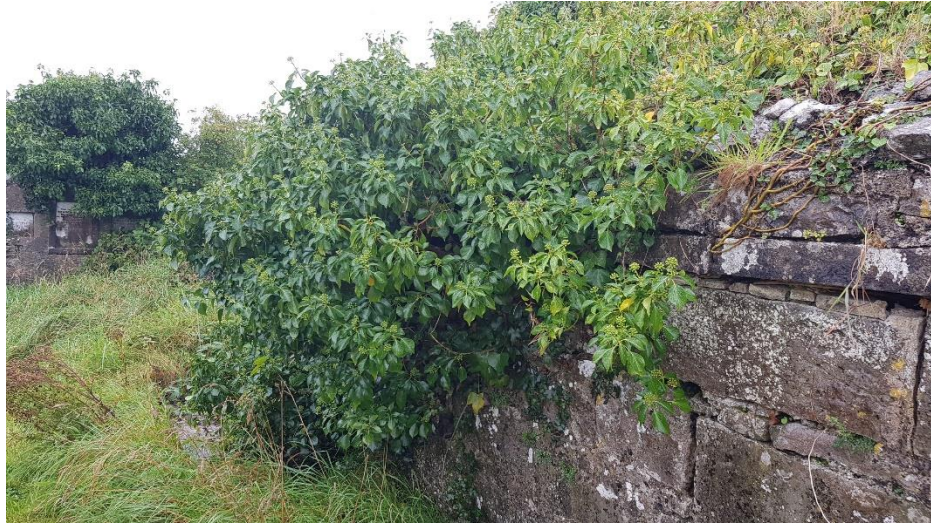
Fig. 12 Detail of squared limestone on south face of mausoleum, with heavy ivy growth on west gable

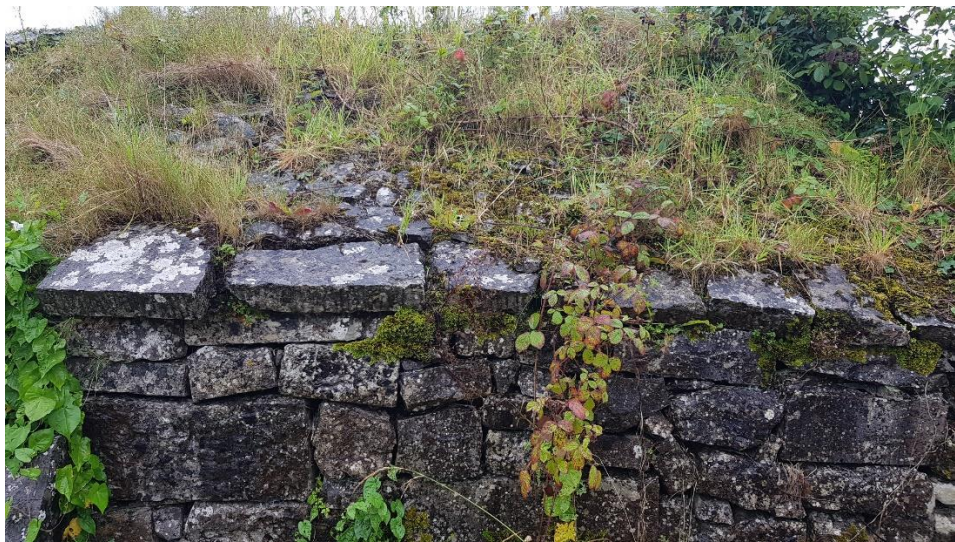
The north external wall is heavily overgrown. The outer face of the wall comprises squared limestone with smaller stones than on the west and south facades. It is possible that this wall incorporates some fabric from the earlier church, but the extent of such survivals could not be determined by visual inspection. Most of the mortar joints are open. It is likely that there has been significant loss of bedding mortar and core material from this wall.

Fig. 13 Detail of north façade of Owen O'Connor Mausoleum

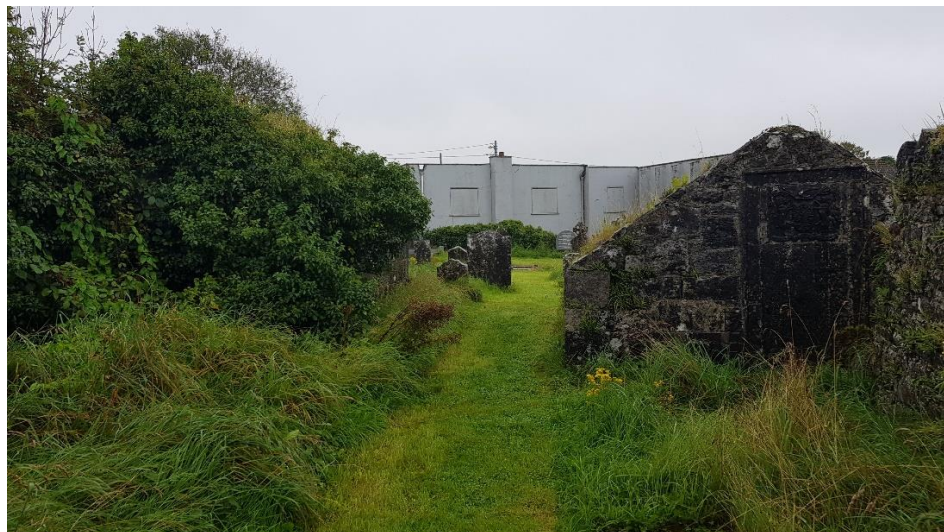
Fig. 14 View of Owen O'Connor Mausoleum (on left) from west. The west gable is completely hidden behind heavy ivy growth.

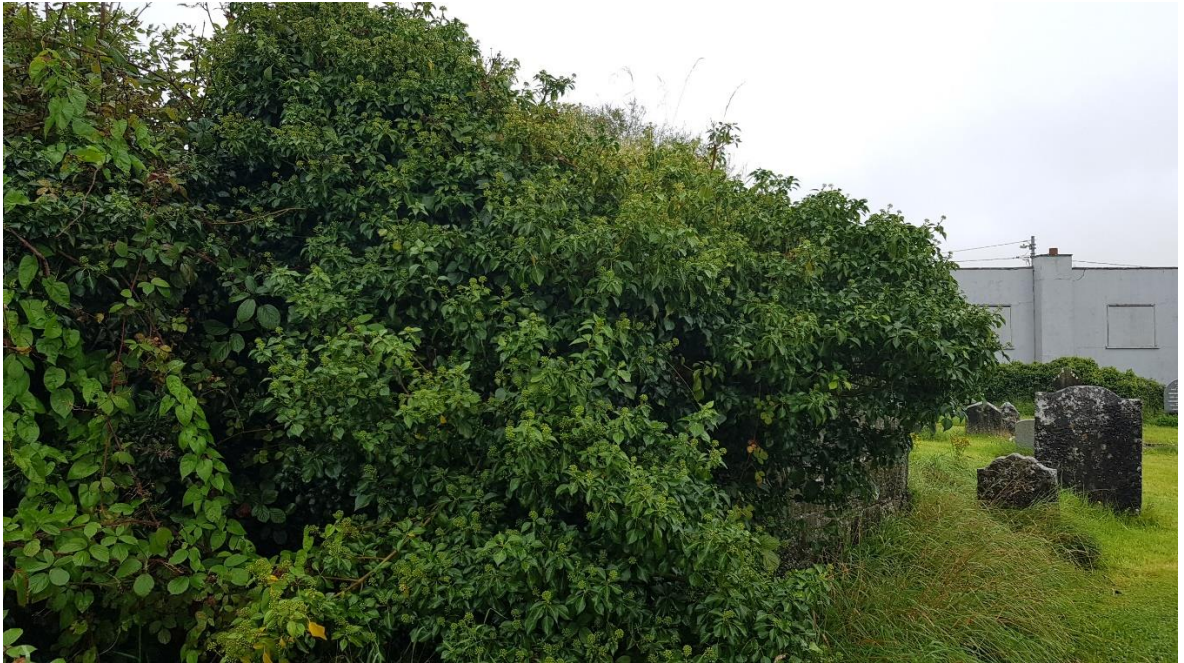
There is established ivy growth on and around the ruined mausoleum, some of which is embedded into the walls and roof. Much of this growth comprises woody plants (whitethorn, buddleia, ivy, etc.) that has become rooted or embedded within the masonry structure. If left unchecked, the root systems of the embedded vegetation will extend into the voids between the inner vaulted structure and the outer walls and roof of the mausoleum. This will cause a further weakening and deterioration of the walls. The west part of the structure, most particularly the west gable, is heavily overgrown and almost completely obscured by ivy growth (*Fig. 14*). There was also surface vegetation, including wild grass, dandelions and bindweed present on the mausoleum structure. Urgent action is required to kill off and carefully remove the vegetation, to consolidate the wall, and to consolidate the pointing of the roof to encourage improved water runoff.

Fig. 15 Vegetation growth on the Owen O'Connor Mausoleum, viewed from south-west

a) Treatment of embedded woody vegetation

The biocide treatment of this vegetation should be carefully targeted on killing the plant from the root upwards. This method involves the application of a biocide treatment under the bark close to the root of the plant. This approach differs from the more-commonly used application of a biocide treatment to the leaves, which will kill the foliage but cause the living plant to retreat into the root system. This can result in expansion of the roots, which can in turn destabilise the ruined structure. The slow and gradual process of killing back the plant will take several months and avoids any expansion or shrinkage of the root system. The approach involves the peeling back of a section of the bark about 50mm high to expose the substrate. A biocide (roundup or similar) is applied in paste form to the open section of the trunk and is then sealed with clingfilm and duct tape. The optimal time to carry out this treatment is in the spring, with allowance for 2-3 repeated applications on each trunk/branch at monthly intervals heading into the summer.

b) Biocide treatment of grassy and non-woody vegetation

Once the treatment of the more established and woody vegetation has taken effect, the walls and roof of the mausoleum should be spray-treated with a non-selective persistent herbicide. It may be necessary to carry out multiple treatments, including an application into any mortar joints that are open or have been raked out to ensure maximum effectiveness of the treatment. Particular care will be required to kill off and removed any vegetation, including bind weed, that is rooted in the core of the collapsed east gable.

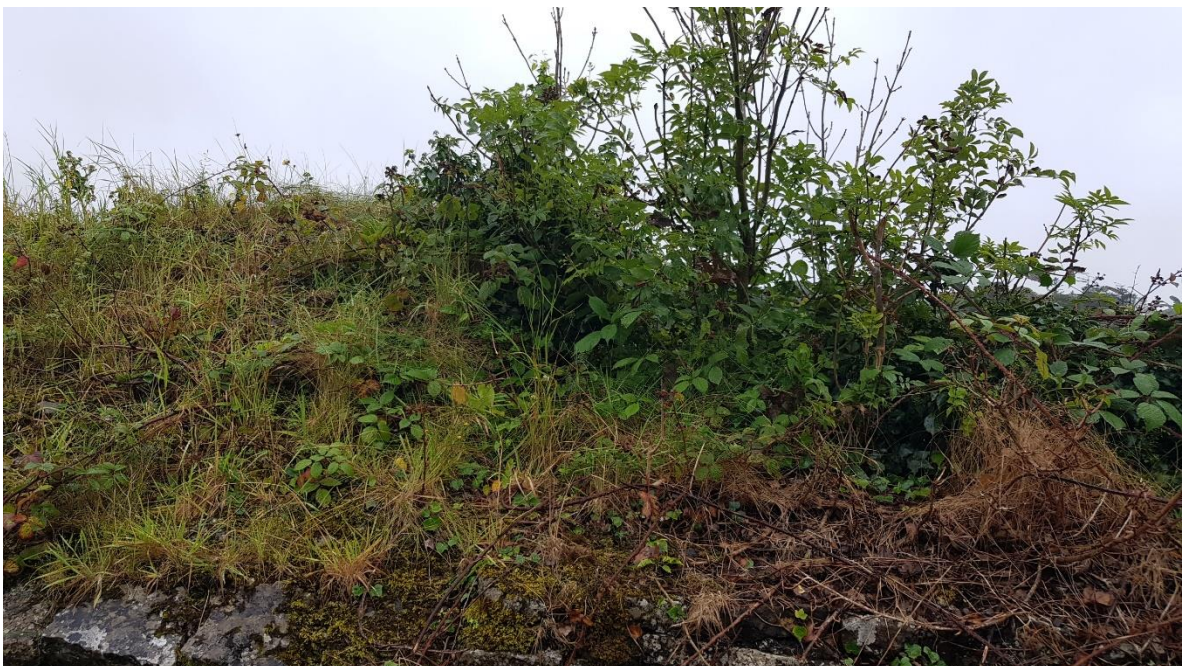
Fig. 16 Detail of vegetation growth on roof of Mausoleum.

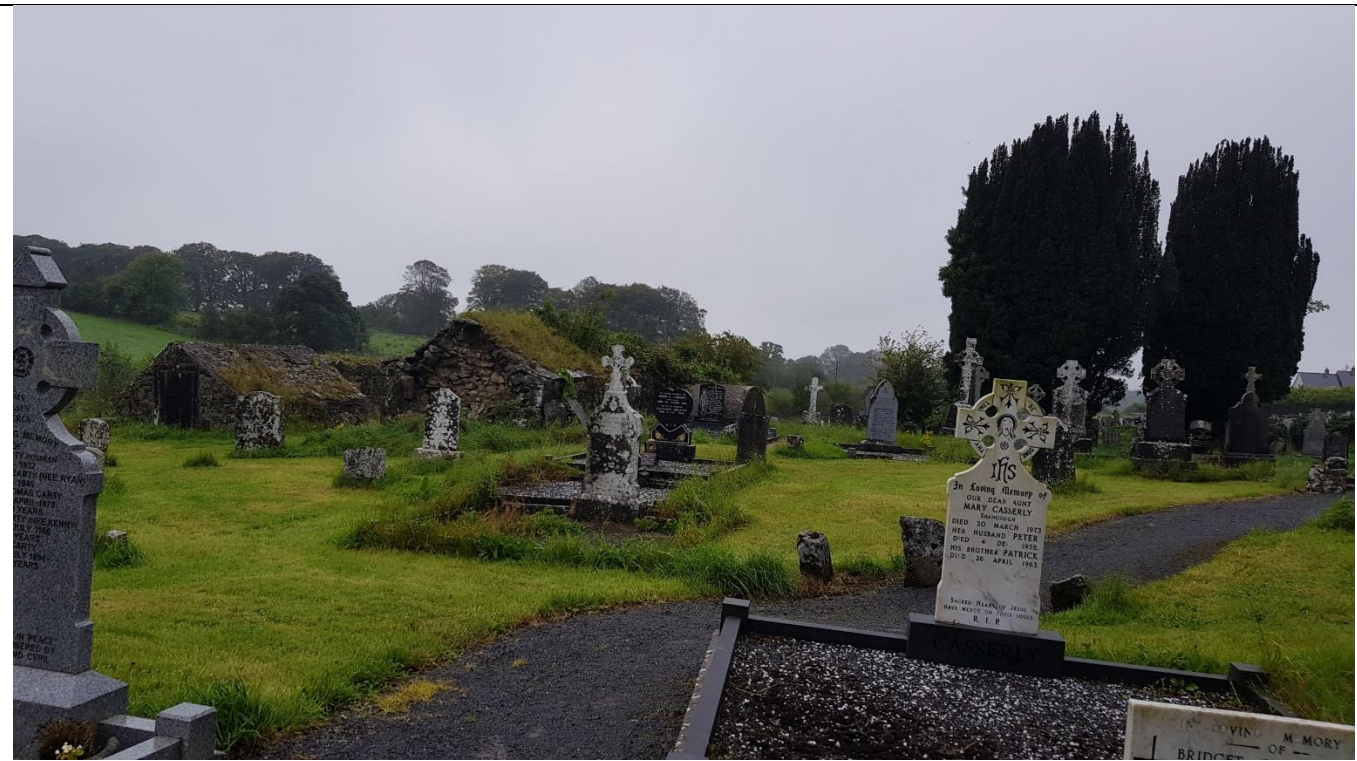
Fig. A1 View of the Owen O'Connor Mausoleum (on right) from entrance to graveyard, to north-east

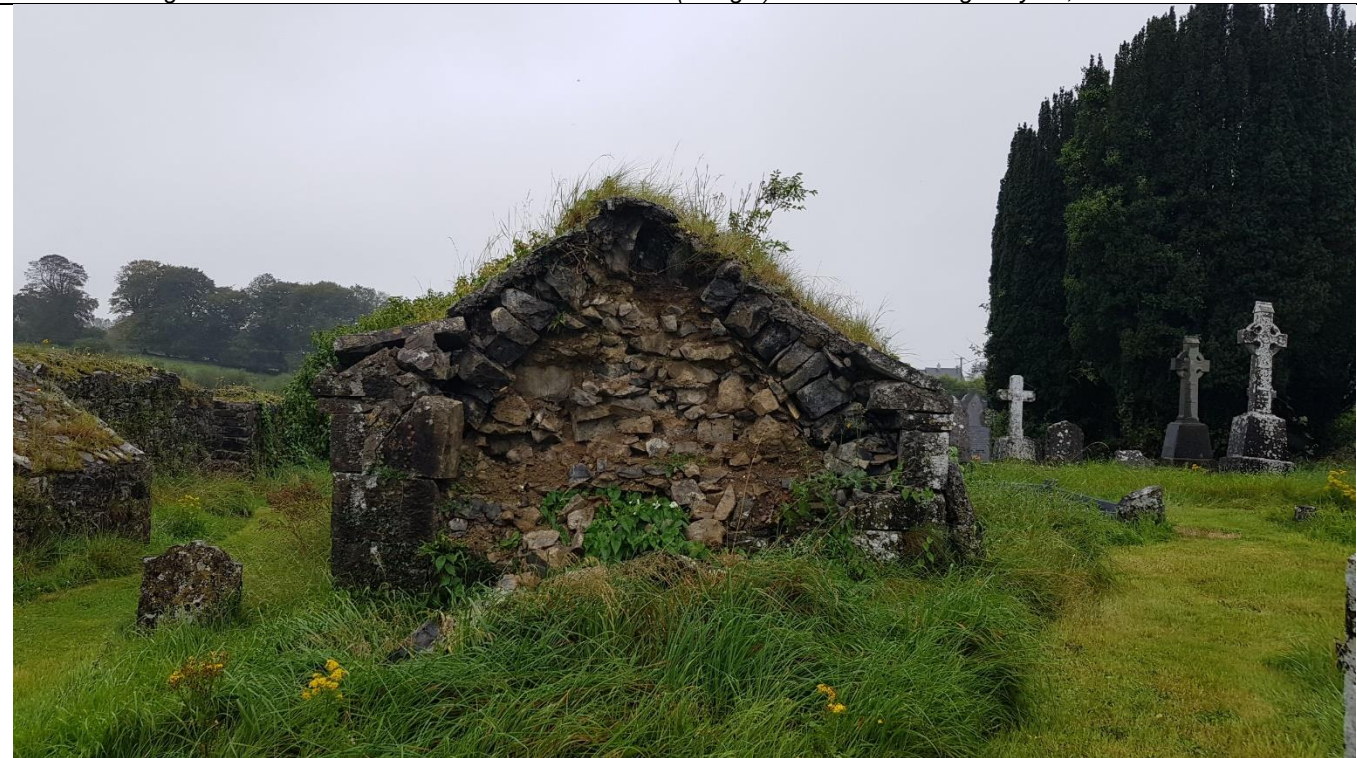
Fig. A2 Collapsed east gable of Owen O'Connell Mausoleum

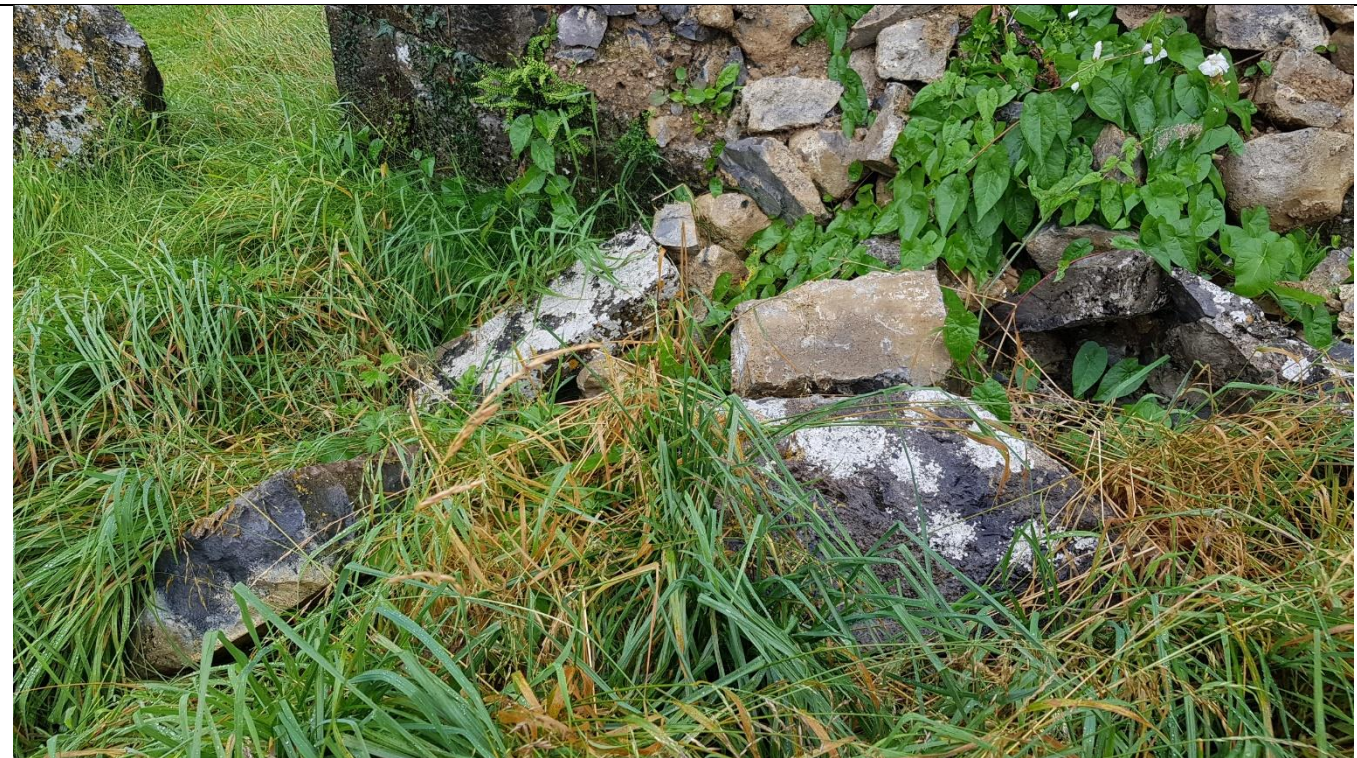
Fig. A3 Collapsed stone rubble at base of east gable

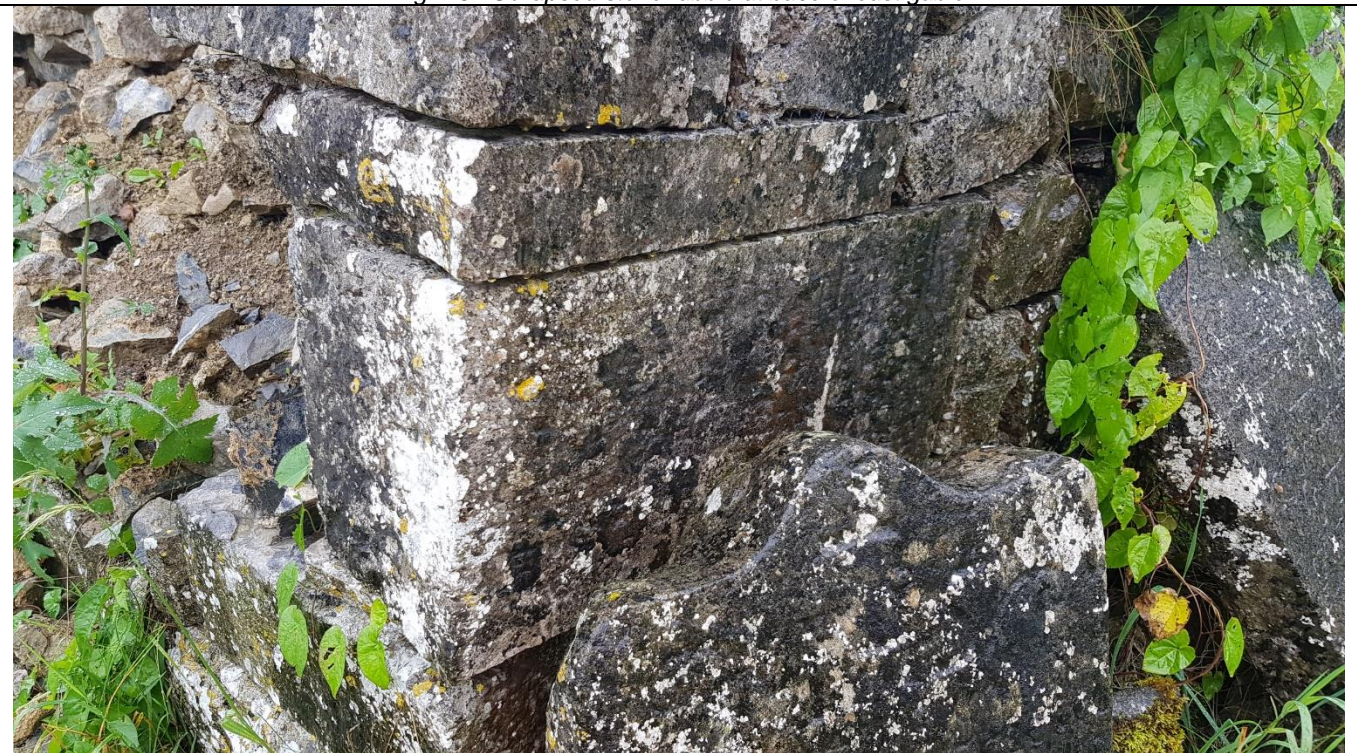
Fig. A4 Detail of north-east corner of mausoleum

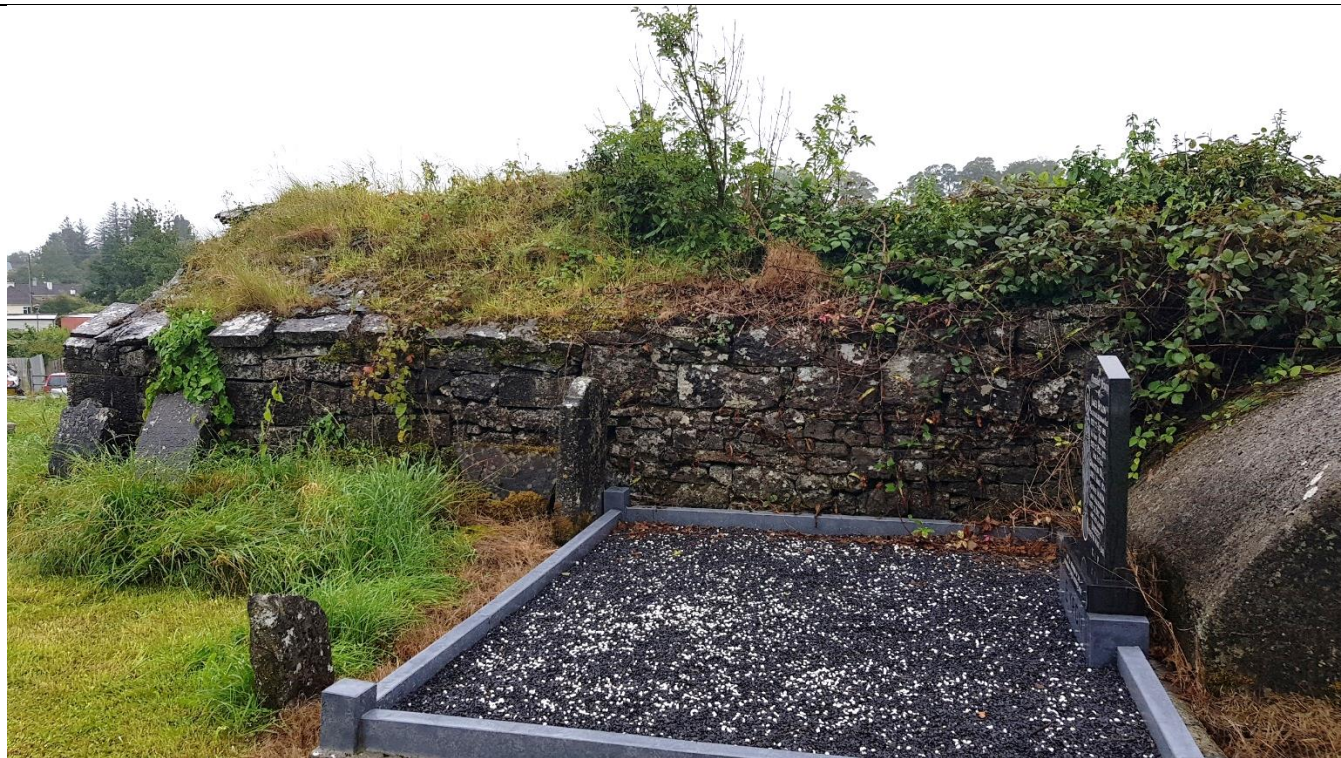
Fig. A5 South external wall of Owen O'Connell Mausoleum. The protruding tree in the centre of the photograph marks the western extent of the mausoleum.

i) Treatment of sapling trees around the perimeter of the mausoleum

There are a number of sapling trees growing against the mausoleum. These have potential to cause damage to the footing and substructure of the walls if they are allowed to grow to maturity. Each individual branch of each sapling is to be treated using the approach outlined under a) above. This involves the peeling back of a section of the bark about 50mm high to expose the substrate. A biocide (roundup or similar) is applied in paste form to the open section of the trunk and is then sealed with clingfilm and duct tape. The optimal time to carry out this treatment is in the spring, with allowance for 2-3 repeated applications on each trunk/branch at monthly intervals heading into the summer.

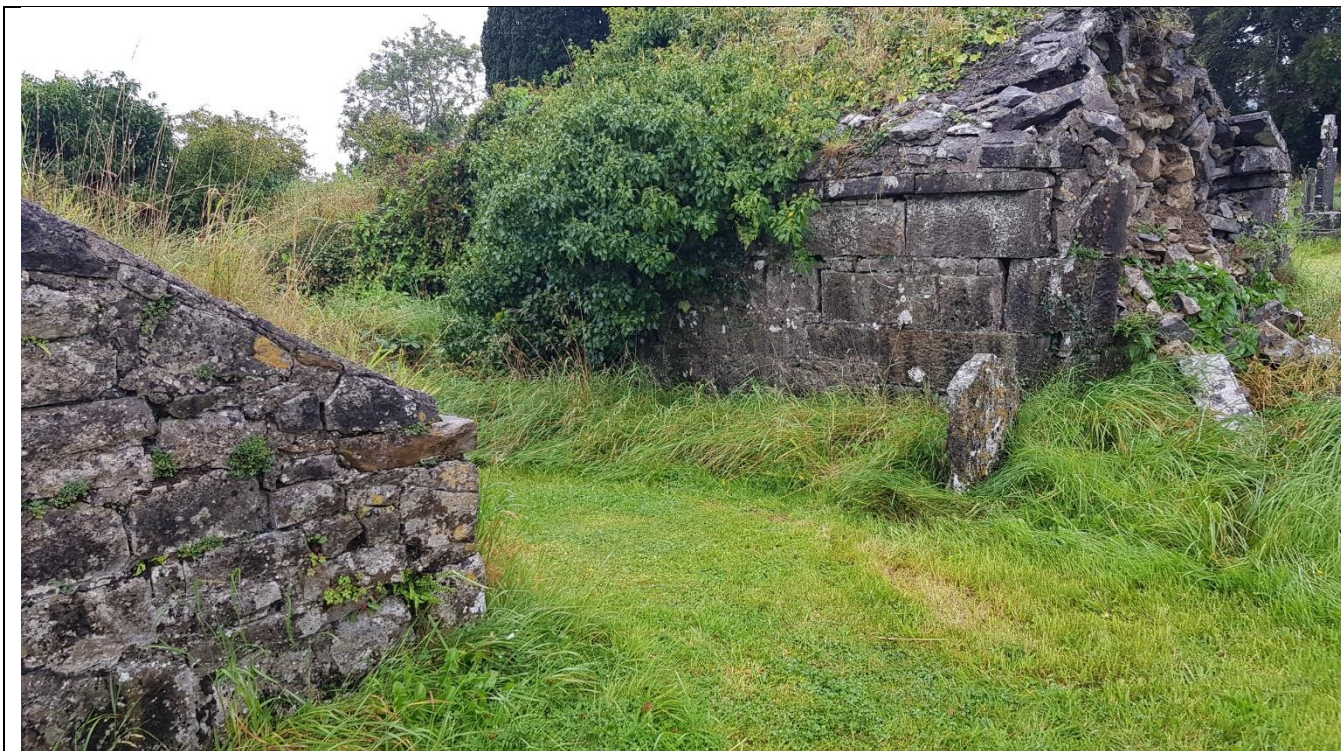
Fig. A7 View of mausoleum from south.
