TULSK GAELIC MEDIEVAL COMPLEX, CO. ROSCOMMON

CONSERVATION MANAGEMENT PLAN

VOLUME 1

<i>Gifford No:</i>		15048/R01	
<i>Status:</i>	FINAL	<i>Copy No:</i>	
	<i>Name</i>	<i>Signature</i>	<i>Date</i>
<i>Prepared by:</i>	Andy Shelley, Gerry Wait and Jackie Heath		28 Nov 08
<i>Checked:</i>	Phil Emery		28 Nov 08
<i>Gifford Approved:</i>	Anne Thompson		28 Nov 08

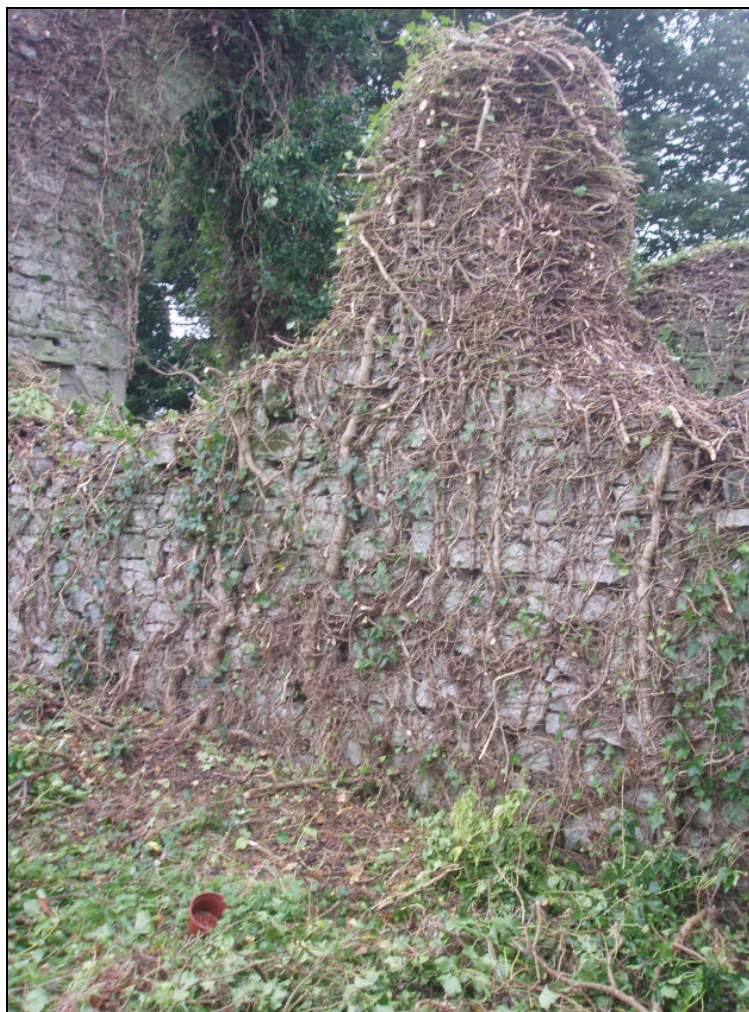
Following consultation, it appears the consensus in Tusk is that the ruin is better seen without the ivy, and this of course concords with the need to conserve its walls. The ivy was therefore heavily trimmed during September 2008. Although this exposed much of the ruin's remains, the stems were so dense in some places that it remained impossible to determine the condition of the stonework.

Figure 12: Ivy growth across the priory is systemic. This is the mass of stems left after initial trimming in September 2008

- Recommendation 2** Removal of the ivy's roots, stems and branches from the priory walls should only begin when funds and a timetable are in place to conserve the fabric that will be exposed.

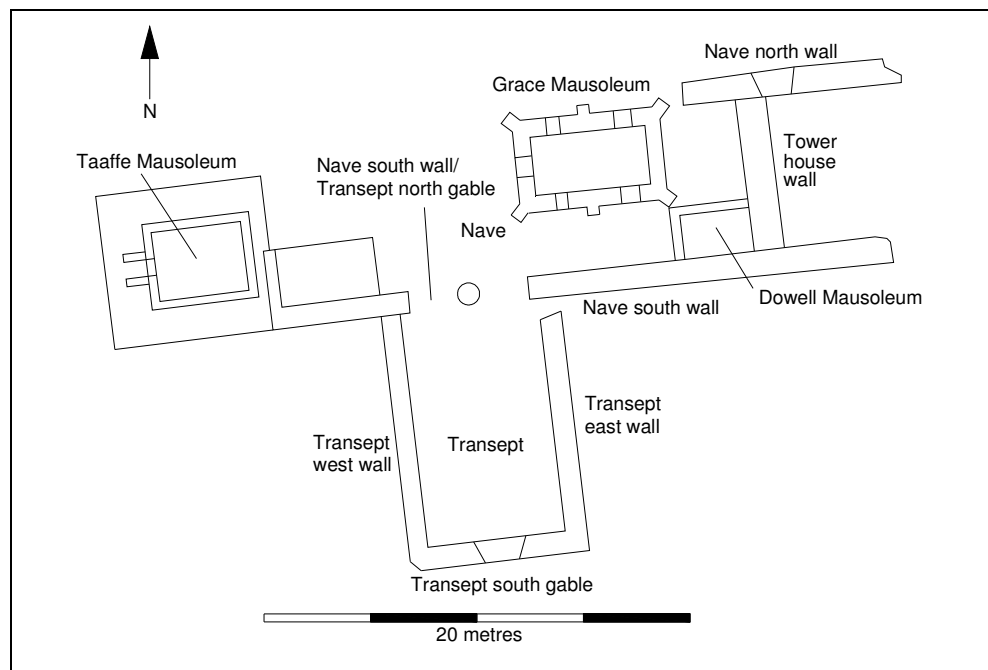
Figure 13: Plan showing location of masonry sections referred to in this report

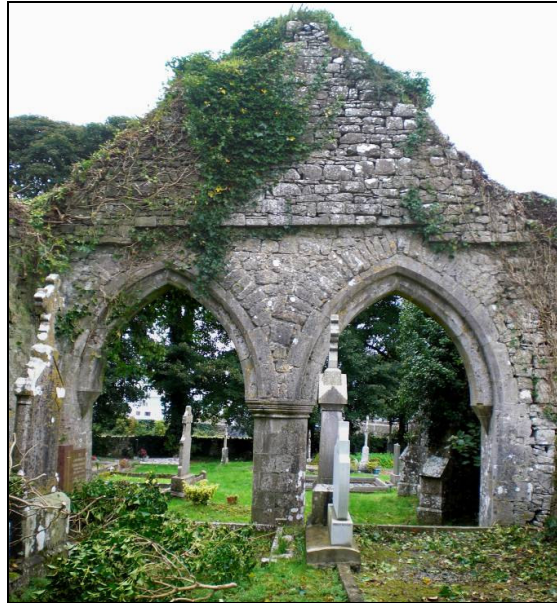
The north gable wall of the transept is potentially unstable. The wall steps in on the north elevation above eaves level so the upper triangle of stonework is perhaps only 400-500mm thick and perhaps 4.2m tall (above eaves) with no structural restraint. By inspection, it appears to lean slightly to the south and the pointing is deeply weathered indicating a potential instability. However, it should be noted that it appears from historic drawings to have been in a similar condition 200 years ago.

Figure 14: Transept north gable/nave south wall

The general structural integrity of the gable walls should be improved by raking out the joints and repointing. A detailed dimensional survey should be undertaken to record the verticality of the wall, and measurements should be repeated annually for, perhaps, ten years.

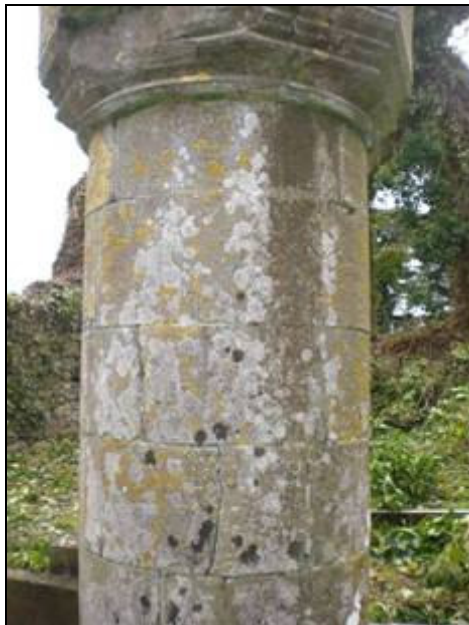
Figure 15: The cylindrical column has a number of vertical cracks in the stonework

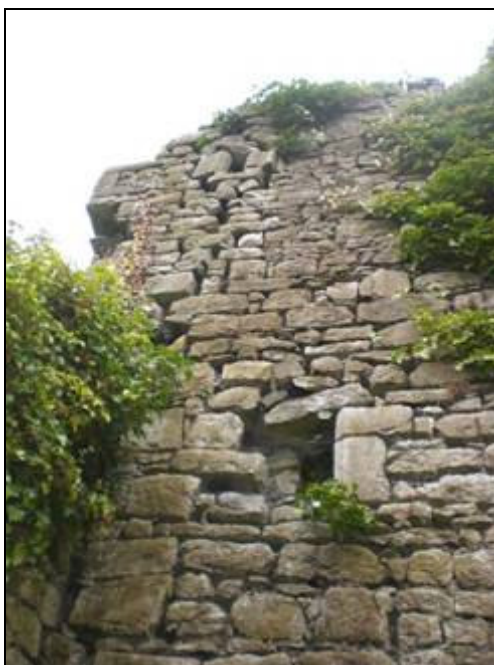
The south gable wall of the transept was still covered with dense ivy stems at the time of the site inspection, and was therefore difficult to inspect. However, the wall is some 8m tall, with no structural restraint above eaves level (approx 4m) and so is therefore vulnerable to instability.

Figure 16: West elevation of the tower wall

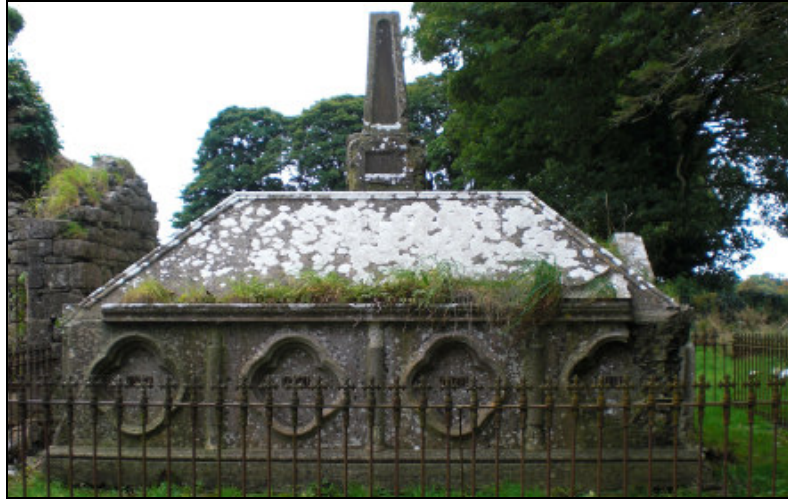
Whilst the stonework of the mausoleum is weathered and, in places, decorative features have been lost, repair of these features is not considered a priority at this time. Regular inspection should continue.

Figure 18: The Taaffe Mausoleum

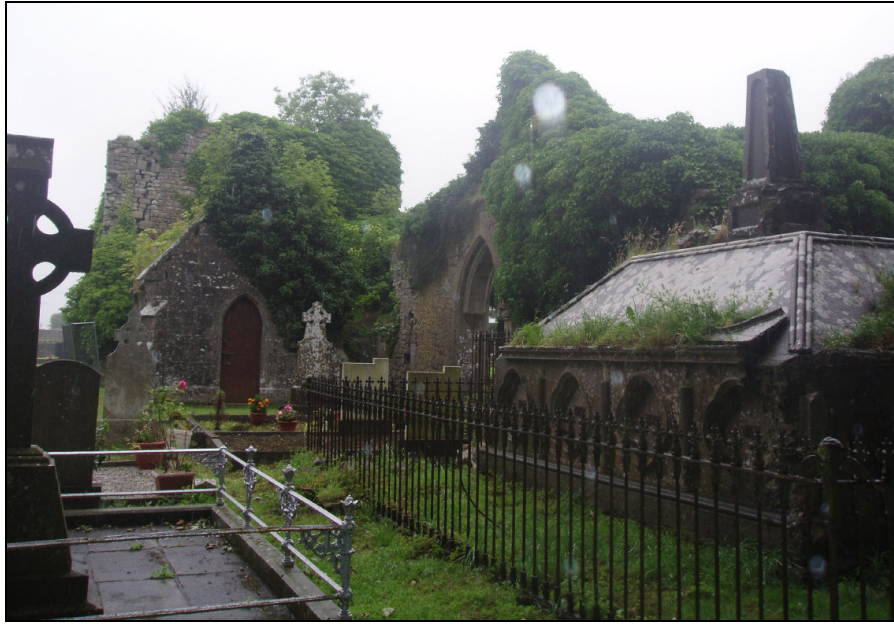
The buttresses of this mausoleum, which was designed in the Victorian Gothic style, have moved away from the walls, which are of stonework with dressed stone cladding. The cladding is not well-bonded to the inner leaf, and the water ingress and subsequent vegetation growth is prising the cladding and the buttresses away from the inner leaf. In places, the cladding stones have come away completely from the stone core of the walls. This is occurring on the flank walls and the corner buttresses.

Figure 19: The Grace Mausoleum lies to the centre-left in this image, and the Taaffe Mausoleum to the right.

The roof flags are in poor condition and this is allowing water to permeate into the fabric of the building; there is a risk of further deterioration, loss of stones and water ingress.

It is recommended that the roof is repaired and the vegetation removed to prevent further damage. The buttresses are not performing any useful structural function and should not be connected back to the building. However, the joint between the buttresses and the walls should be pointed to prevent further damage. The stone cladding to the flank walls should be partially rebuilt, with one stone removed and replaced at a time and tied to the inner leaf using stainless steel remedial wall ties.

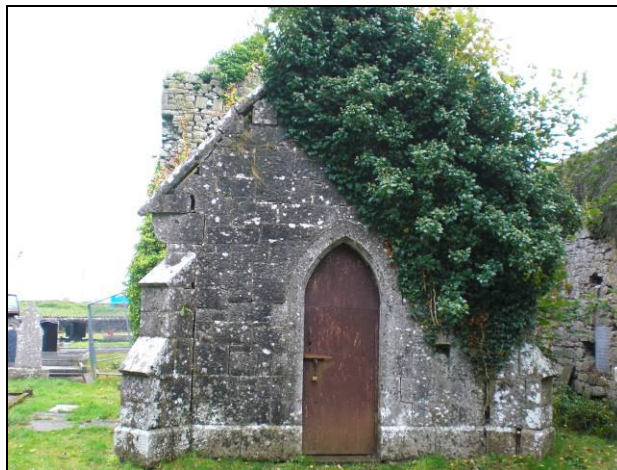
Figure 20: The west elevation of the Grace Mausoleum

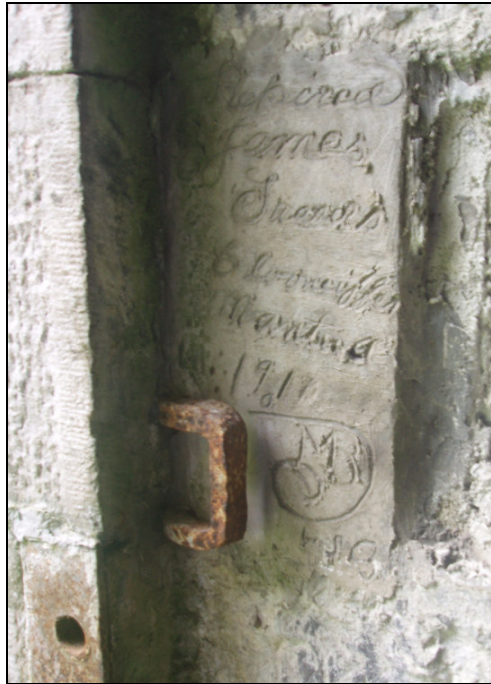
Figure 21: Inscribed graffiti inside the entrance to the Grace Mausoleum

- Recommendation 5** An area of historic graffiti survives inside the left door jamb of the entrance, and care should be taken not to damage or remove this during renovation works.

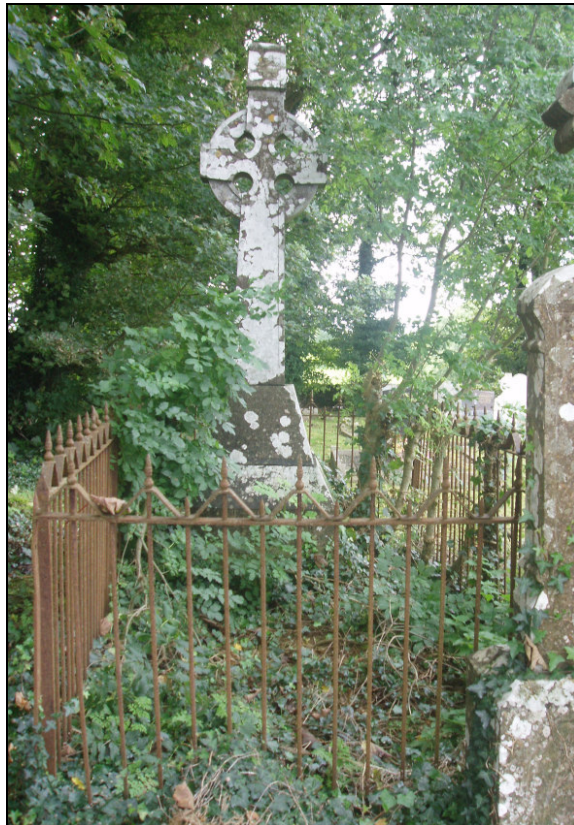
Figure 22: Enclosure in south-western part of the graveyard

Recommendation 6 Over time, the base of the uprights, which are in a corroded condition, may rot out, and at this time the railings will need to be removed and fully renovated.

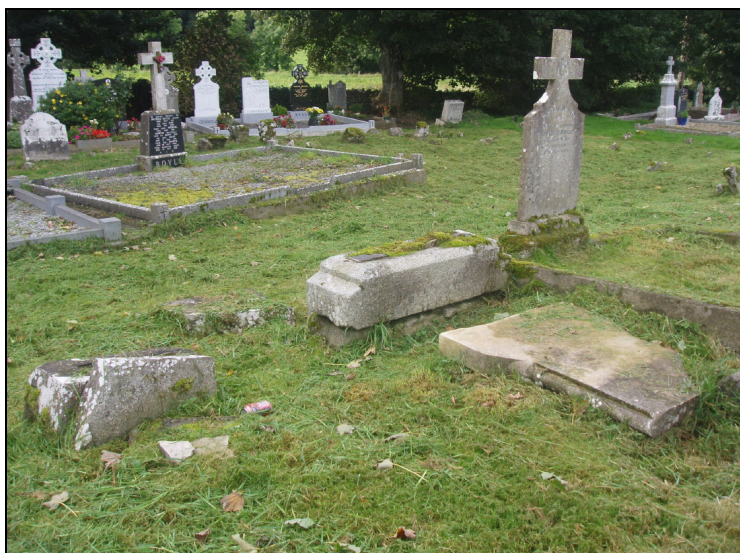
Figure 25: Some localised damage to the grave-markers has occurred over the years

Recommendation 9 Despite the temptation, there is little need to right the historic fallen grave-markers. The effects of time and weathering are a key characteristic of graveyards, and suit their character of gentle decay. Gravestones should not be raised or straightened, unless by doing so their integrity is stabilised, and they should not be cleaned. Any conservation measures which are required to make markers safe must be designed to slow down the rates of deterioration, and not to effect a restoration. The most effective policy is to take steps to ensure that no further damage is caused by visitors, falling trees or masonry.

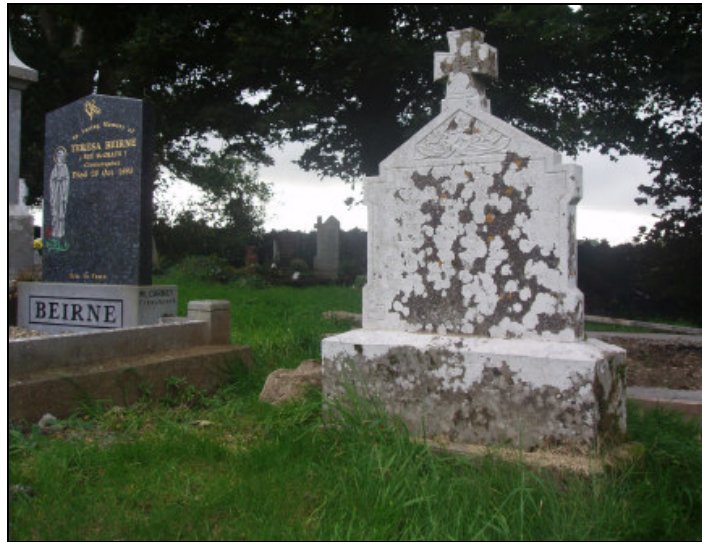
Figure 26: Moss and lichen add to the character of graveyards

might be beneficial to consult a lichenologist to ascertain whether the lichens are benign or not. Mosses are generally sympathetic to gravestones and should only be removed if there is clear evidence that the growths are having a detrimental effect on the integrity of the stone.

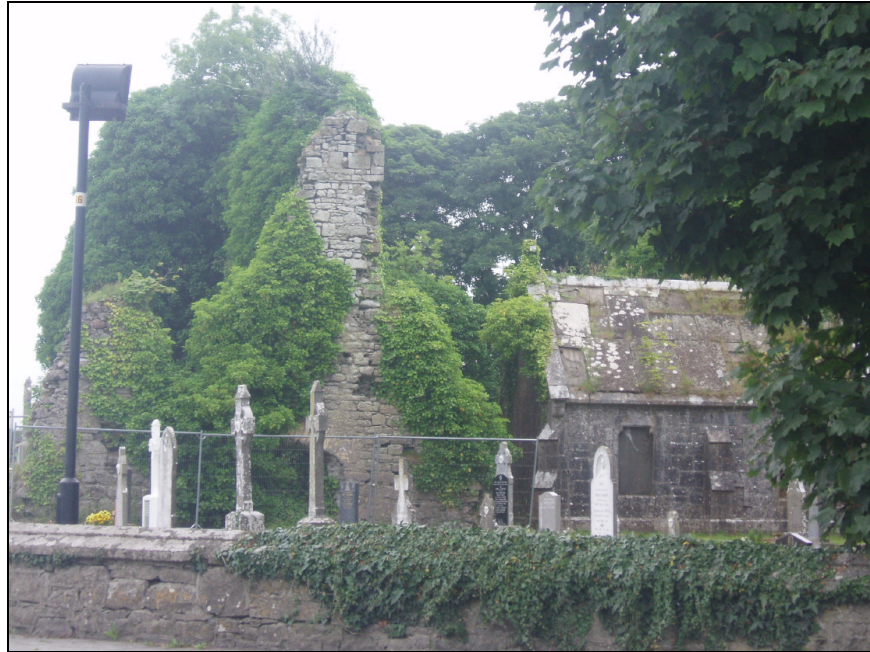
The priory is currently lit by a high-level floodlight mounted on a pole which sits immediately inside the roadside wall. Although this was no doubt erected with the best intentions, the apparatus detracts from the setting of the monument, and should be re-sited at a low level. The lux level must also be considered carefully, since it might conflict with the habitat for bats and other species (see below).

Figure 27: How the site is floodlit should be reconsidered

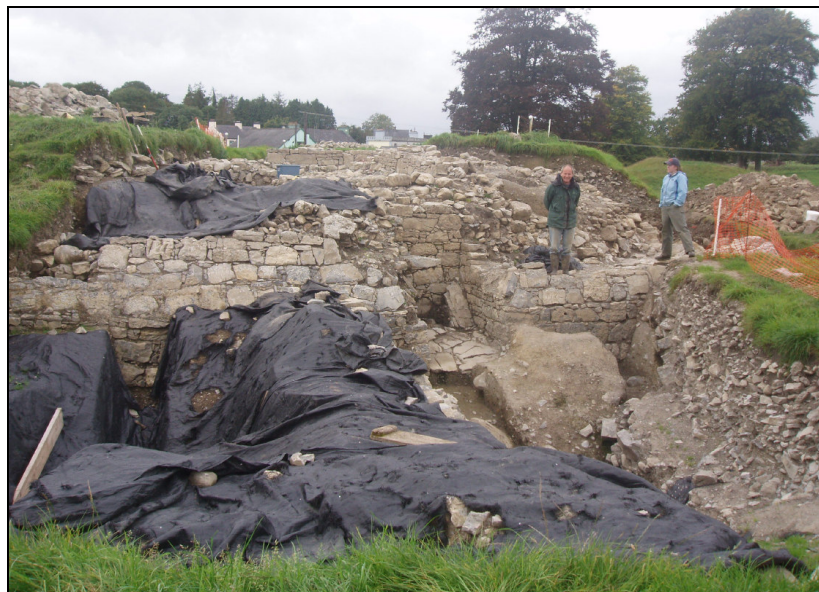
Figure 29: Recent archaeological excavation by the Discovery Programme have revealed the substantial foundations to a tower house

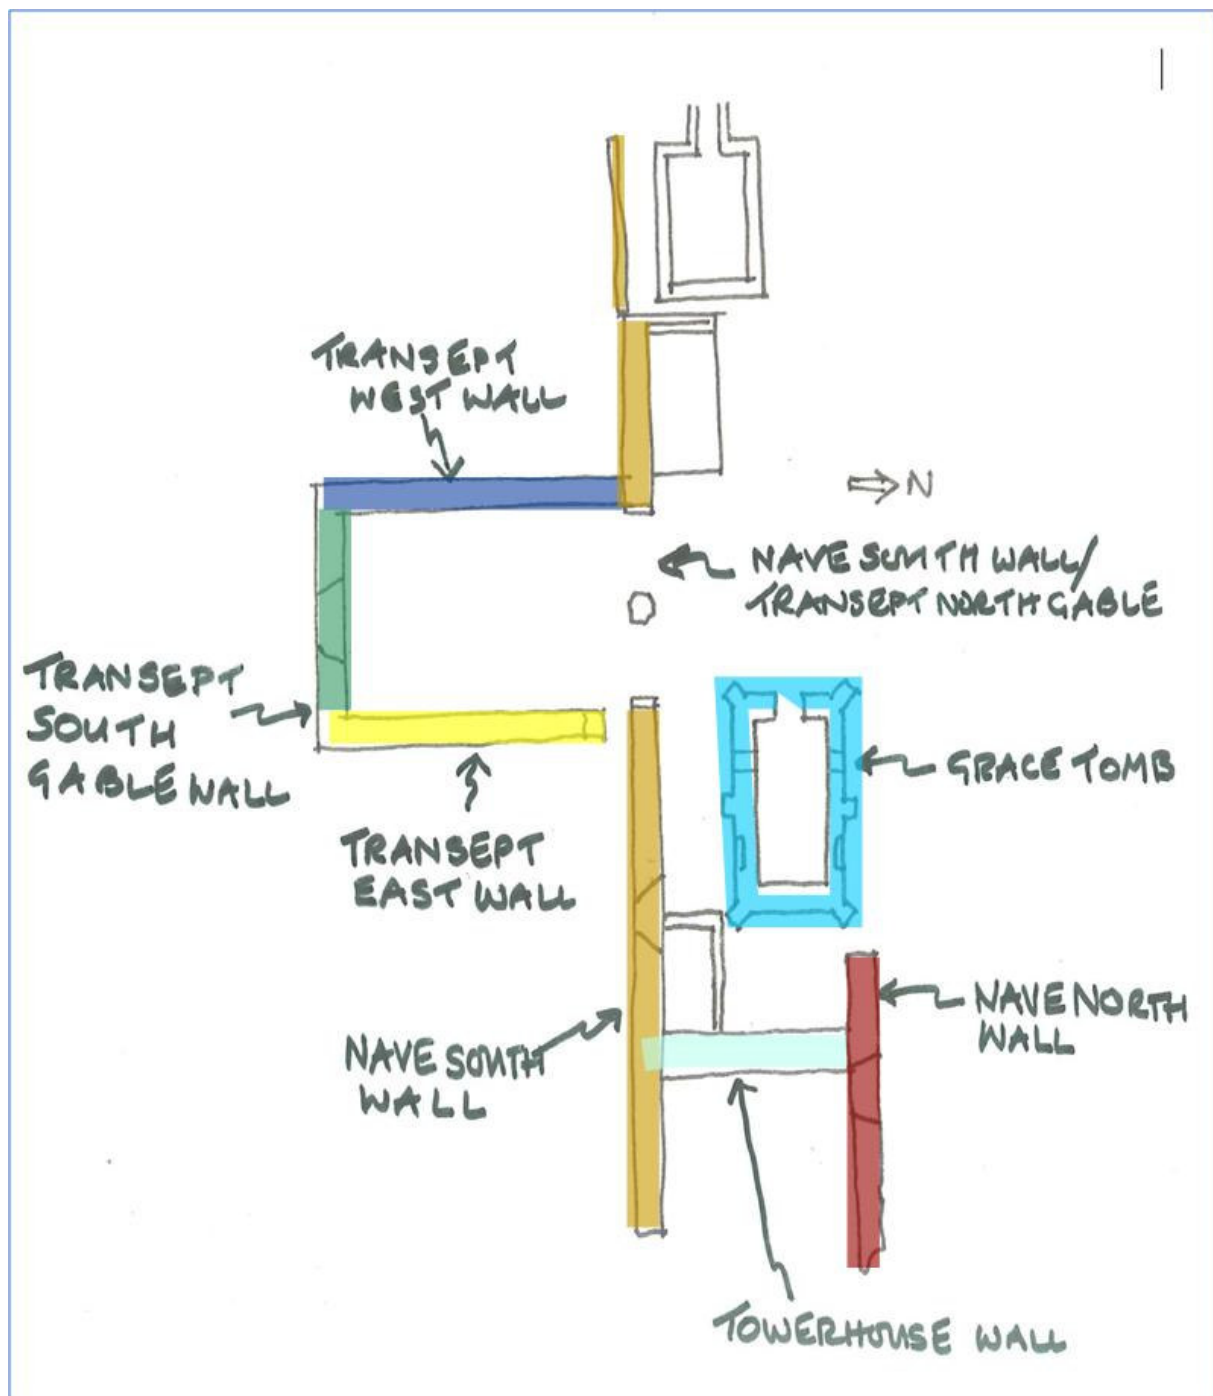
Figure A1: Tulsk Priory conservation works, by zone
Colours correspond with works listed in the Action Plan, Appendix 1 and Plates A1 to A13

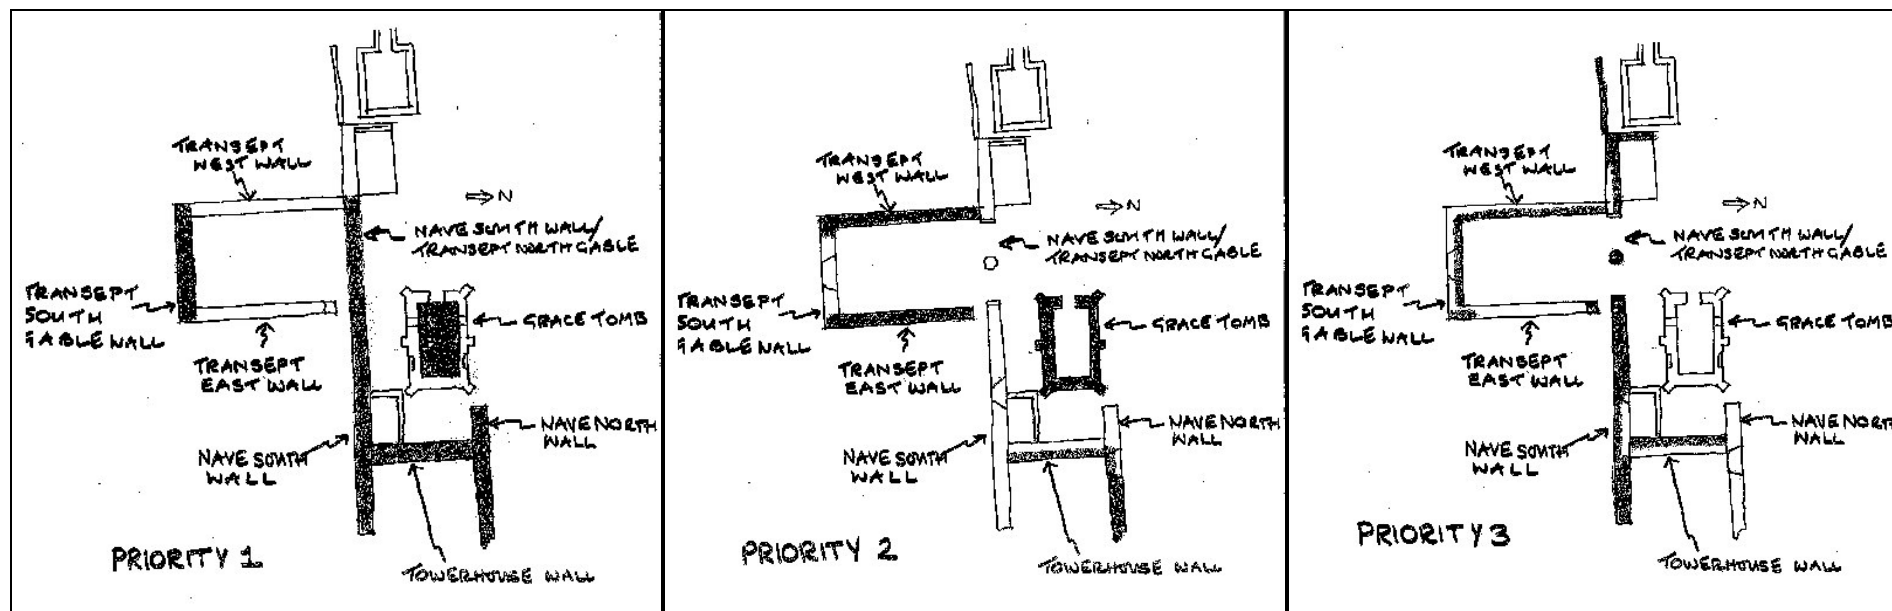
Figure A2: Tusk Priory conservation works, by Priority Zone

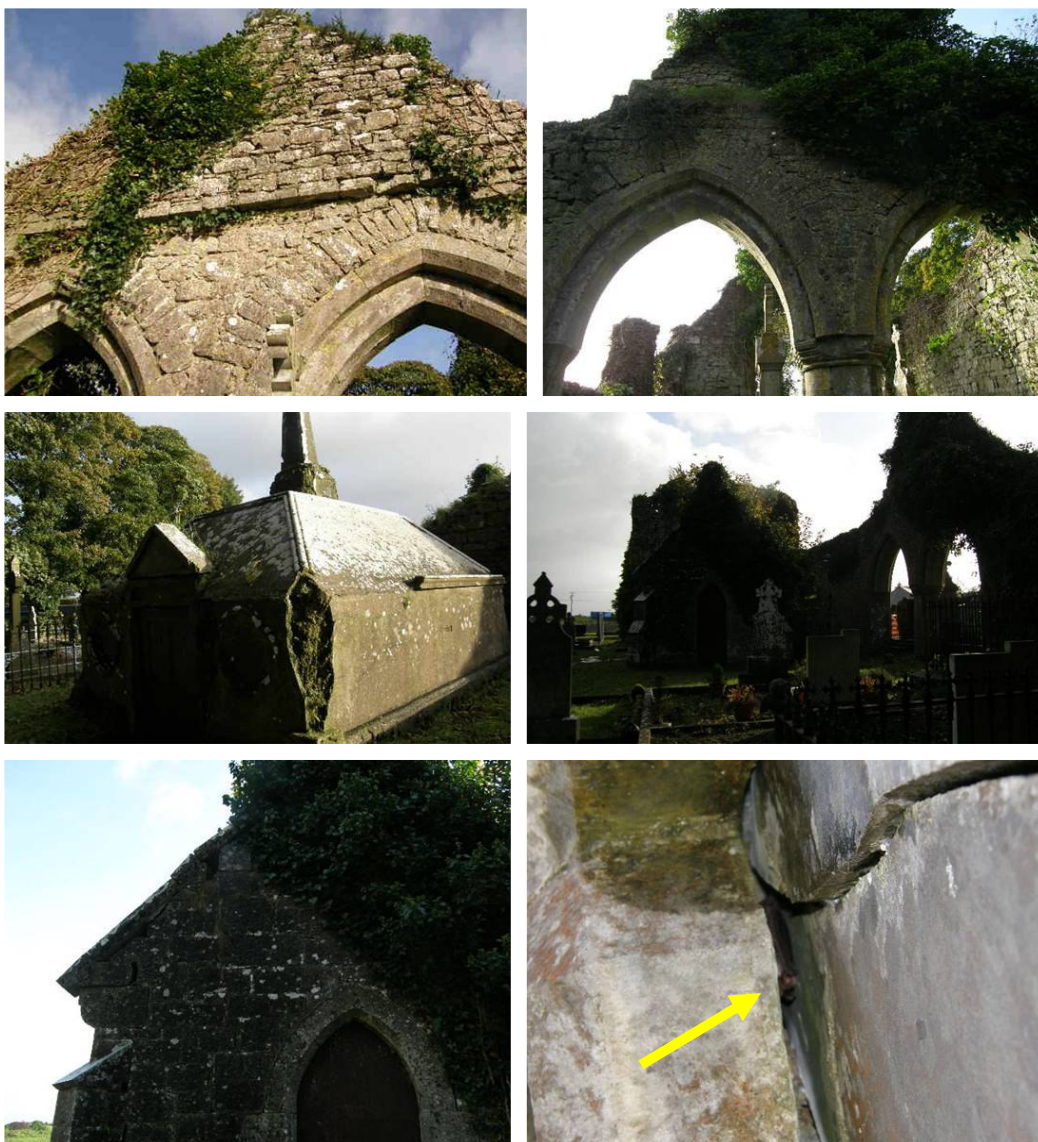
There are considerable numbers of crevices and cavities in stonework and ivy cover (Plate A15). There are holes within the arches, chimneys and in window and door frames.

Plate A15: Roosting potential and bat evidence at Tusk Priory.
The four upper photographs indicate roost potential within the graveyard, while the bottom two photographs indicate the actual roost site of a torpid brown long-eared bat.

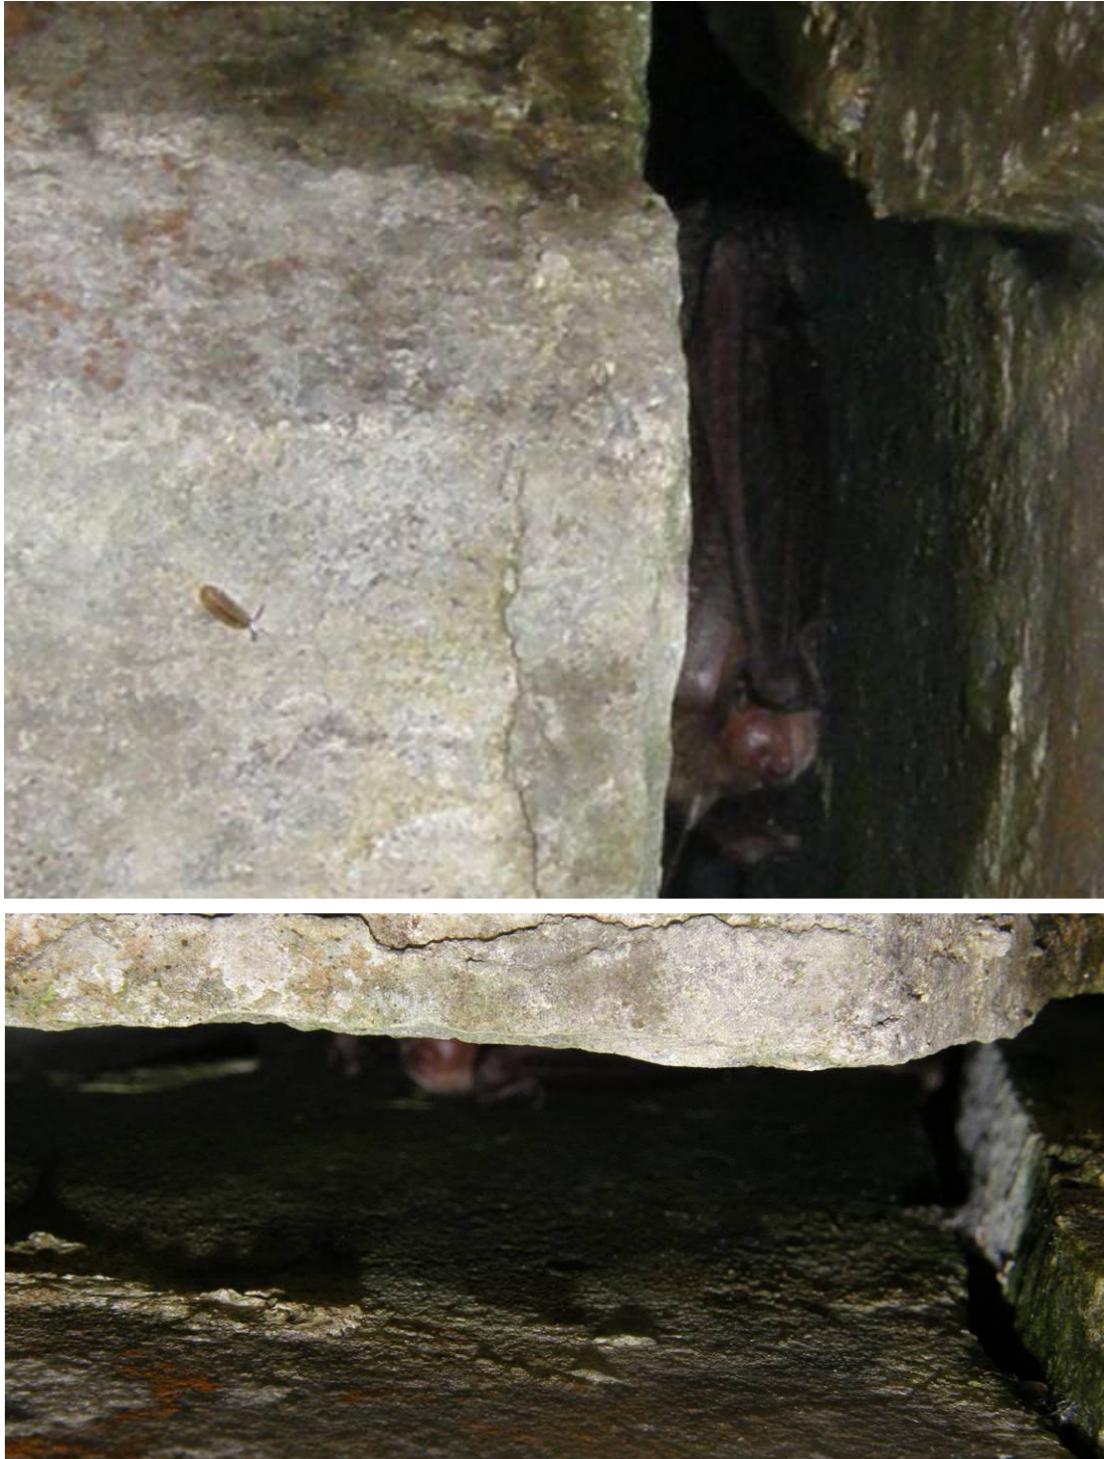
Plate A16: Brown long-eared bat in a window frame of the Grace Mausoleum.
The upper picture shows the bat from side-on, while the lower picture shows the nose and thumbs of the roosting bat from below.

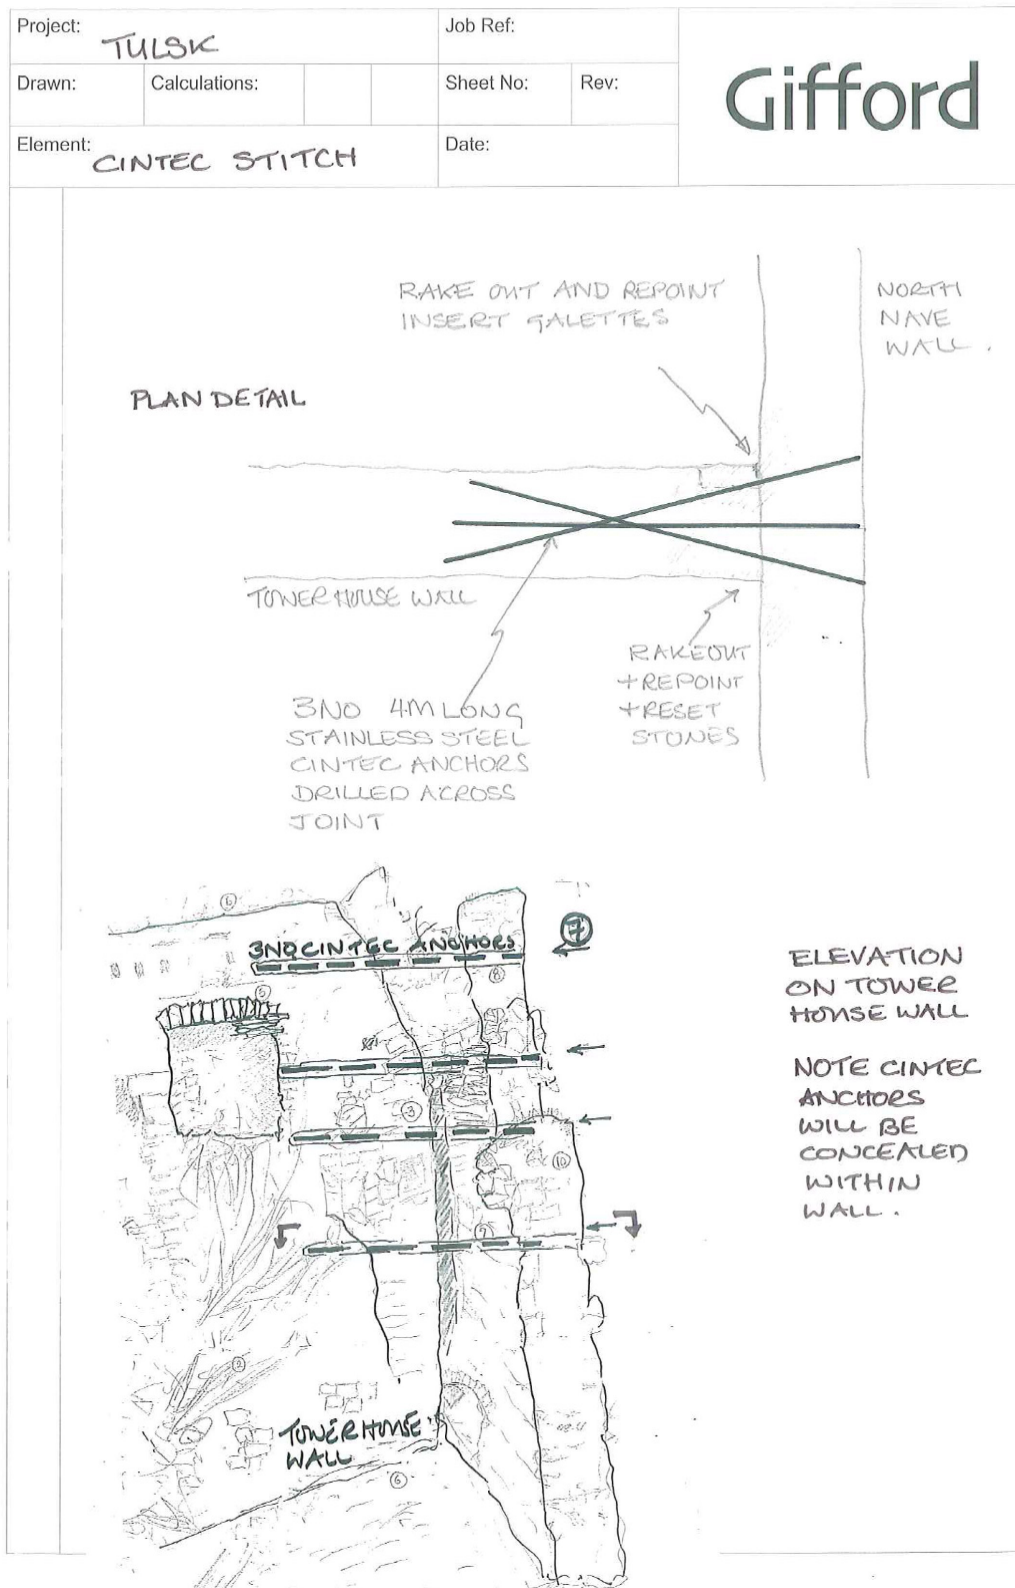
Figure A3: Detail of Cintec stitching
