A Proposed Development Site at

Monksland

Athlone, Co Roscommon

Archaeological Screening Report

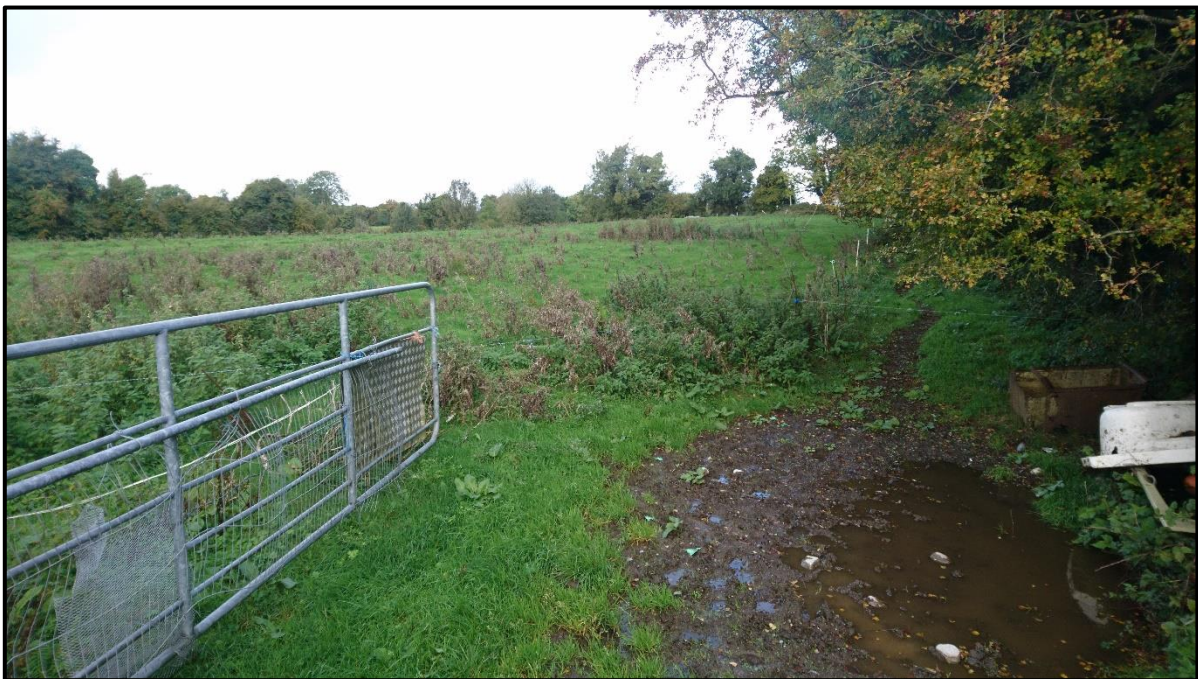
Plate 2: View looking north from the gateway at the south-western corner of the proposed development site

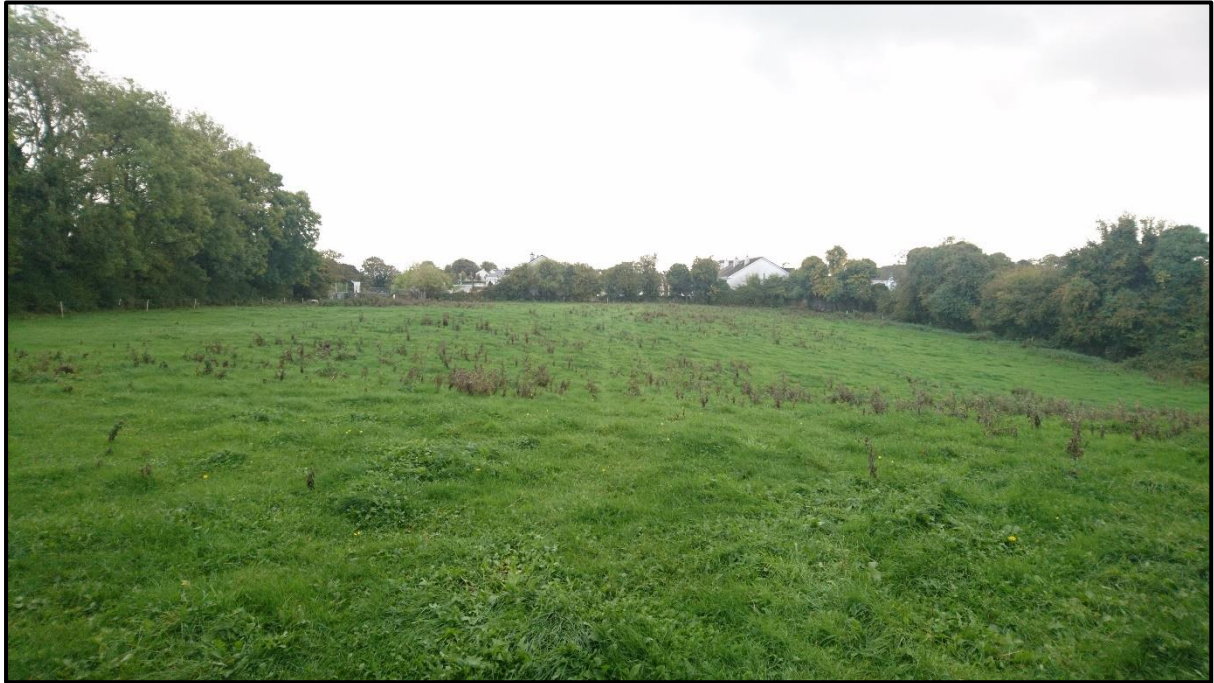
- 3.2 Aerial imagery (Plate 1) suggests that the topographic undulations in the site represent an esker, a linear deposit of gravel and sand formed through glacial activity. The site boundaries are generally defined by overgrown hedgerows and post-and-wire fencing, though collapsed drystone walls were noted in places. No features of archaeological interest were noted on the site during the site inspection.

Plate 3: View looking south across the eastern part of the proposed development site

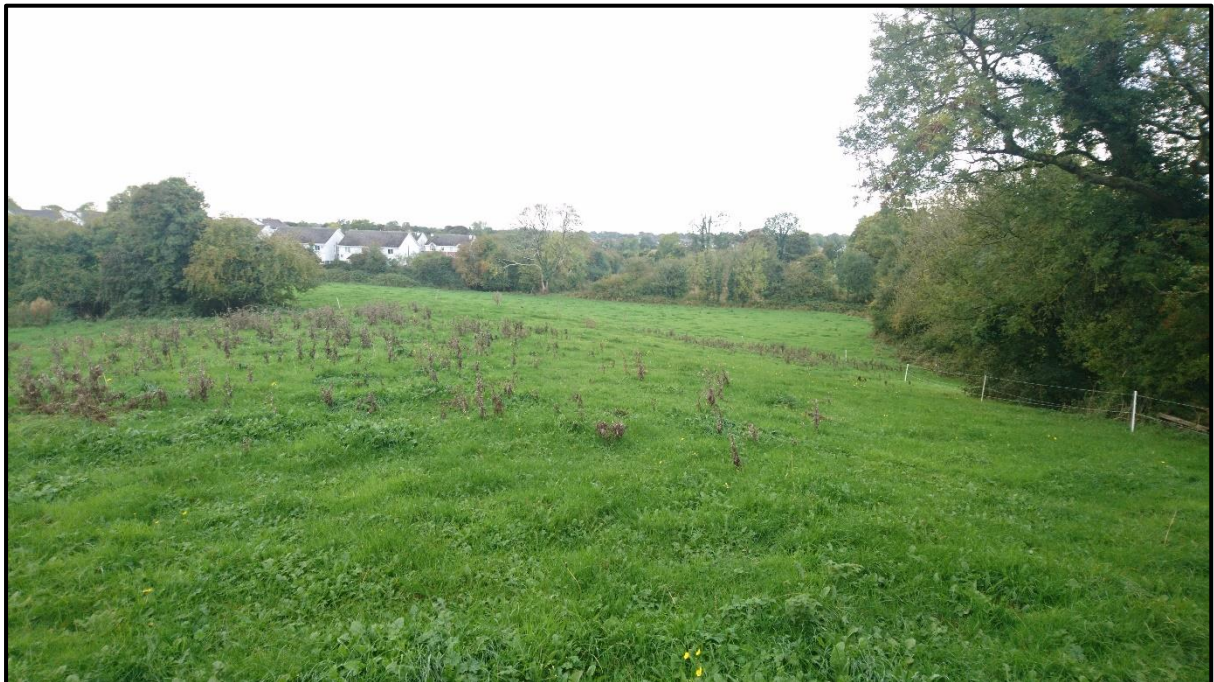
Plate 4: View from the north-eastern corner of the site looking southwest along the esker ridge towards the western part of the site

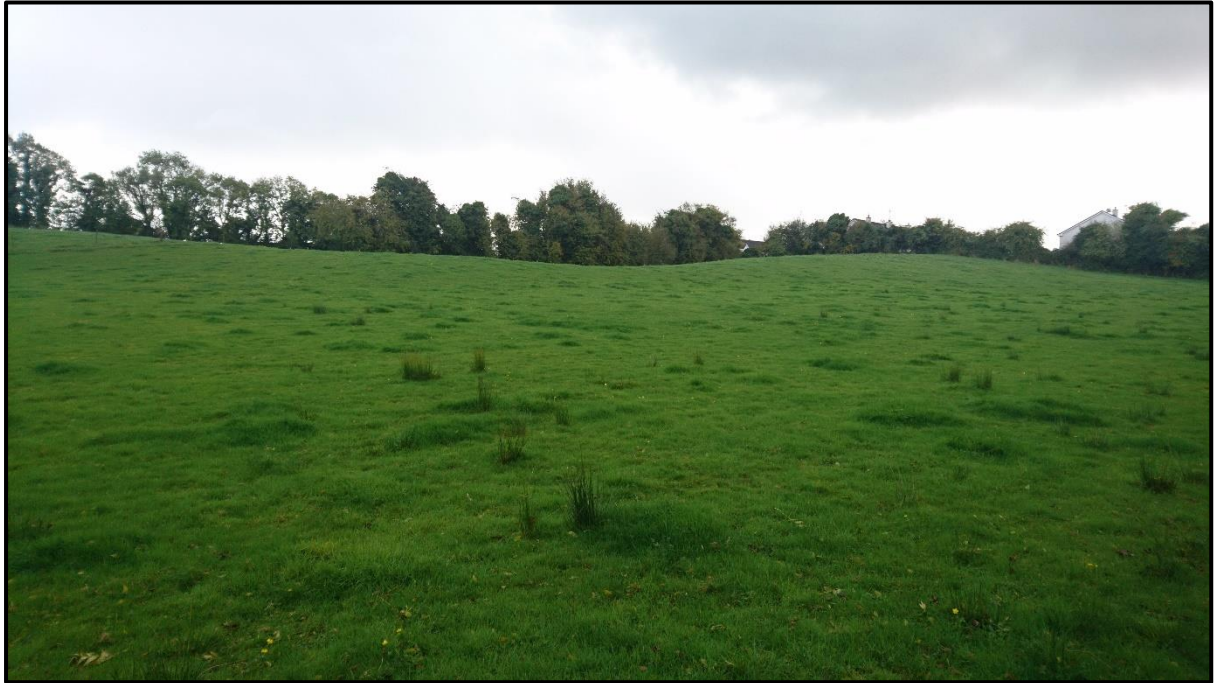
Plate 5: View from the north-western corner of the site looking uphill towards the southeast

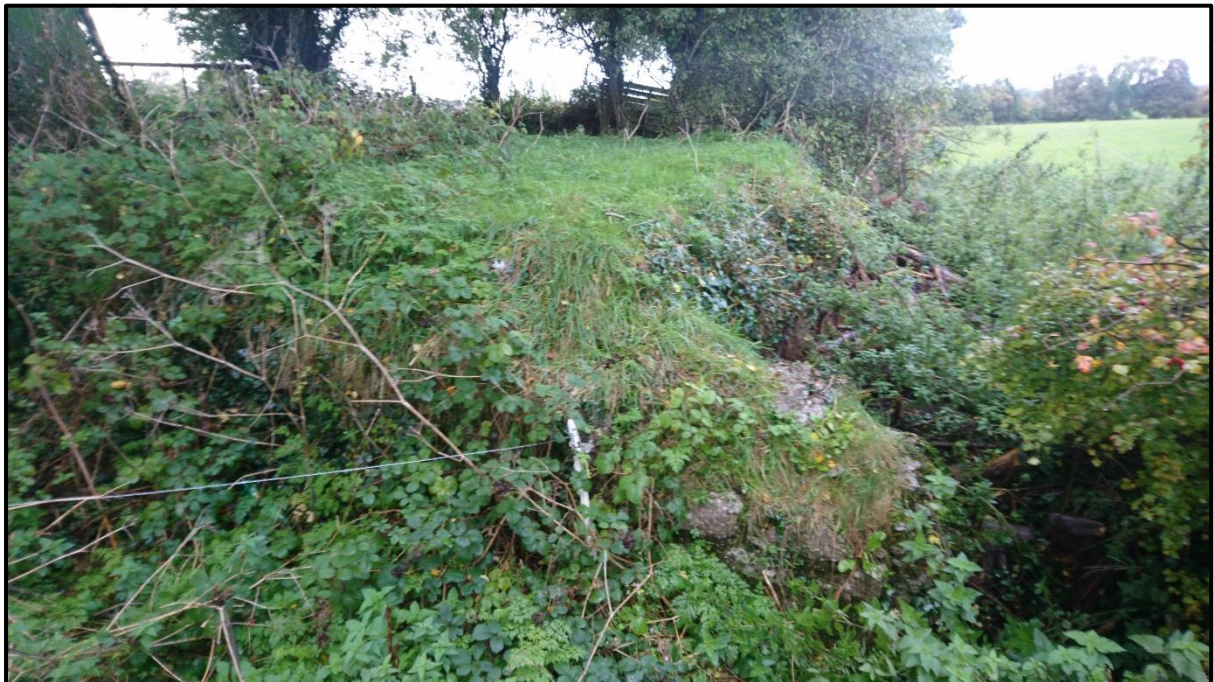
- 3.3 To the northeast of the proposed development, the overgrown ruins of a brick- and stone-built structure were noted during the site inspection. This structure appears to represent the remains of the building shown on the Ordnance Survey maps (see Figure 2 and Section 2.7 above). It survives as a single-storey, semi-subterranean basement-like structure which is covered with grass (Plate 6) and is largely inaccessible. It seems to represent the basement (Plate 8) of an 18th- or early 19th-century building of uncertain function. The building appears to have been accessed via the laneway which runs along the eastern boundary of the proposed development site – a gateway off the laneway gives direct access to the area around the structure. Though the building is located in the corner of the adjacent field and does not appear to have extended into the proposed development site at any time, it may extend right up to the boundary of the proposed development site.

Plate 6: The brick- and stone-built structure close to the north-eastern corner of the proposed development site – the proposed development site lies beyond the hedgerow to the left

- 4.1.3 No NIAH structures or Protected Structures exist on, or within 1km of, the proposed development site. The vaulted basement of an early modern building in an adjoining field is worthy of preservation, but it lies just outside the boundary of the proposed development site. Consideration should be given to this structure during the design process – ideally a buffer zone should be established around it in the north-eastern corner of the proposed development site and, if groundworks are required in the area, they should be monitored by a suitably qualified archaeologist.

- 4.2.1 If Roscommon County Council decide to commission a residential development on the proposed development site, it is recommended that:
- i) The design process should minimise development in the north-eastern corner, and
 - ii) Works in the north-eastern corner during the construction phase should be monitored by a suitably qualified archaeologist

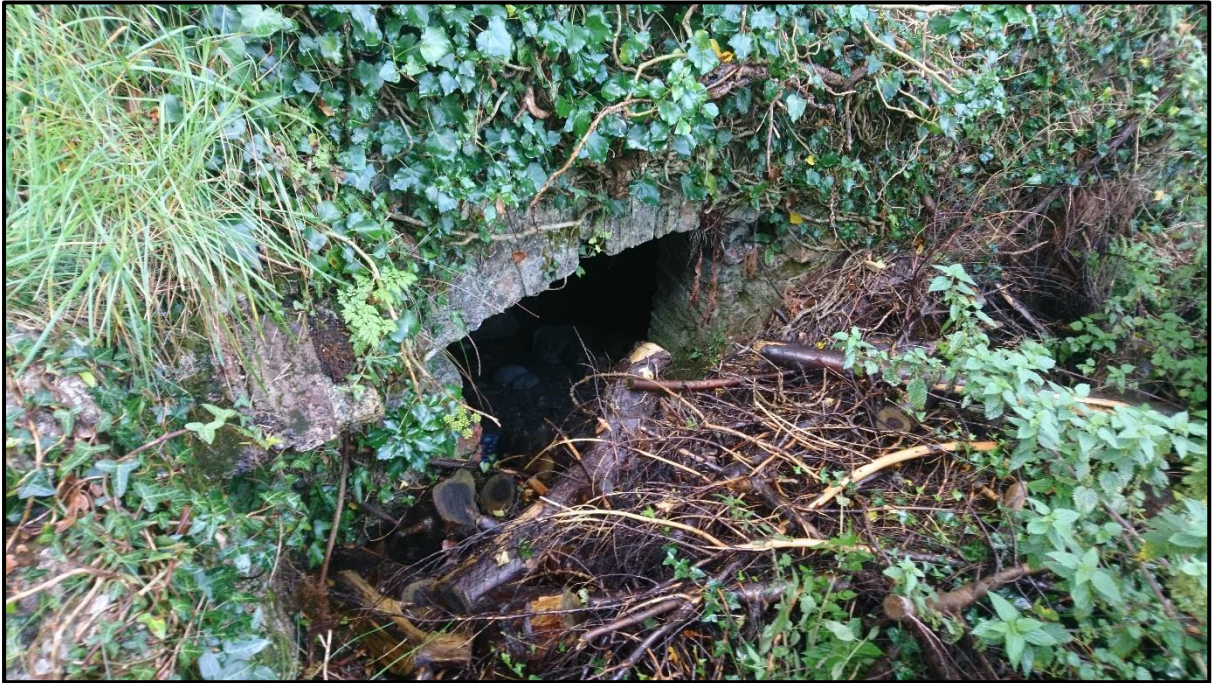
Plate 7: The brick- and stone-built structure close to the northeast corner of the proposed development site

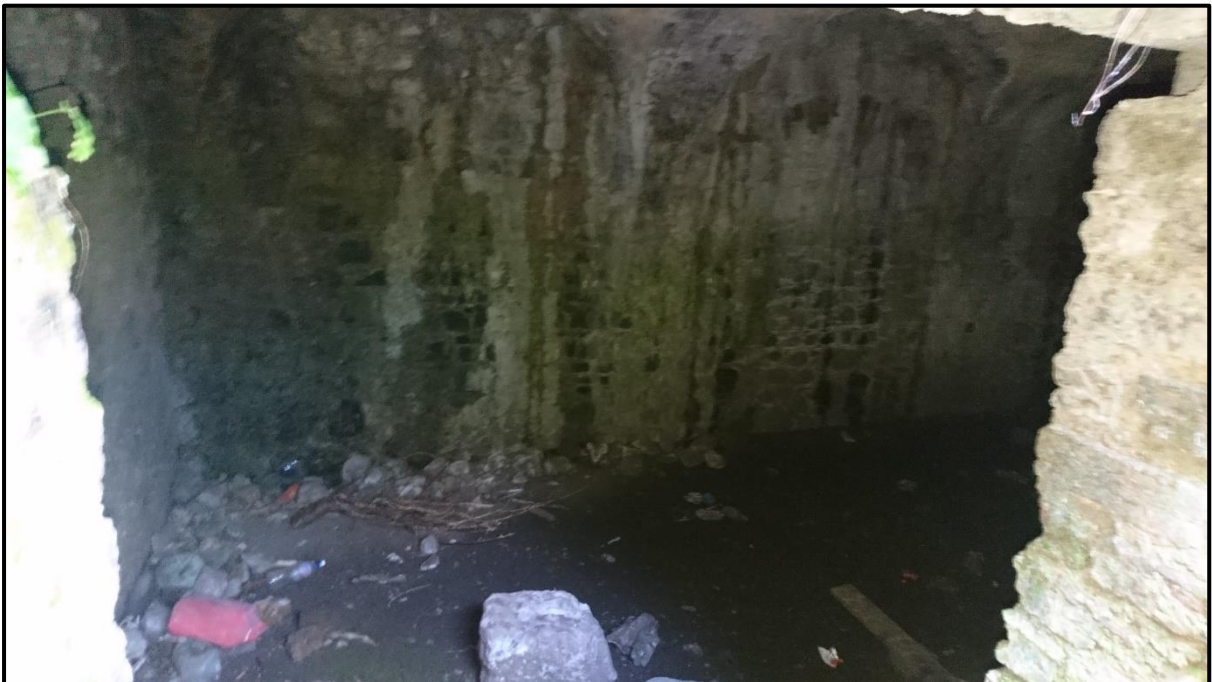
Plate 8: The vaulted area of the brick- and stone-built structure close to the north-eastern corner of the proposed development site
