## APPENDIX 6-2

# **Aquatic Macrophyte Survey Report**

Hodson Bay Waterfront  
Park, Co. Roscommon

Project Title: **Hodson Bay Waterfront Park, Co. Roscommon**

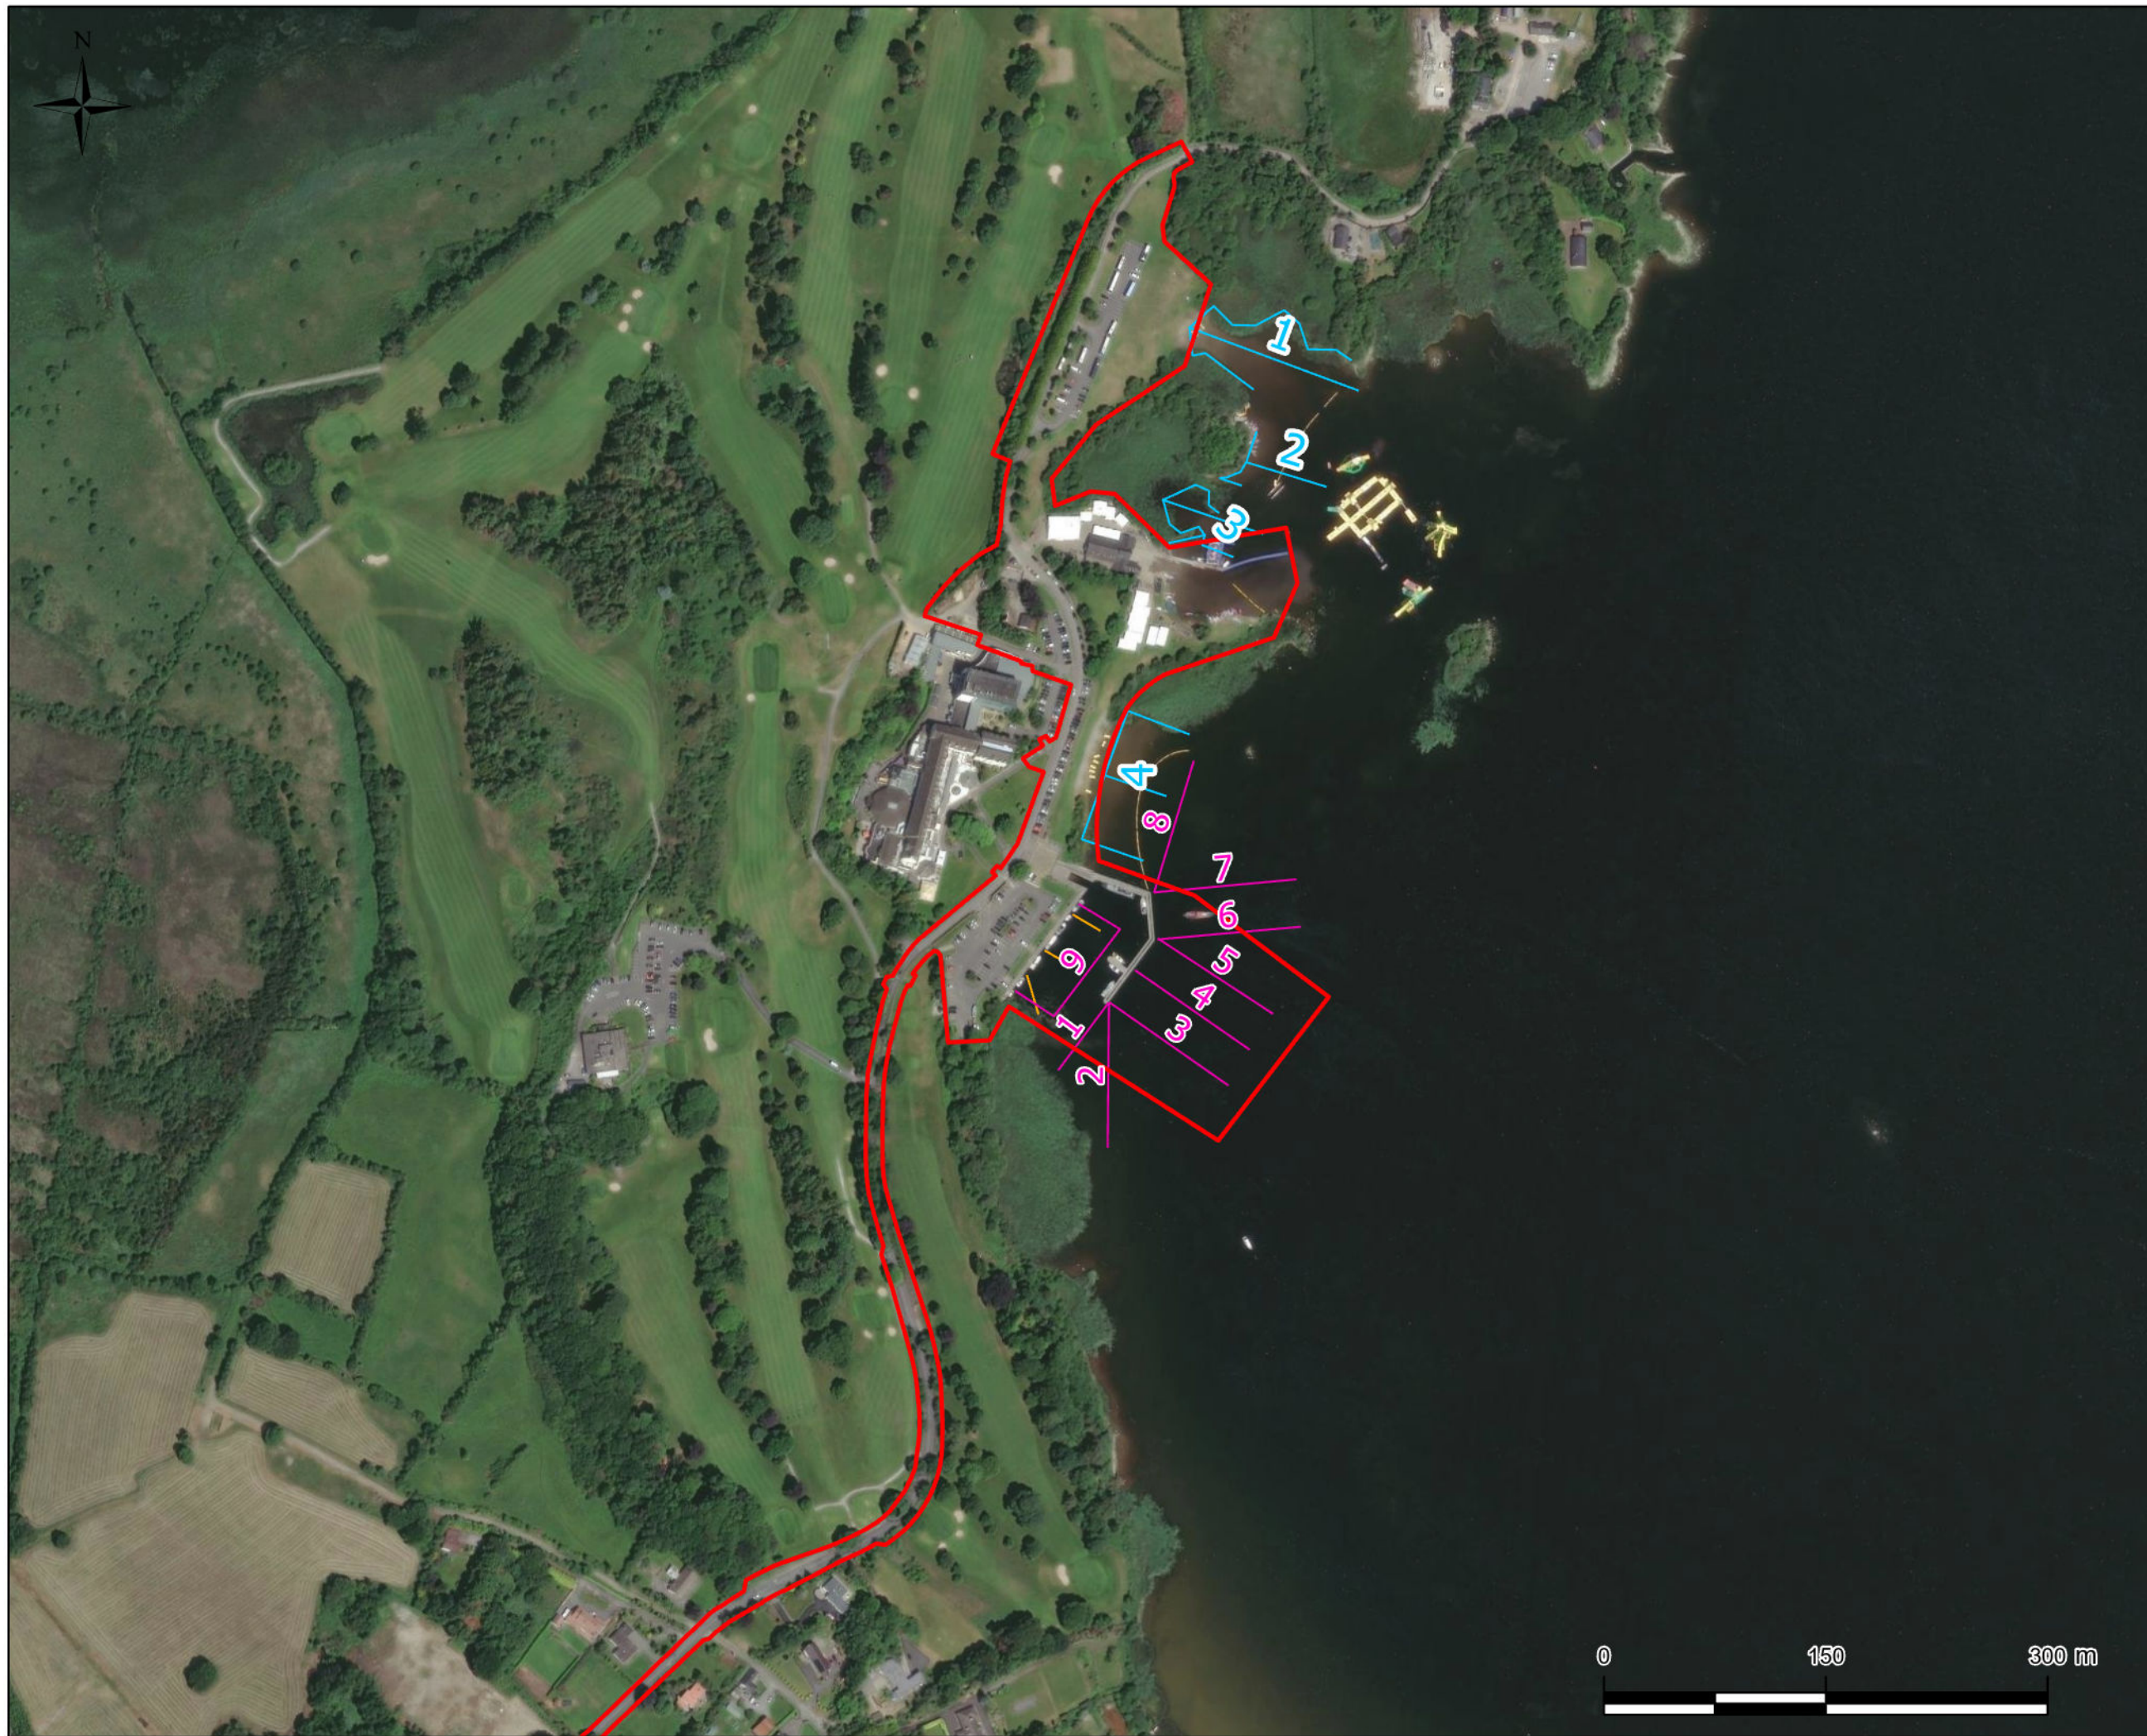
| 241220 | Figure 2-1 | 1:8,000 |

4 no. transects from the shoreline were waded, 1 no. transect was surveyed via grapnel throw, while 9 no. transects were surveyed using an aquatic drone. The length of wading transects were determined by the wadable depth of water at each. While the tether of the drone measures 100 m, the length of drone transects conducted was approx. 90 m from the starting point, taking into account the effect of currents within Lough Ree. Using the robotic arm attachment on the aquatic drone, grab samples were taken along each of the aquatic drone transects. Locations of both manual wading surveys and aquatic drone surveys are shown in Figure 2-1.

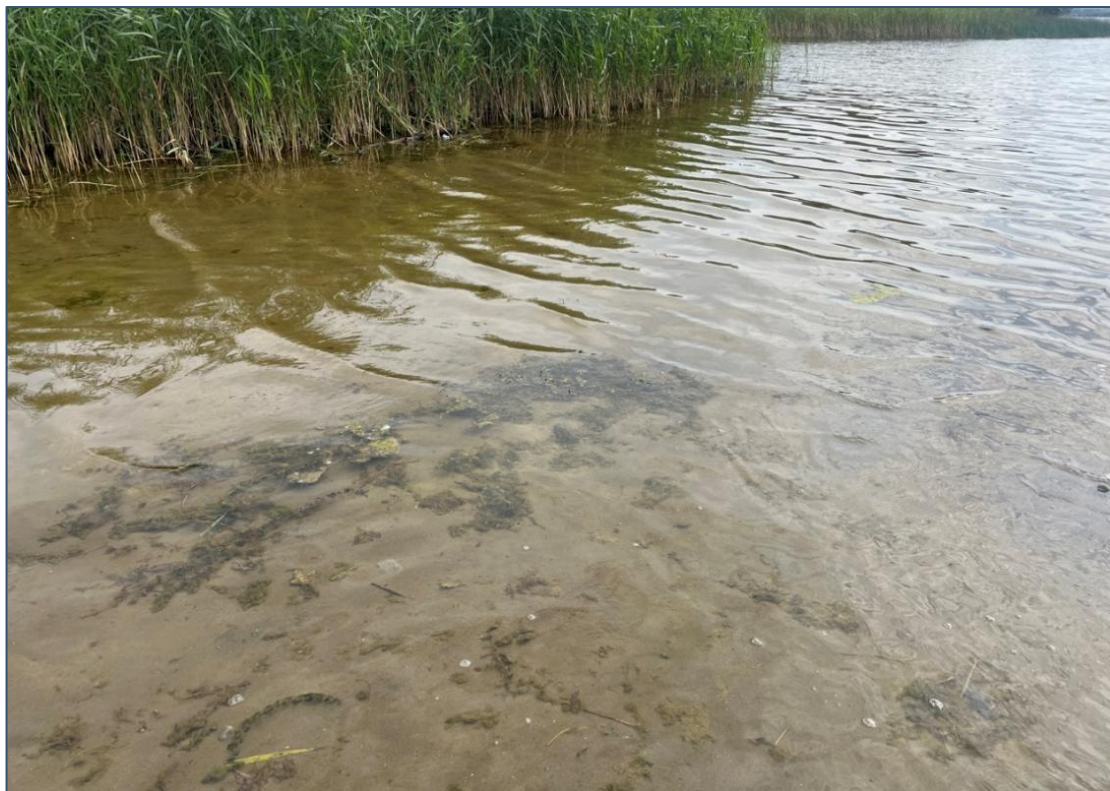
Wading Macrophyte transect 1 was conducted through the northern-most bay, partially within the Proposed Development Site. Macrophyte assemblage up to 20 m perpendicular to the shoreline consisted of **Occasional** patches of pondweeds (including Long-leaved Pondweed (*Potamogeton lucens* x *gramineus* = *P. x angustifolius*), Small pondweed (*Potamogeton berchtoldii*), Shining Pondweed (*Potamogeton lucens*) and perfoliate pondweed (*Potamogeton perfoliate*) and the Third Scheduled Invasive species Nuttall's waterweed (*Elodea nuttallii*), among otherwise bare silt and sand based lake bed substrates (Plate 3-1)

*Plate 3-1. A representative photo of sparse macrophyte coverage and silt and sand substrates throughout the first 65 m of wading macrophyte transect 1*

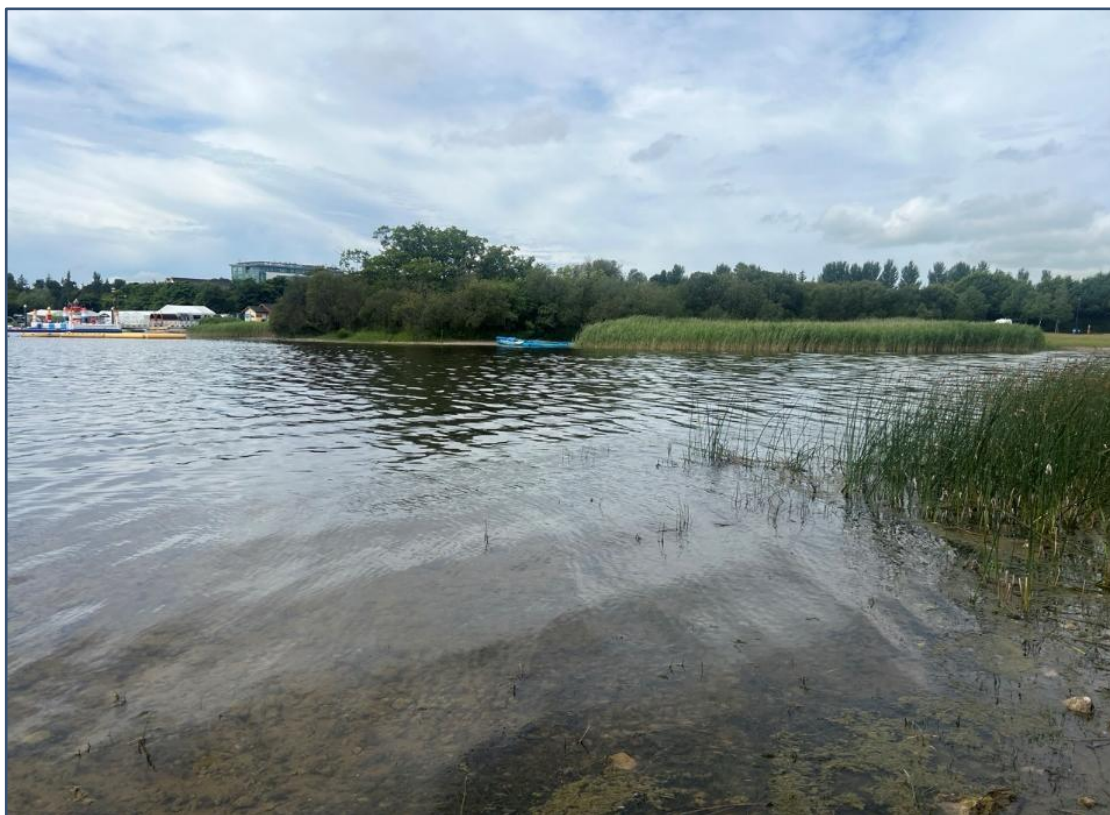
More dense patches of an assemblage of the above pondweed species were recorded in more **Frequent** density from approx. 65 m perpendicular to the shoreline, as well as **Occasional** spiked water-milfoil (*Myriophyllum spicatum*) and **Rare** patches of delicate stonewort (*Chara virgata*) and greater water-moss (*Fontinalis antipyretica*) (Plate 3-2).

*Plate 3-2. A representative photo of denser macrophyte coverage from 65 m out in wading transect 1*

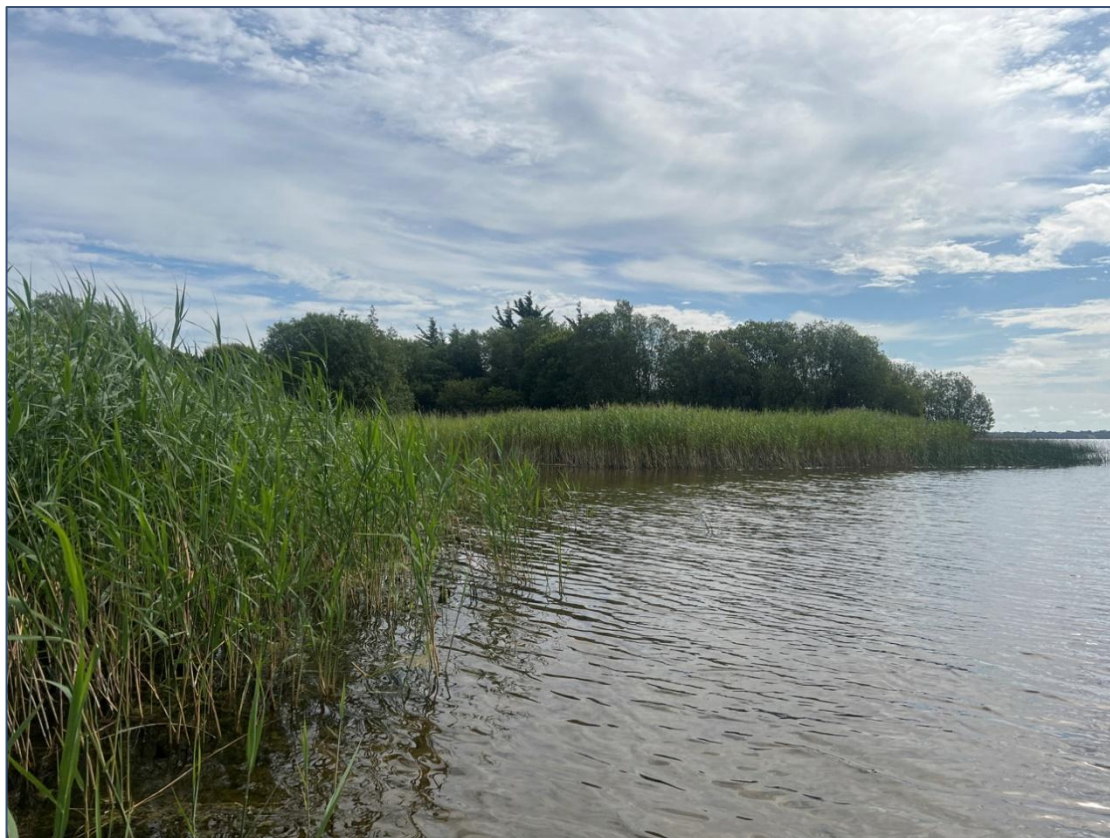
Reed and large sedge swamp (FS1) habitat bordered the central wading transect 1 to the north and south, with species throughout these dense habitats including reed-canary grass (*Phalaris arundinacea*) and common reed (*Phragmites australis*), both recorded as **Dominant**, with unbranched bur-reed (*Sparganium emersum*) and arrowhead (*Sagittaria sagittifolia*), both recorded as **Frequent**, found below the waterline on the border of this habitat. Common club-rush (*Schoenoplectus lacustris*) was also recorded as **Abundant** throughout stands of common reed and reed-canary grass. Other species which were recorded as **Occasional** included common spike-rush (*Eleocharis palustris*), yellow water lily (*Nuphar lutea*), water horsetail (*Equisetum fluviatile*). *Cladophora* sp. algae was present throughout macrophytes in open water and around reedbeds.

Plate 3-3. A representative photo of **Reed and large sedge swamp (FS1)** habitat dominated by common reed and reed-canary grass

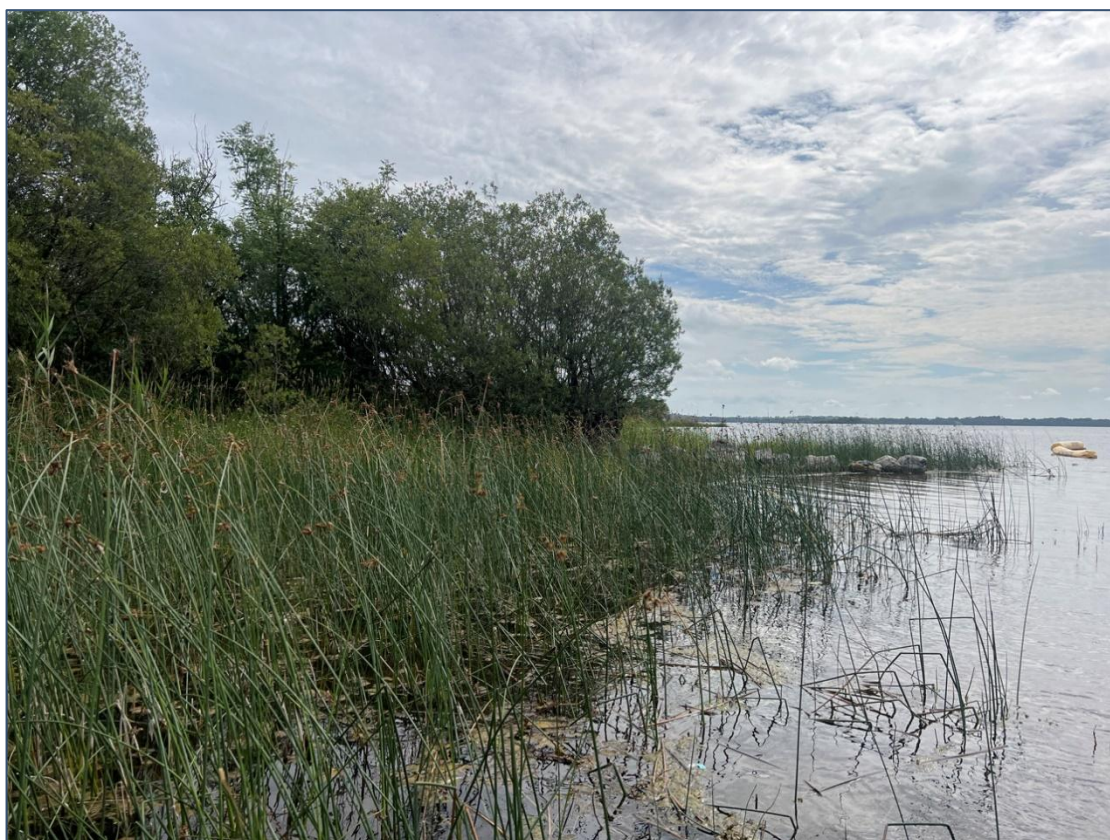
Plate 3-4. A representative photo of common club-rush dominant sections of **Reed and large sedge swamp (FS1)** habitat along wading transect 1

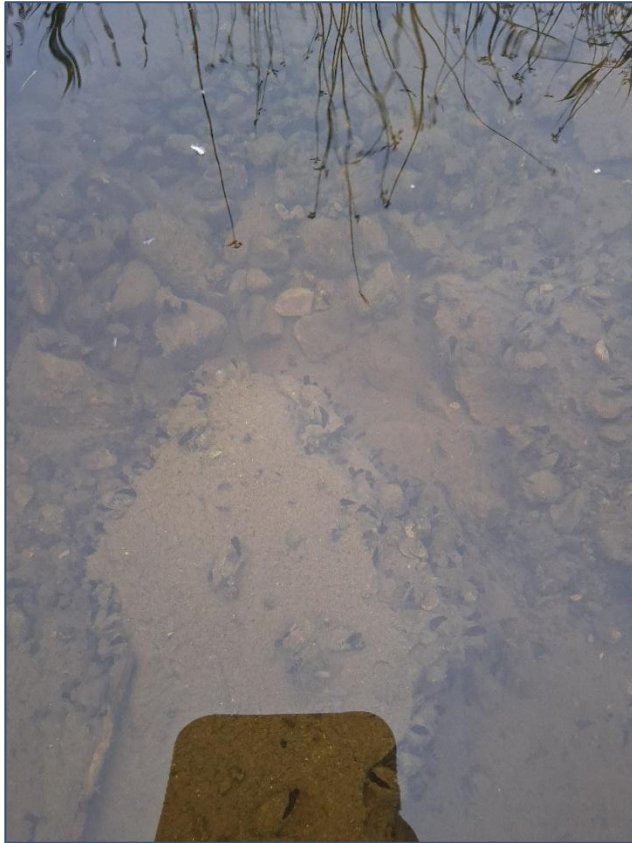
Encrusted deposits of quagga and zebra mussel were present intermittently along the lakebed throughout wading transect 1 (Plate 3-5).

Plate 3-5. A representative photo of quagga and zebra mussel found along wading macrophyte transect 1

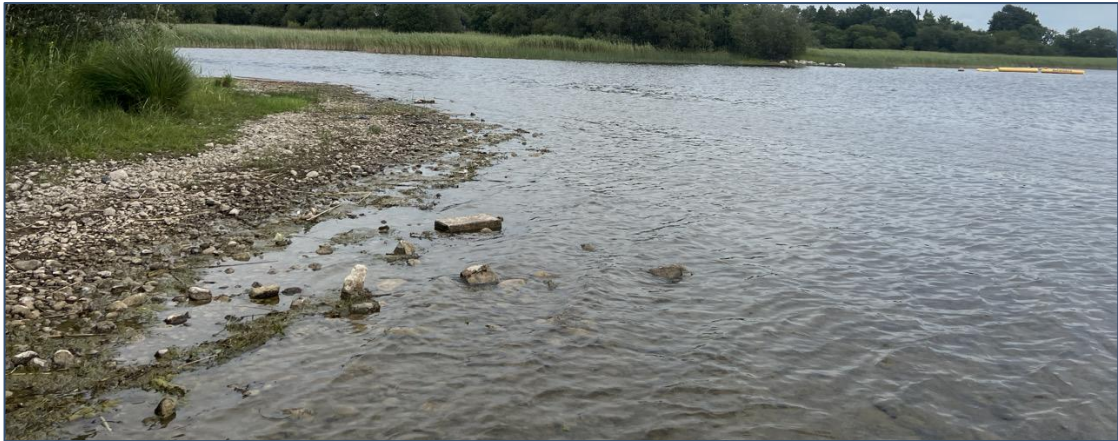
Between 5–65 m from the shoreline, macrophytes on the lakebed consisted of Nuttall’s waterweed (***Dominant***), long-leaved pondweed and perfoliate pondweed (***Frequent***) and small pondweed (***Occasional***), with beds of ***Frequent*** delicate stonewort (Plate 3-6).

Plate 3-6. A representative photo of cobble-dominated lakebed substrate at wading macrophyte transect 2

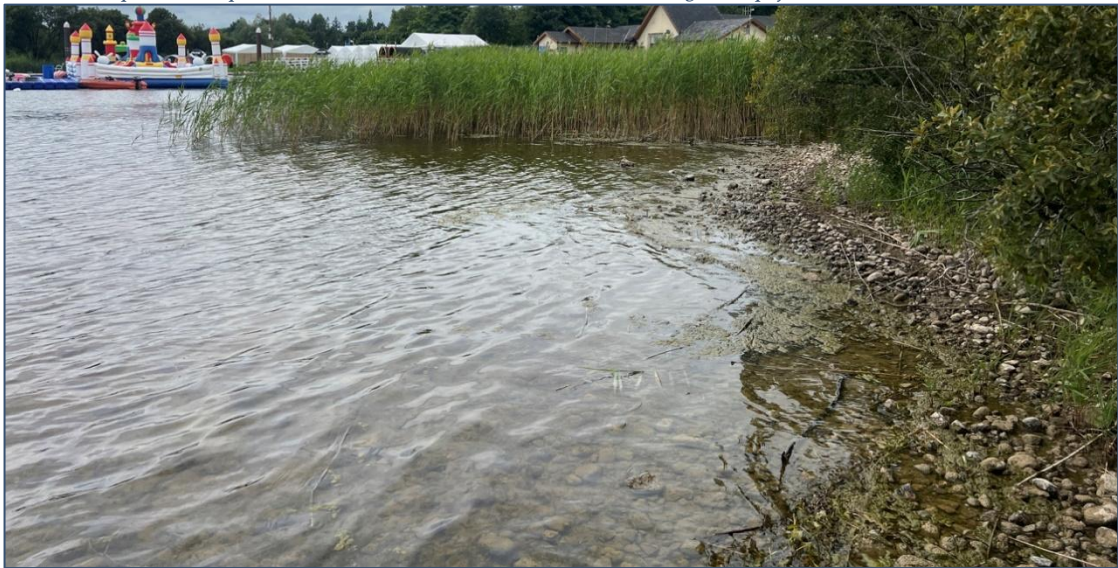
Along the southern side of the transect, stands of **Reed and large sedge swamp (FS1)** consisting of common reed, reed-canary grass and common club-rush (all recorded as ***Dominant***) were present continuously from the shoreline to 20 m perpendicular to the shoreline (Plate 3-8). Yellow water lily, unbranched bur-reed and arrowhead (all recorded as ***Frequent***) were present along the margins between reedbeds and open water.

Plate 3-7. A representative photo of areas of **Reed and large sedge swamp (FSI)** habitat along wading macrophyte transect 2

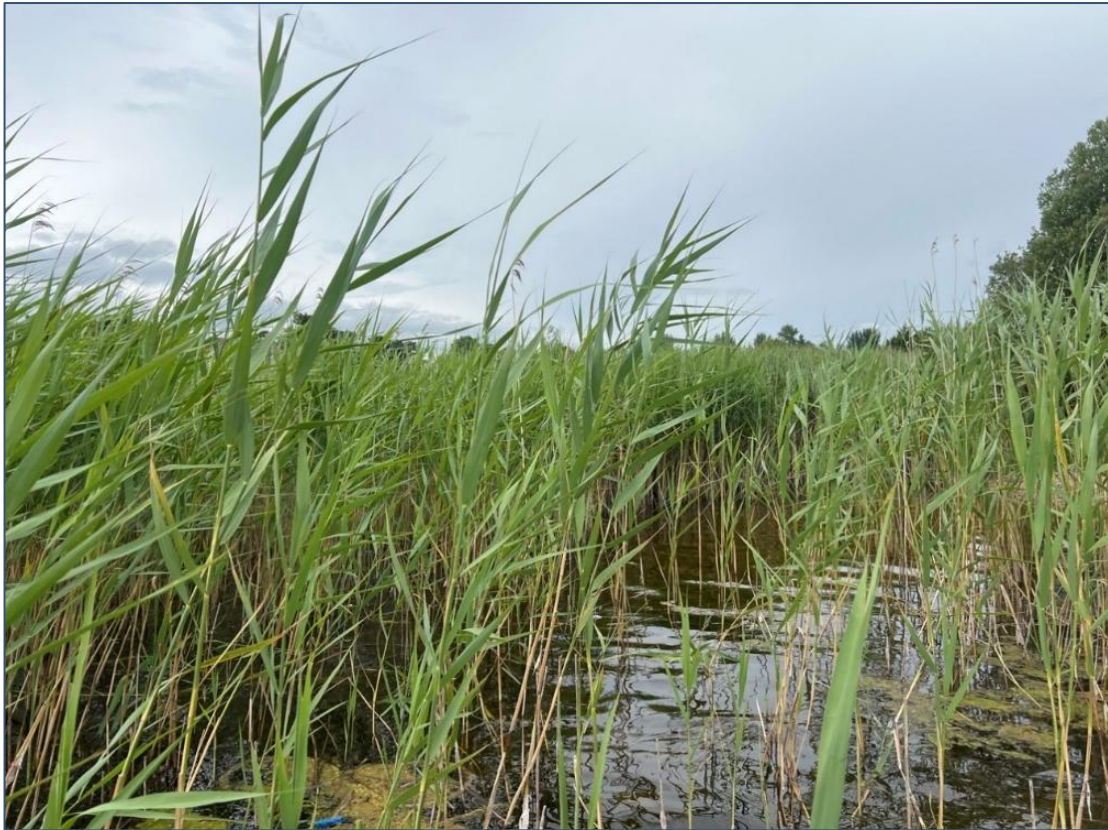
Plate 3-8. A representative photo of common reed and reed-canary grass dominant reed beds along the southern side of wading macrophyte transect 2

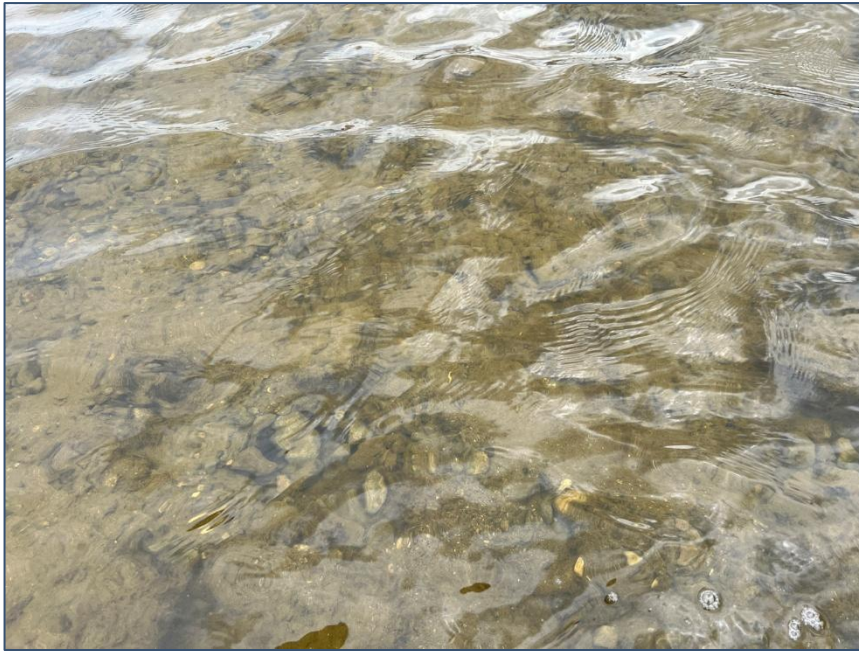
*Plate 3-9. A representative photo of lakebed substrate in areas with high levels of existing disturbance within the Baysports Facility*

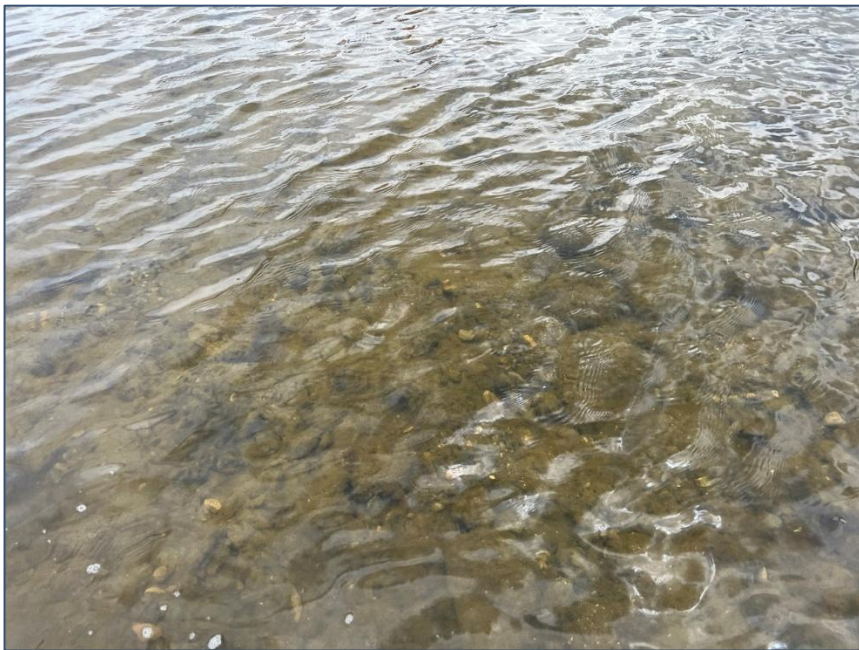
*Plate 3-10. A representative photo of lakebed substrate in areas with high levels of existing disturbance within the Baysports Facility*

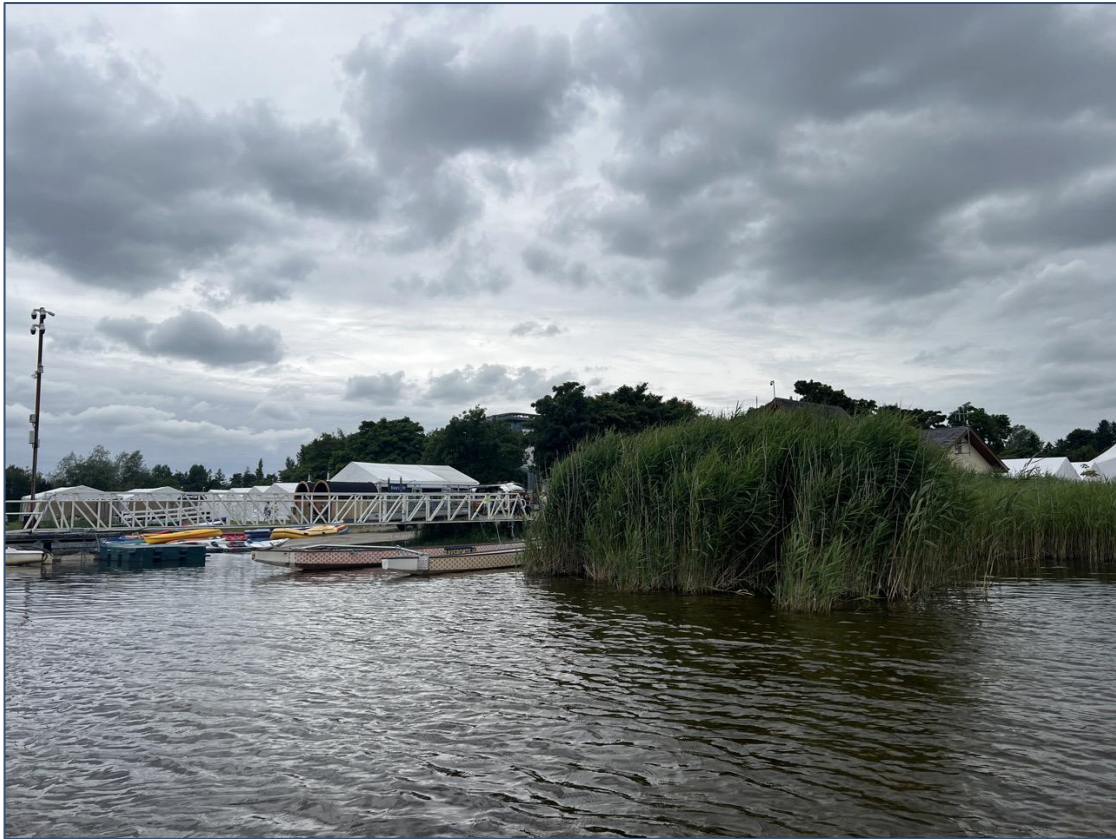
Wading Macrophyte transect 3 was conducted within the Proposed Development Site, located along the area of Lough Ree directly north of the Baysports facility. Lakebed substrate consisted of a mixture of sand and silt, as well as gravel and cobbles. Quagga and zebra mussel encrustations were observed throughout the transect. Within the bounds of the existing Baysports water sports facility, habitat consisted largely of areas of highly disturbed lakebed, with gravel, sand and silt substrates and little to no macrophyte coverage (Plate 3-9, Plate 3-10), with a fringing **Reed and large sedge swamp (FS1)** habitat bordering between the Baysports facility and adjacent bay (Plate 3-11).

Plate 3-11. A representative photo of bordering **Reed and large sedge swamp (FS1)** habitat between the Baysports facility and northern bay

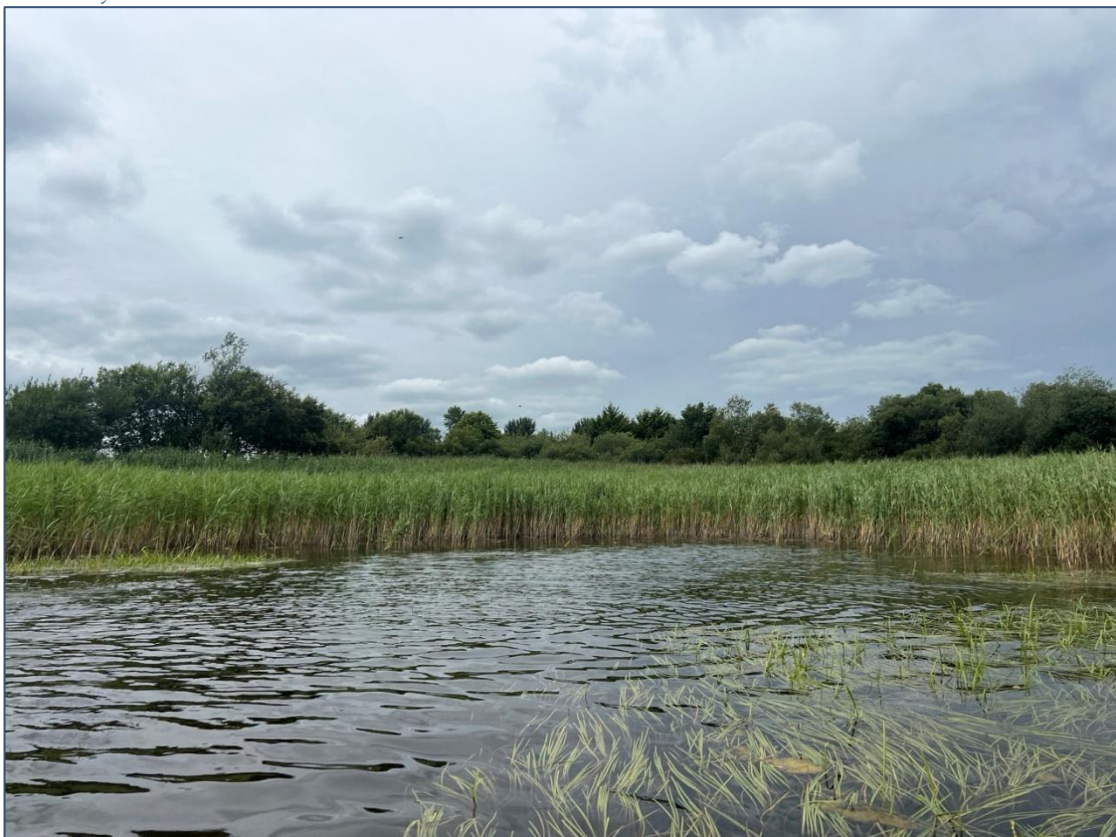
Plate 3-12. A representative photo of the centre of wading macrophyte transect 3

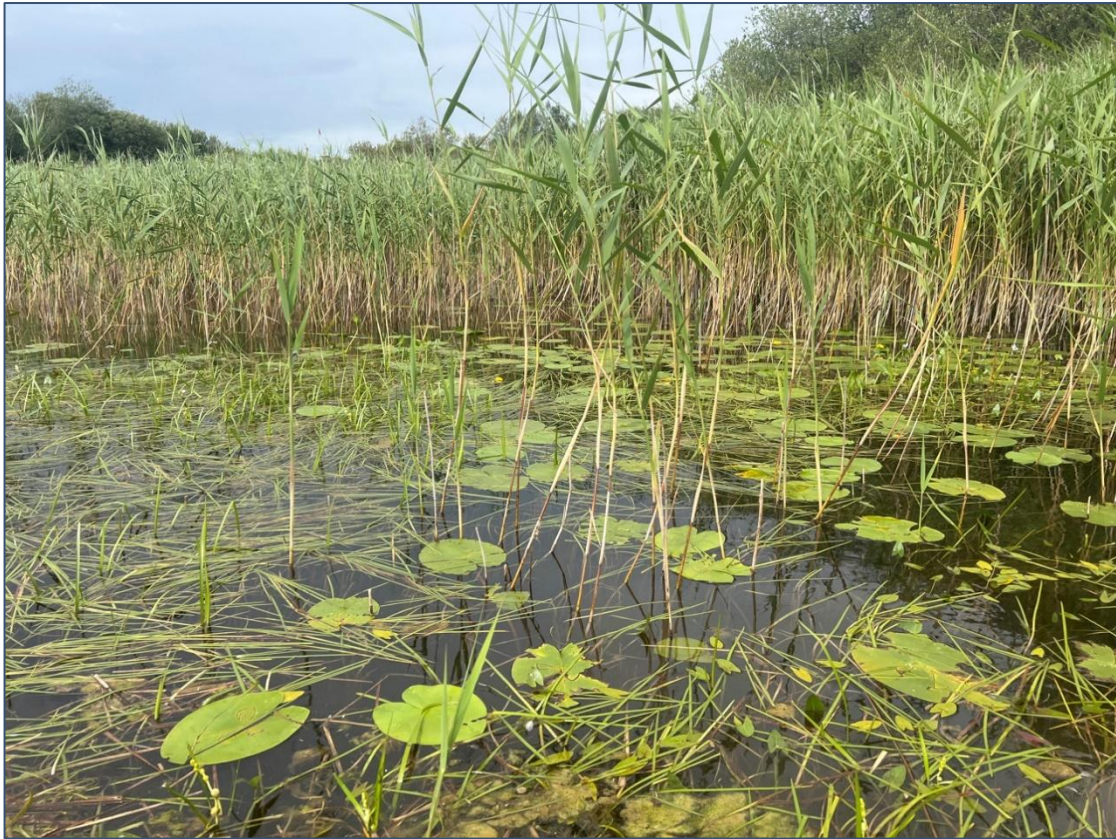
*Plate 3-13. A representative photo of yellow water lily present throughout macrophyte transect 3*

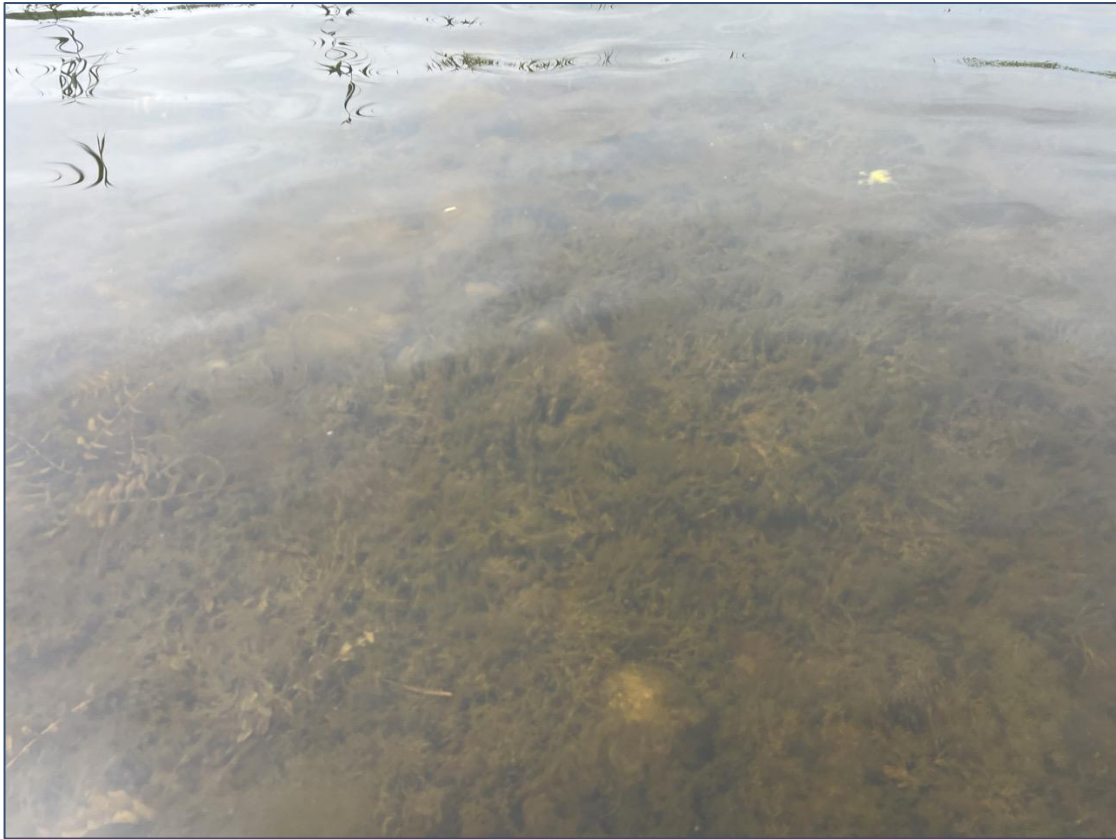
Plate 3-14. A representative photo of charophyte beds with pondweed sp. and Nuttall's pondweed throughout

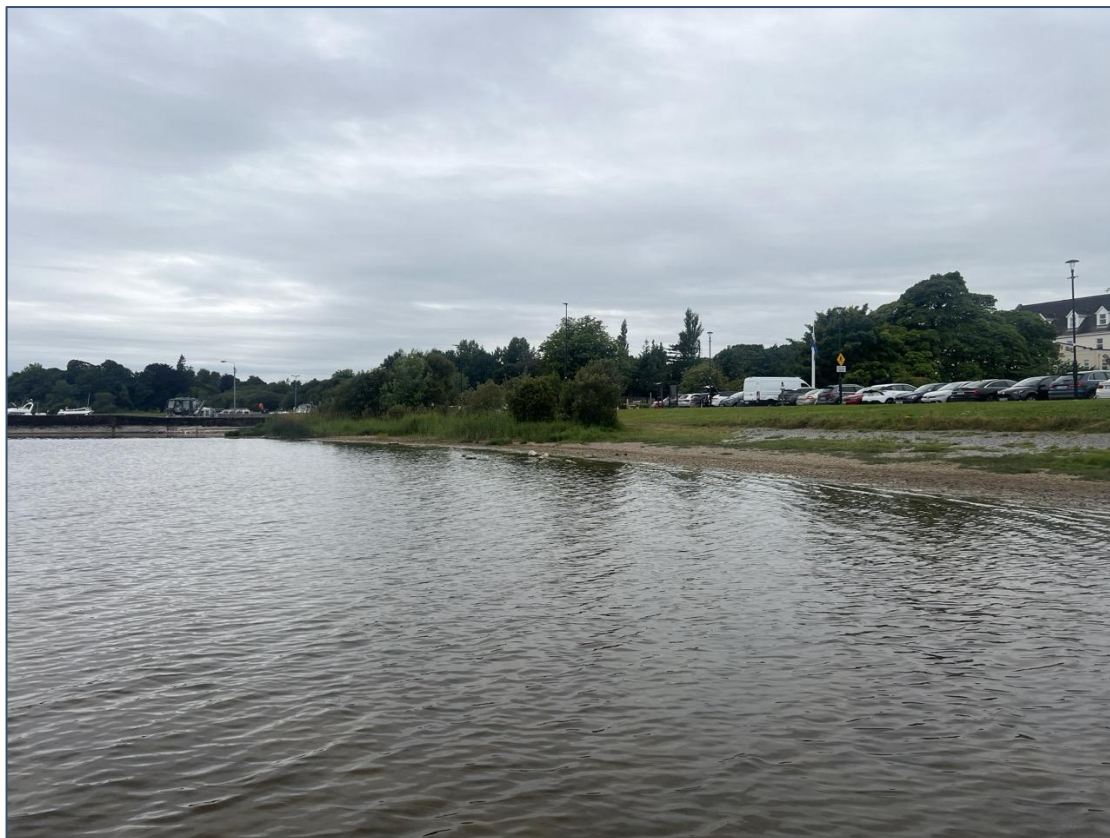
Wading macrophyte transect 4 was conducted from the shoreline directly north of the existing marina, partially within the Proposed Development Site. Lakebeds substrates were primarily composed of silt and sand, similar to wading transect 1. However, macrophyte coverage on the lakebed was denser, although still patchy. Macrophytes recorded as **Frequent** up to 70 m from the shoreline (the limit of wadable depth) included delicate stonewort, long-leaved pondweed and perfoliate pondweed. Nuttall's pondweed was recorded as **Abundant**, particularly in areas of deeper water along the northern side of the existing marina. Fennel-leaf pondweed (*Stuckenia pectinata*) was also recorded as **Frequent** throughout the bay in wading transect 4. Much of the submerged macrophytes in wading transect 4 were overlain with siltation (Plate 3-15, Plate 3-16, Plate 3-17).

Plate 3-15. A representative image of the bay in which wading macrophyte transect 4 was conducted

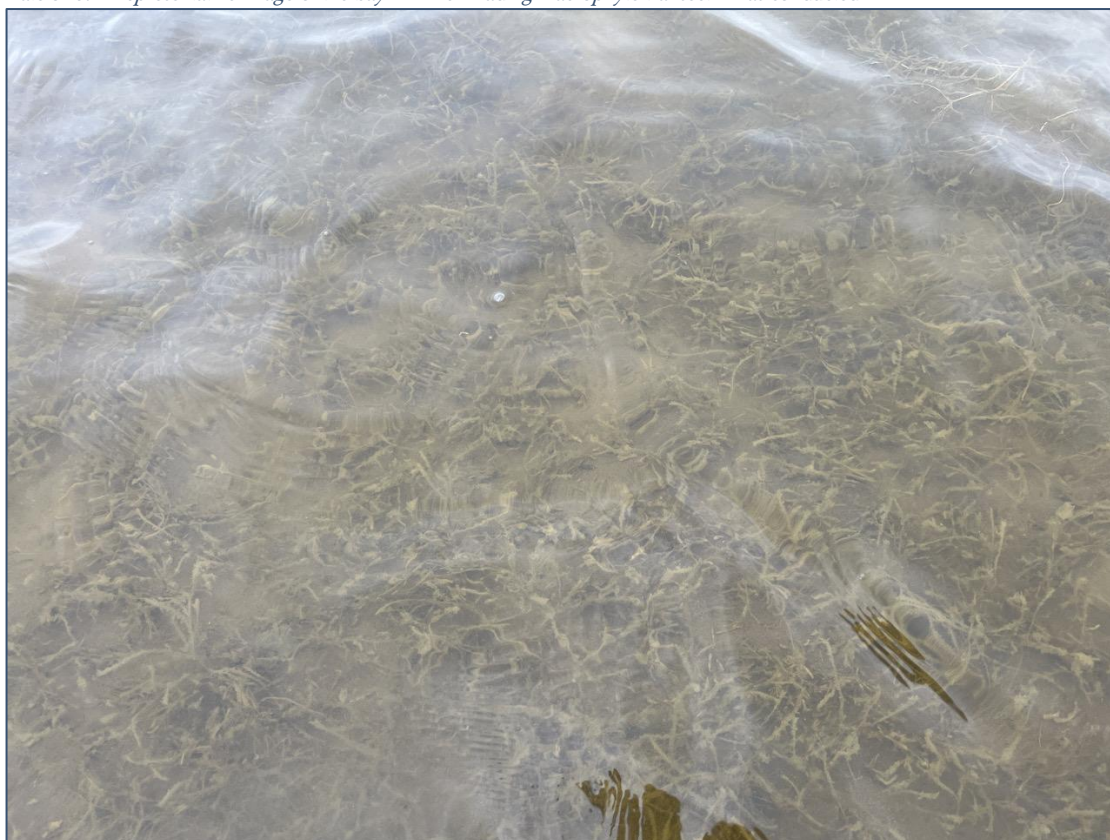
Plate 3-16. A representative image of continuous but patchy macrophyte coverage at wading transect 4

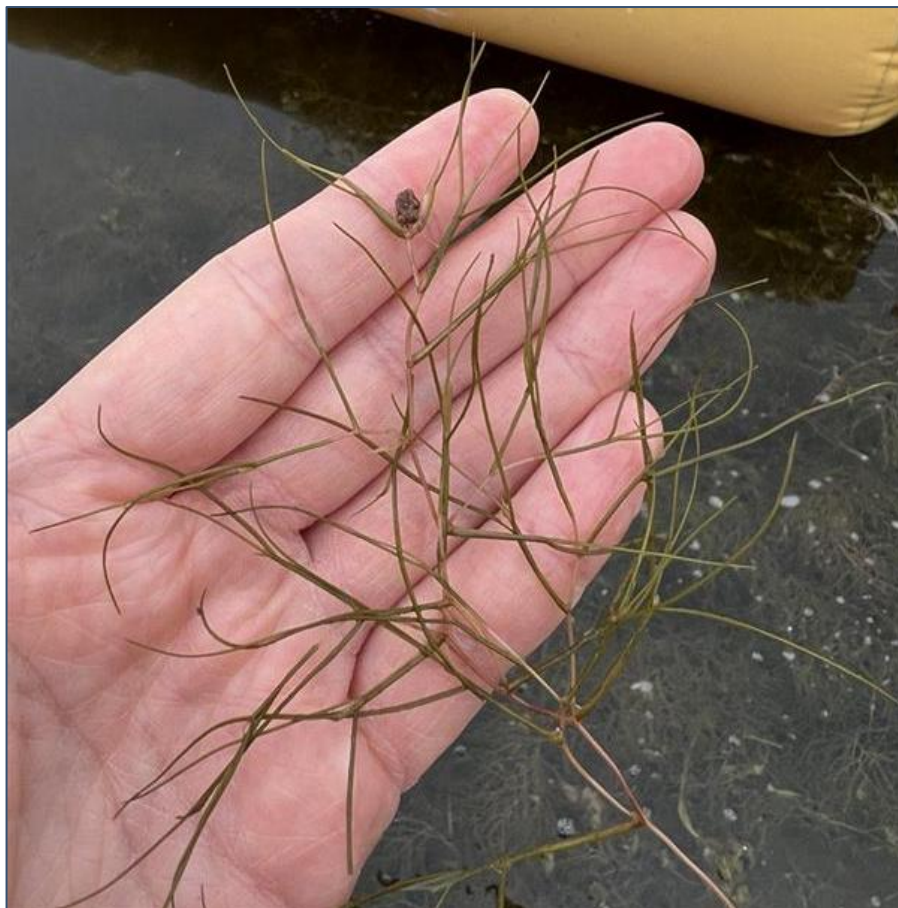
Plate 3-17. A representative photo of Fennel-leaf pondweed identified throughout wading transect 4

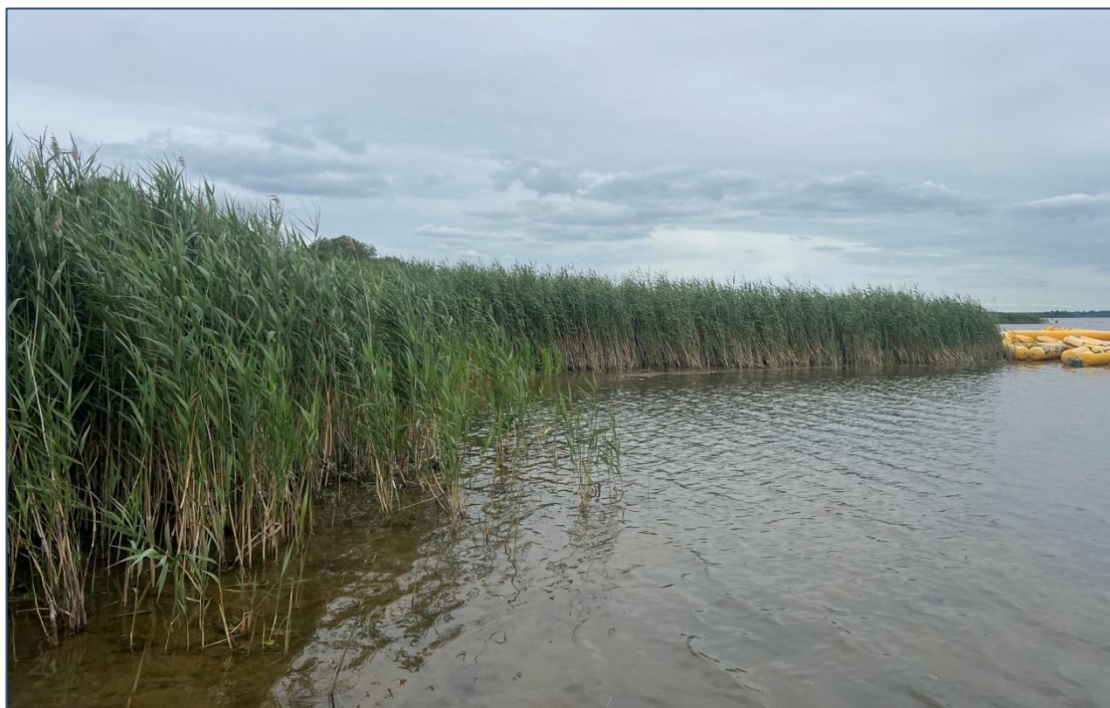
Along the northern side of the bay, **Reed and large sedge swamp (FS1)** habitat extended up to 60 m perpendicular to the shoreline and consisted of common reed and reed-canary grass (**Dominant**), common club-rush (**Frequent**) and bulrush (*Typha latifolia*, **Occasional**). Plants recorded marginally and emergently along the shoreline included water mint (**Occasional**) and horsetail (*Equisetum sp.*, **Rare**), common spike-rush (**Rare**) and lesser spearwort (*Ranunculus flammula*, **Rare**)

Plate 3-18. A representative photo of **Reed and large sedge swamp (FS1)** habitat located along the northern side of wading macrophyte transect 4

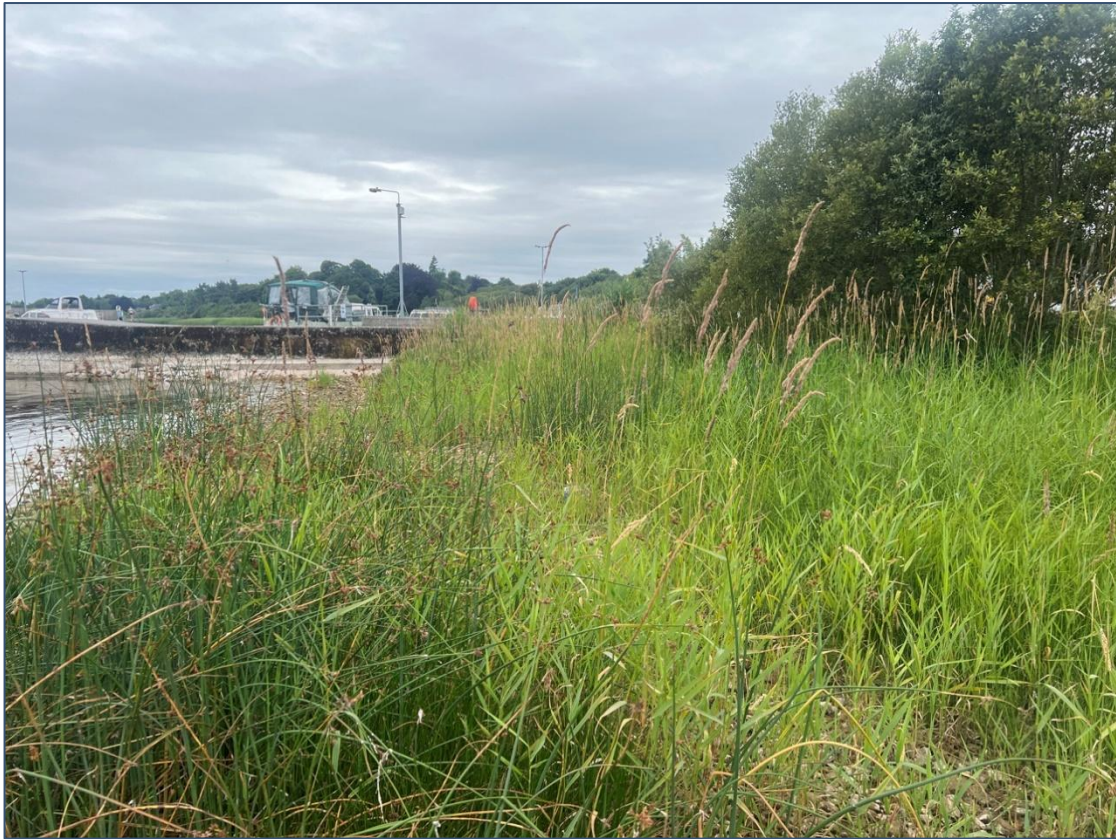
Plate 3-19. A representative photo of vegetation assemblage on the shoreline, including common-club rush and common spike-rush

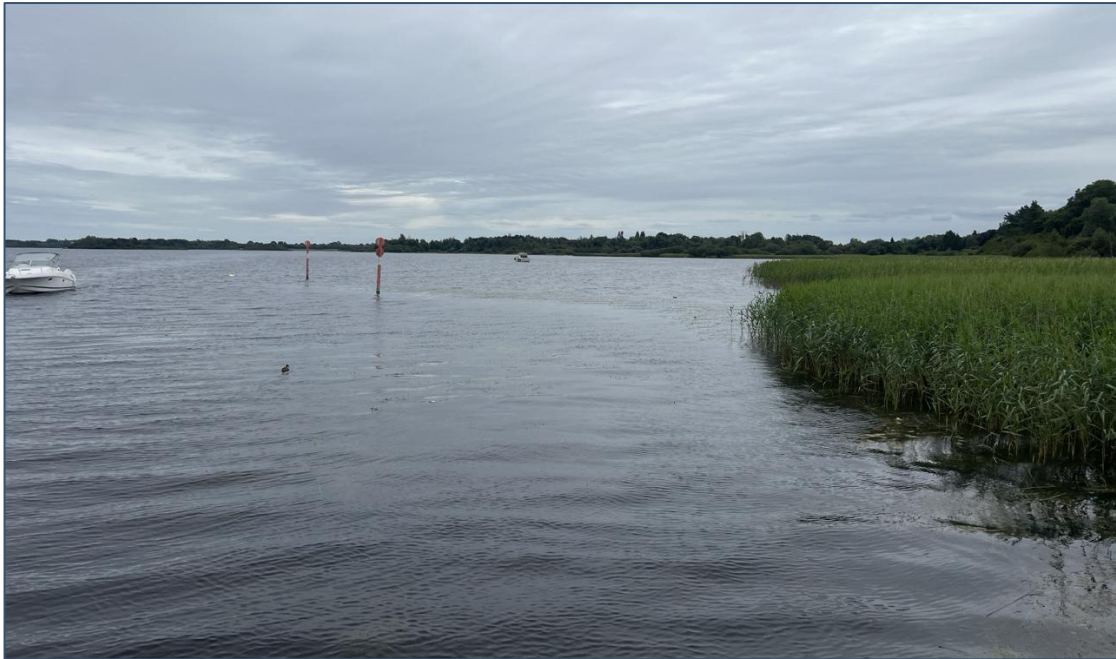
Canadian waterweed (*Elodea Canadensis*) and Nuttall's waterweed were **Dominant** throughout the marina, in conjunction with Ivy-leaved duckweed (*Lemna triscula*) recorded as **Abundant**. The invasive species starry stonewort (*Nitellopsis obtusa*) was also recorded as **Abundant** throughout the marina. Perfoliate pondweed and greater water-moss were recorded as **Frequent** in areas of grapnel throw survey (Plate 3-20, Plate 3-21).

Plate 3-20. A representative photo of the prohibitively deep water in the vicinity of the existing marina

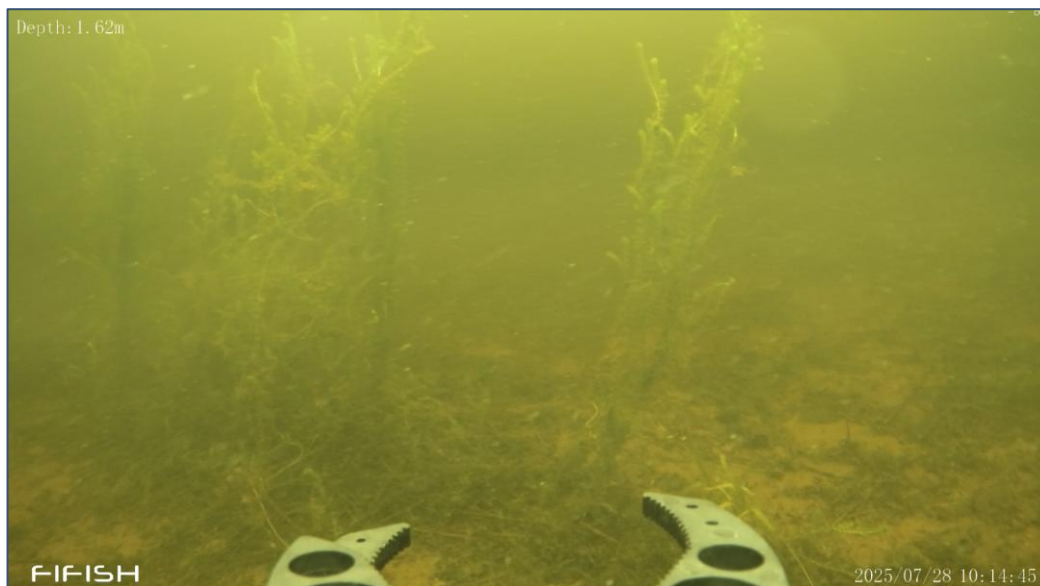
Aquatic drone transect 1 was conducted from the end of the marina, moving approx. 55 m southwest toward the reed beds south of the marina. Aquatic drone transect 1 was conducted partially within the Proposed Development Site. Lakebed substrates consisted primarily of silt and sand-based substrates, with continuous, patchy coverage of Nuttall's waterweed and Canadian waterweed recorded as ***Dominant***, in conjunction with ivy-leaved duckweed recorded as ***Abundant***, up to 2.2m deep throughout the transect (Plate 3-22).

Plate 3-22. A representative photo taken via aquatic drone of Canadian and Nuttall's waterweed throughout aquatic drone transect 1
