## APPENDIX 6-2

# **Aquatic Macrophyte Survey Report**

Hodson Bay Waterfront  
Park, Co. Roscommon

Project Title: **Hodson Bay Waterfront Park, Co. Roscommon**

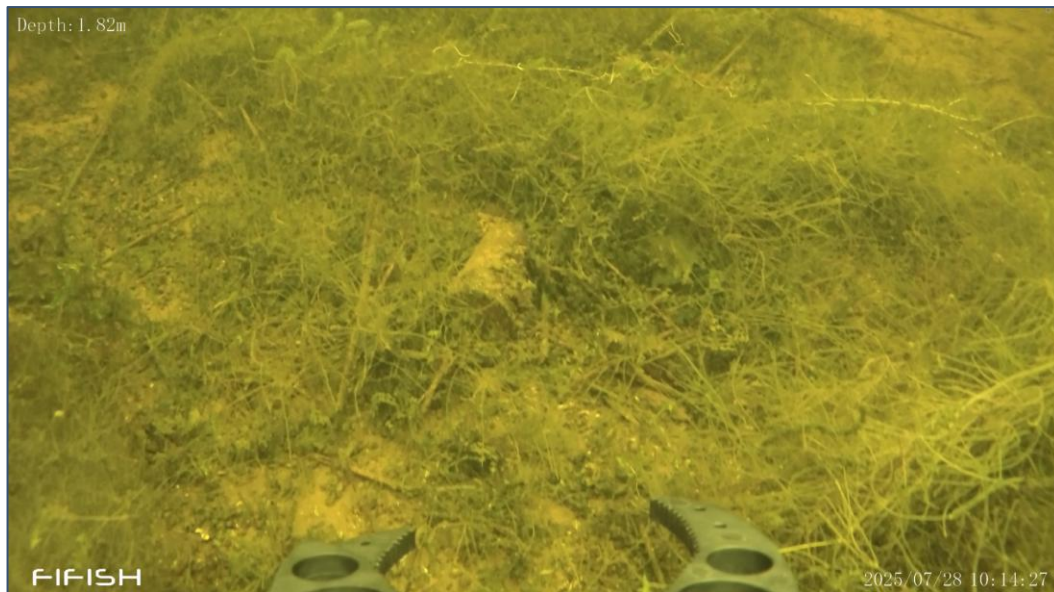
The invasive species starry stonewort was recorded as ***Abundant*** along the lakebed throughout much of the transect. Juvenile quagga mussels were frequently found in association with starry stonewort (Plate 3-23), with encrustations of zebra and quagga mussel along the lakebed throughout aquatic drone transect one. In areas of shallower water toward the reedbeds, underwater leaves of arrowhead and yellow water lily were also observed, both recorded as ***Occasional***, while shining and perfoliate pondweed were recorded as ***Frequent*** on the margins of reedbeds to the south (Plate 3-24).

Plate 3-23. A representative photo taken via aquatic drone of the lakebed, dominated by starry stonewort, Canadian waterweed and Nuttall's waterweed

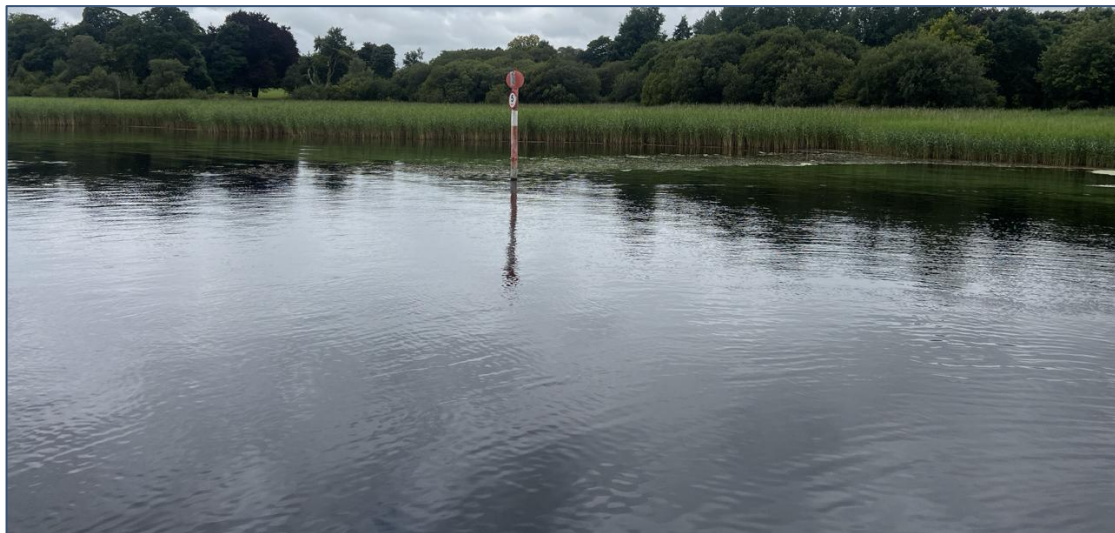
Plate 3-24. A representative photo of aquatic drone transect 1 from the marina

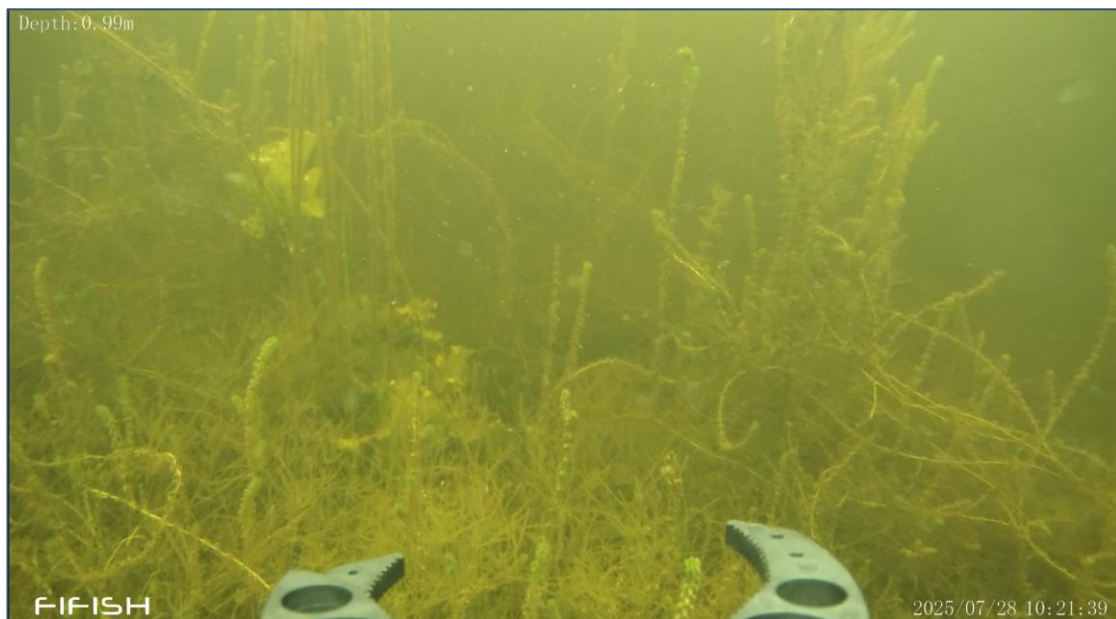
of delicate stonewort (recorded as ***Frequent***) but was dominated by the non-native species starry stonewort, which was recorded as ***Abundant*** (Plate 3-26). Plate 3-27 shows a representative photo of the location of aquatic drone transect 2.

Plate 3-26. A representative photo of areas of *Elodea* spp. beds, with charophytes throughout

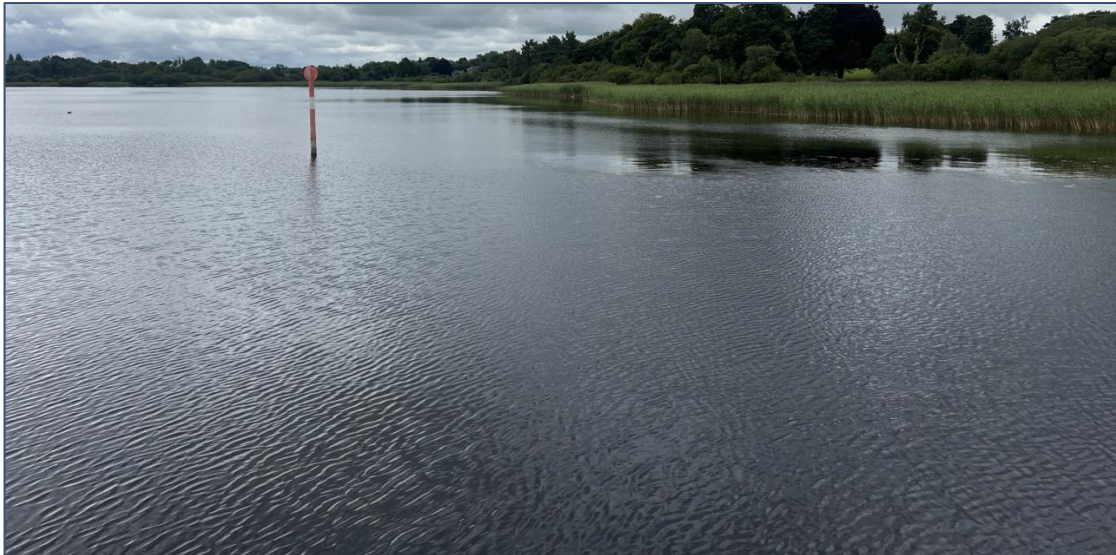
Plate 3-27. A representative photo of aquatic drone transect 2 from the marina

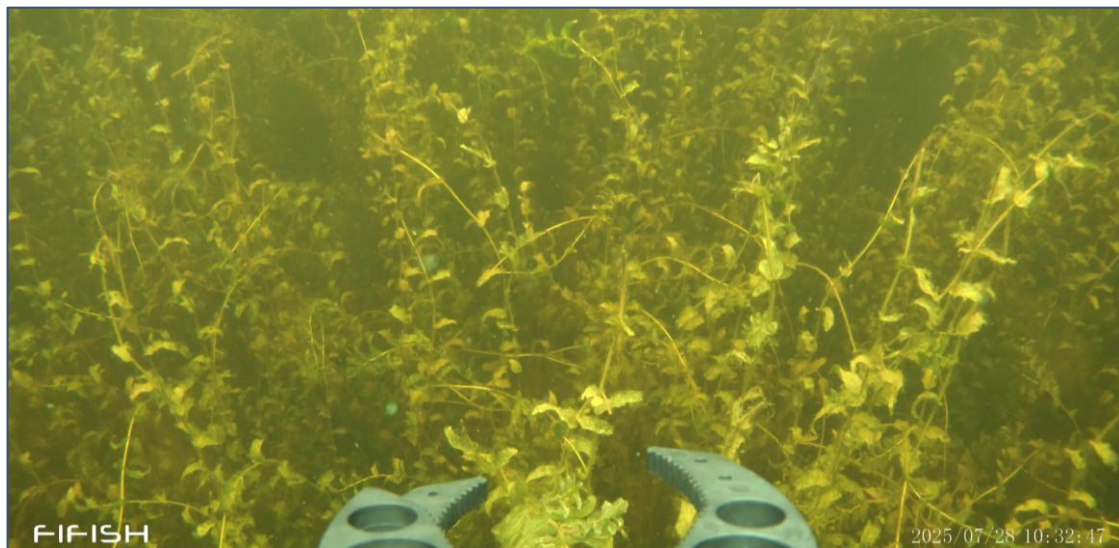
Plate 3-29. A representative photo of pondweed-dominant areas of lakebed along aquatic drone transect 3

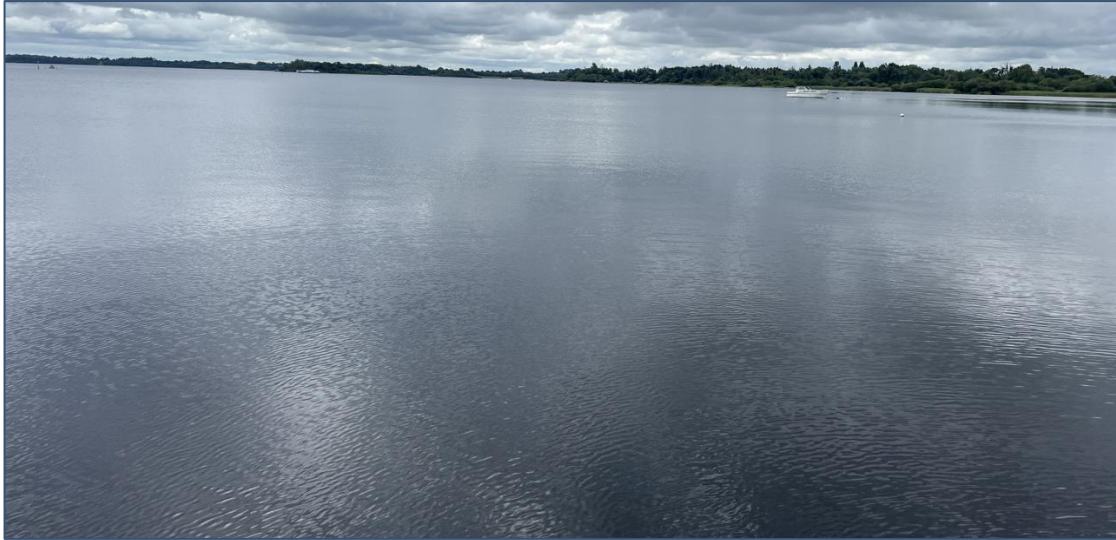
Plate 3-31. A representative photo of the location of aquatic drone transect 3

Aquatic drone transect 3 was conducted from the end of the marina, moving approx. 90 m southeast from the southern corner of the marina. Aquatic drone transect 3 was conducted partially within the Proposed Development Site. Lakebed substrates along this transect consisted primarily of silt and sand, with encrustations of quagga and zebra mussel noted, particularly in the first 20 m of the transect. High levels of siltation were evident along aquatic drone transect 3 in the vicinity of the existing marina.

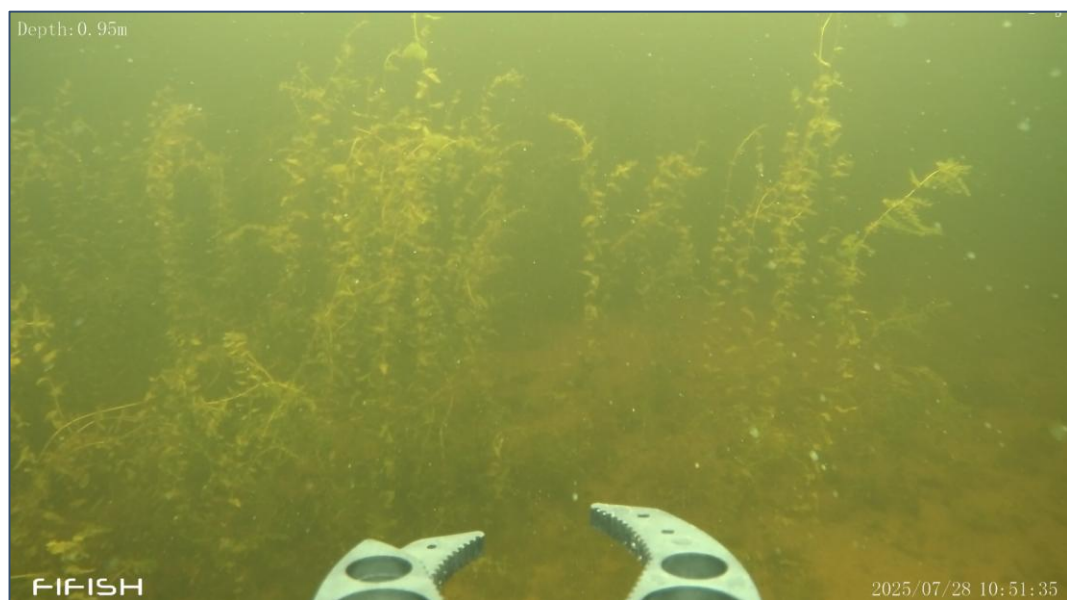
Lakebed substrates along this transect again consisted primarily of silt and sand, with encrustations of quagga and zebra mussel noted, particularly in the first 20 m of the transect, grading into charophyte **Dominant** beds at up to 2 m deep, featuring delicate stonewort, common stonewort and the non-native stonewort (Plate 3-32). From approx. 65 m out along the transect, pondweed beds, dominated by perfoliate pondweed (**Dominant**) were present and also featured Nuttall's waterweed (**Frequent**) and the aforementioned charophyte species throughout (recorded as **Abundant** throughout this section). *Cladophora sp.* was also present throughout pondweed beds, recorded as **Abundant** (Plate 3-33, Plate 3-34).

Plate 3-33. A representative photo of sparse areas of pondweed beds at the approximate halfway point of aquatic drone transect 4

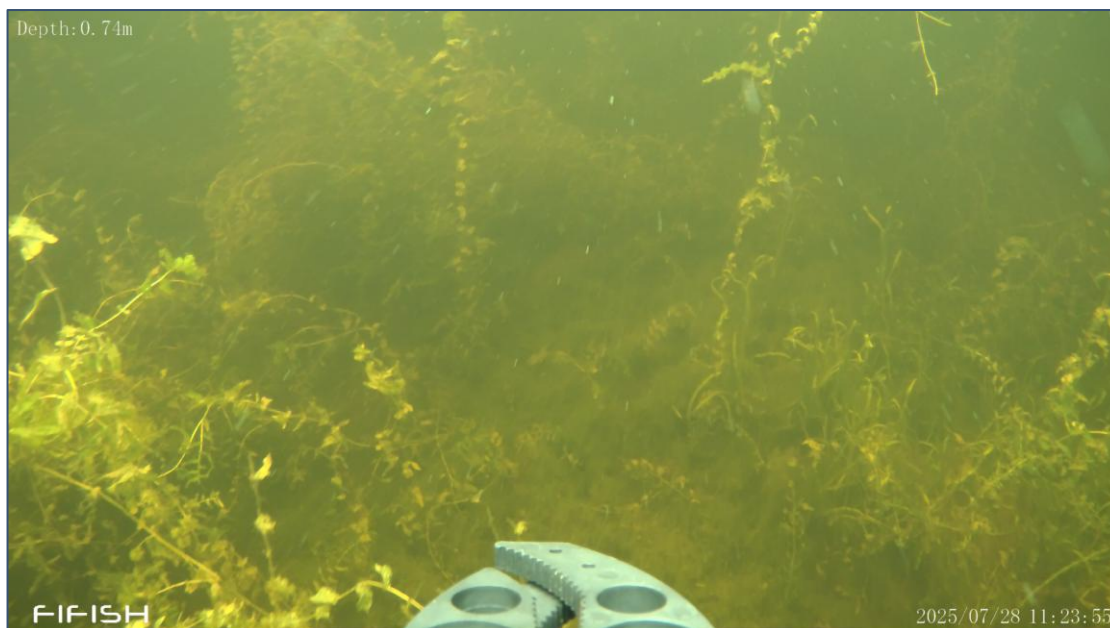
Moving from the marina out to open water, the underwater leaves of yellow water lily were present, recorded as ***Occasionally***. Pondweed beds, featuring ***Abundant*** perfoliate pondweed and Nuttall's waterweed, were recorded from approx. 20 m out along the transect, with ***Occasional*** underwater leaves of arrowhead (Plate 3-37).

Plate 3-37. A representative photo of perfoliate pondweed with Nuttall's waterweed and underwater leaves of arrowhead

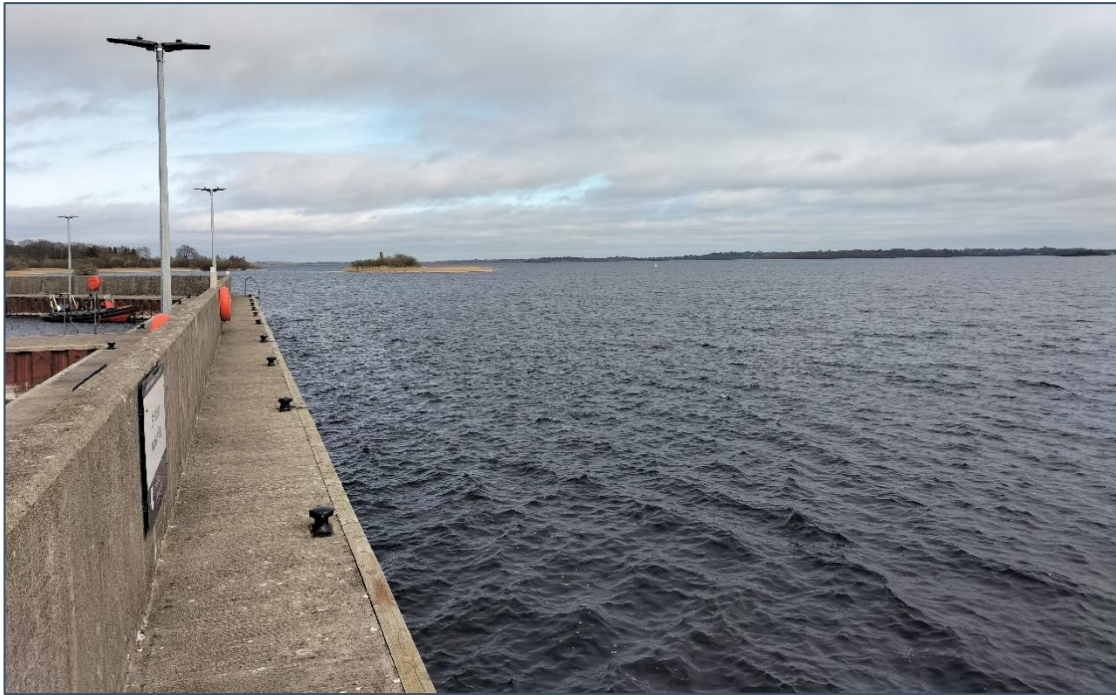
Plate 3-39. A representative photo of the open water in which aquatic drone transects 4 and 5 were conducted

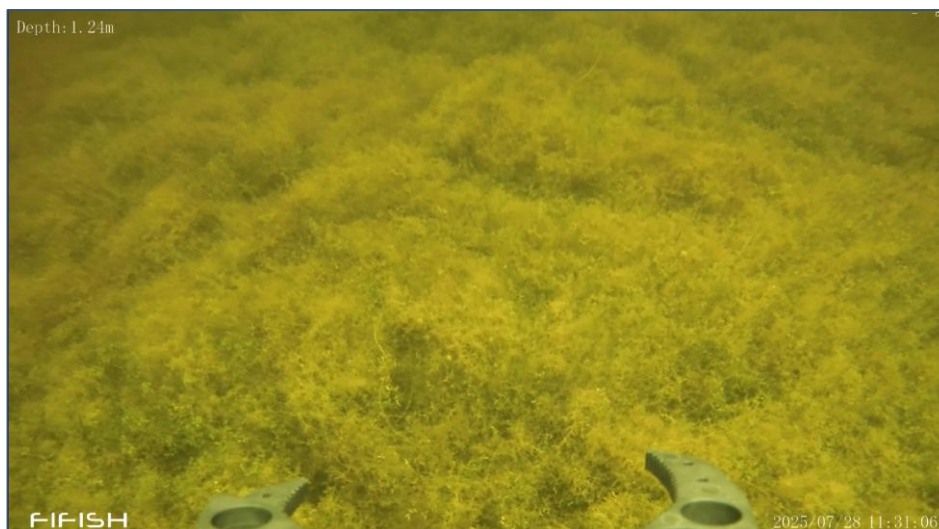
Plate 3-40. A representative photo of dense pondweed beds with *Cladophora* throughout.

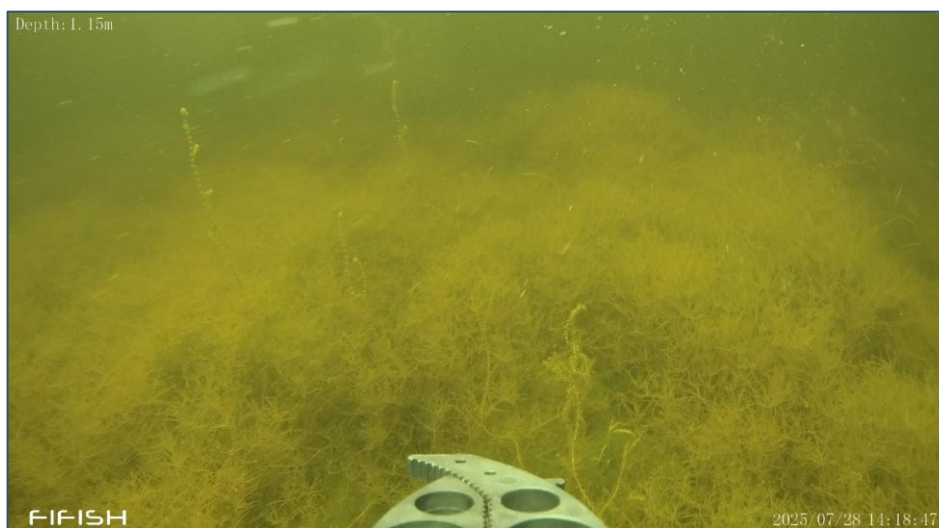
Plate 3-41. A representative photo *Nuttall's waterweed* present throughout dense mats of *stony starwort* and *Cladophora* sp., along aquatic drone transect 6

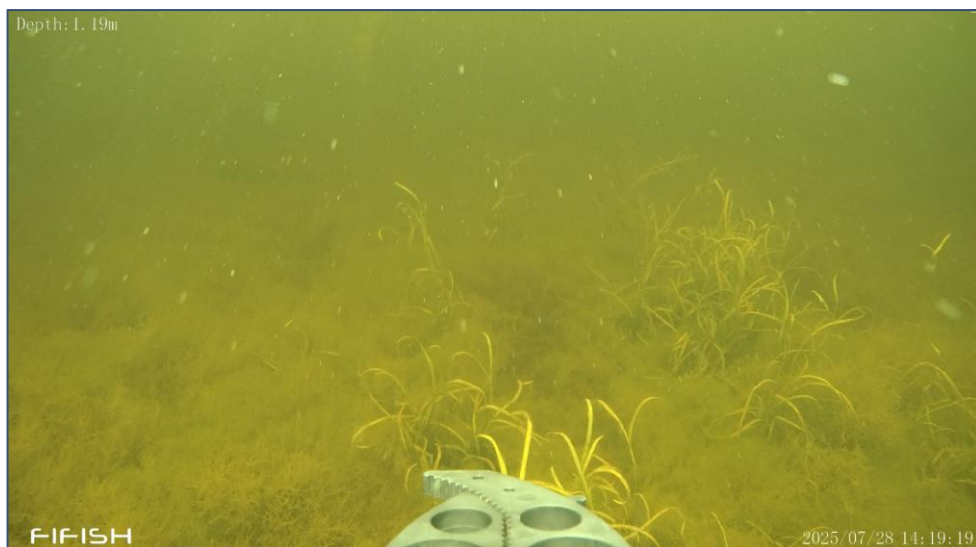
Plate 3-43. A representative photo of the underwater leaves of arrowhead throughout

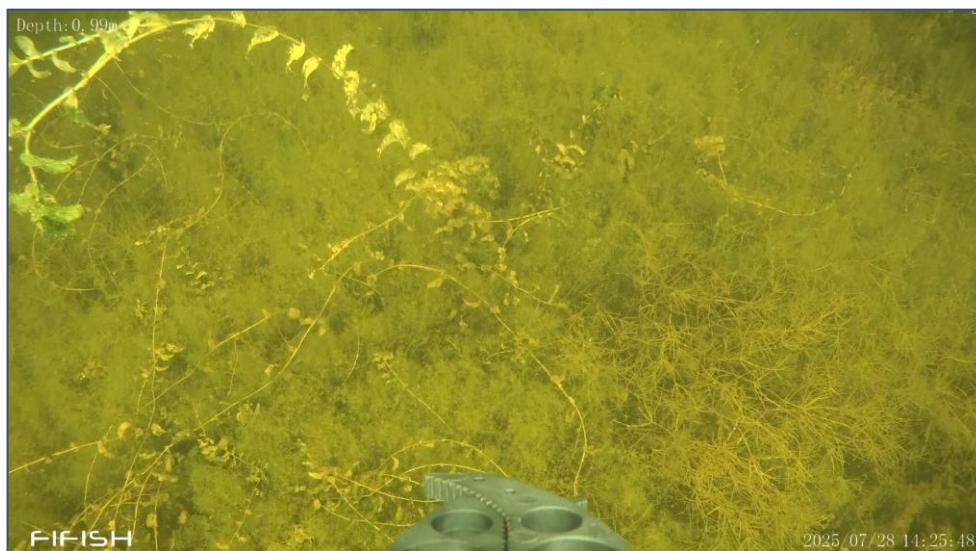
At approx. 20 m along the transect, the lakebed was covered with dense mats of perfoliate pondweed, recorded as **Dominant**, with dense *Cladophora sp.* coverage throughout. Charophyte beds, consisting of delicate stonewort and the non-native starry stonewort (both recorded as **Abundant**) were present throughout pondweed growth from approx. 24 m along the transect, with stony starwort and *Cladophora sp.* becoming the dominant coverage beyond approx. 30 m. Nuttall's waterweed was present throughout charophytes from approx. 37 m along the transect (Plate 3-40, Plate 3-41). Arrowhead was identified throughout the transect, recorded as **Frequent** (Plate 3-43). Moving beyond approx. 43 m, starry stonewort became **Dominant**, with perfoliate pondweed throughout, still recorded as **Abundant**. This coverage and species composition continued for much of the remainder of the transect (Plate 3-42, Plate 3-44).

Plate 3-44. A representative photo of perfoliate pondweed and starry stonewort, with *Cladophora* sp. throughout

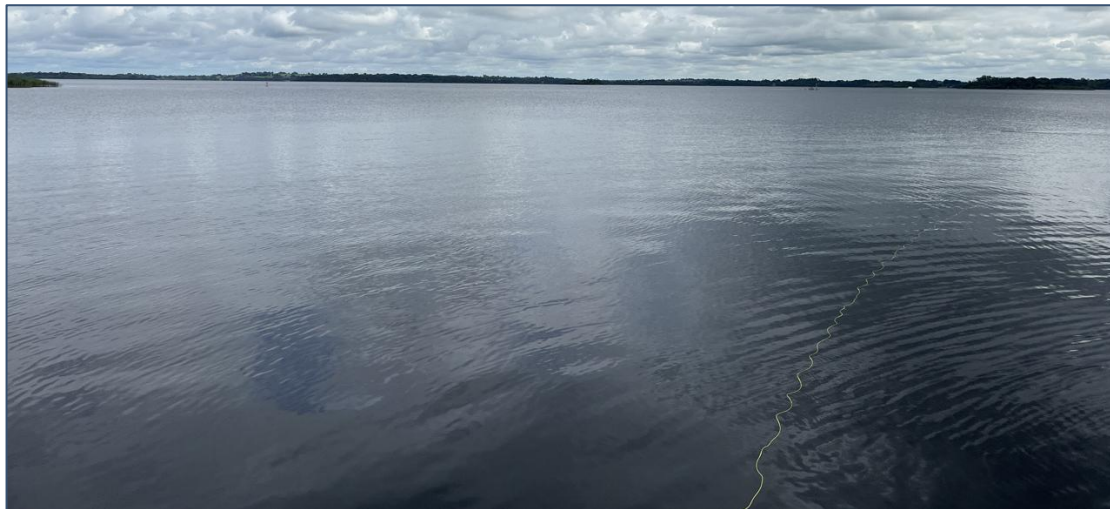
Plate 3-45. A representative photo of the location of aquatic drone transect 6

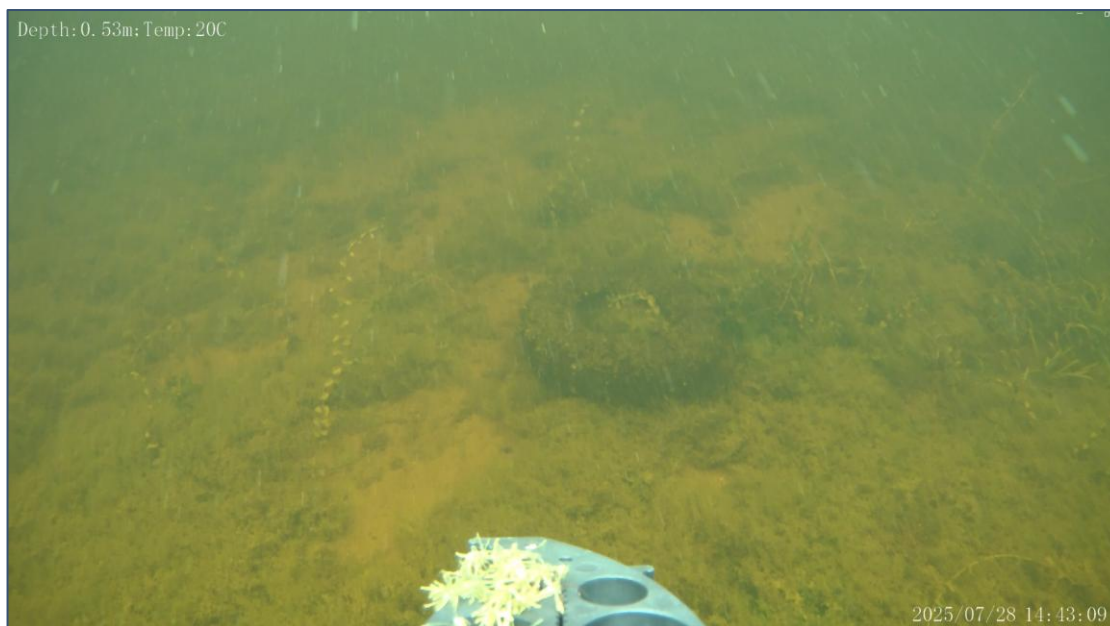
Plate 3-47. A representative photo of fly tipping present throughout aquatic drone transect 7

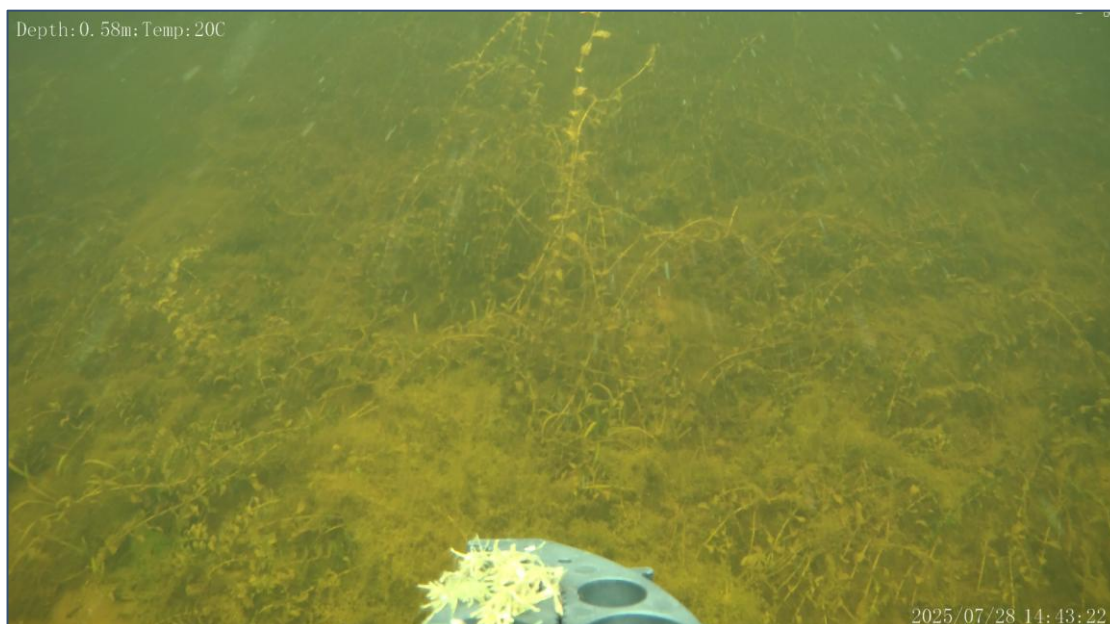
Plate 3-48. A representative photo of perfoliate pondweed with Cladophora throughout along aquatic drone transect 7

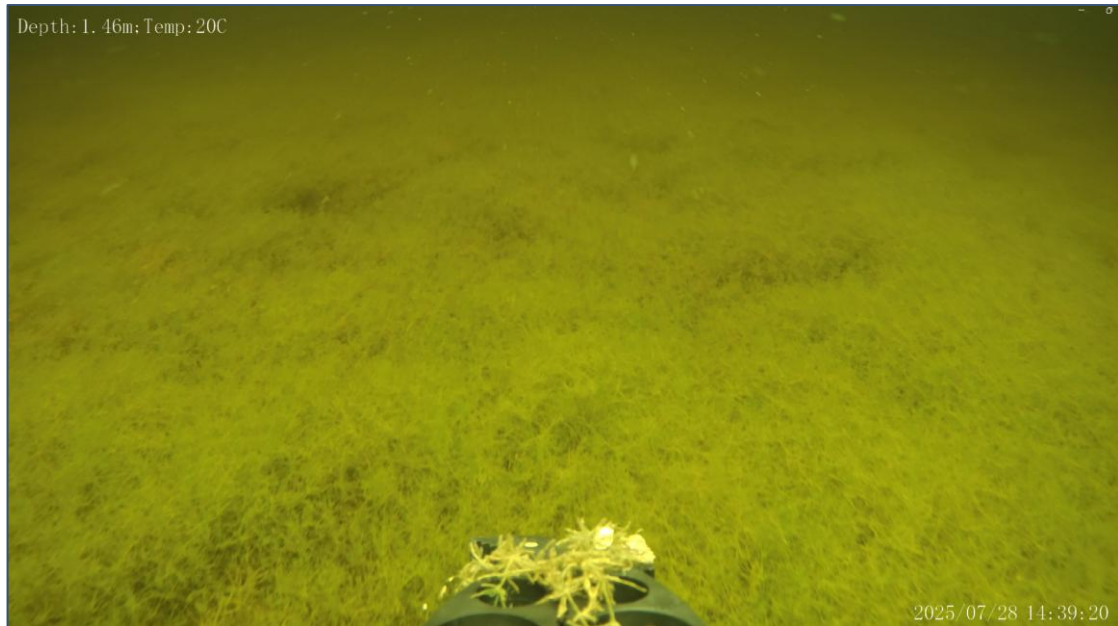
Between 10 m and 35 m along transect, lakebed macrophyte coverage consisted primarily of **Abundant** but patchy perfoliate pondweed coverage, with ivy leaved duckweed (**Frequent**) and *Cladophora* sp. (**Abundant**) throughout (Plate 3-48). Moving beyond 40 m to the end of the transect, the lakebed was covered by charophyte beds featuring **Dominant** starry stonewort and **Frequent** delicate stonewort (Plate 3-49).

Plate 3-49. A representative photo of charophyte beds which dominated the lakebed from 40 m along aquatic drone transect 7

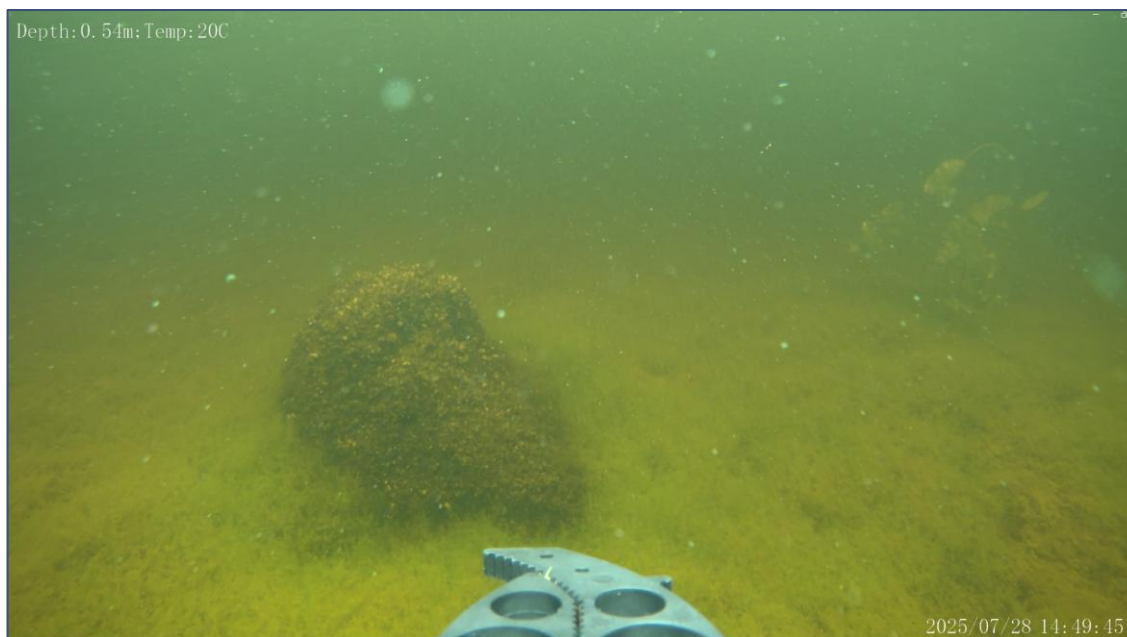
Plate 3-50. A representative picture of quagga and zebra mussel deposits, ***Occasional*** underwater yellow water lily leaves and continuous charophyte beds

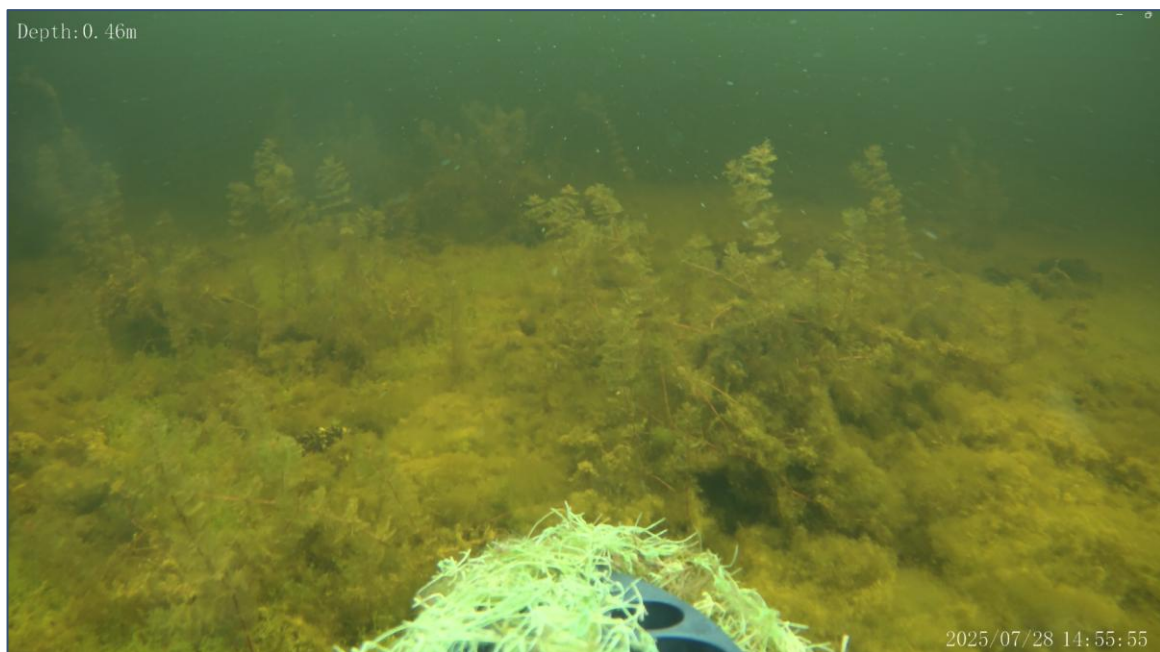
Plate 3-53. A representative photo of a spiked water milfoil **Dominant** section of aquatic drone transect 8

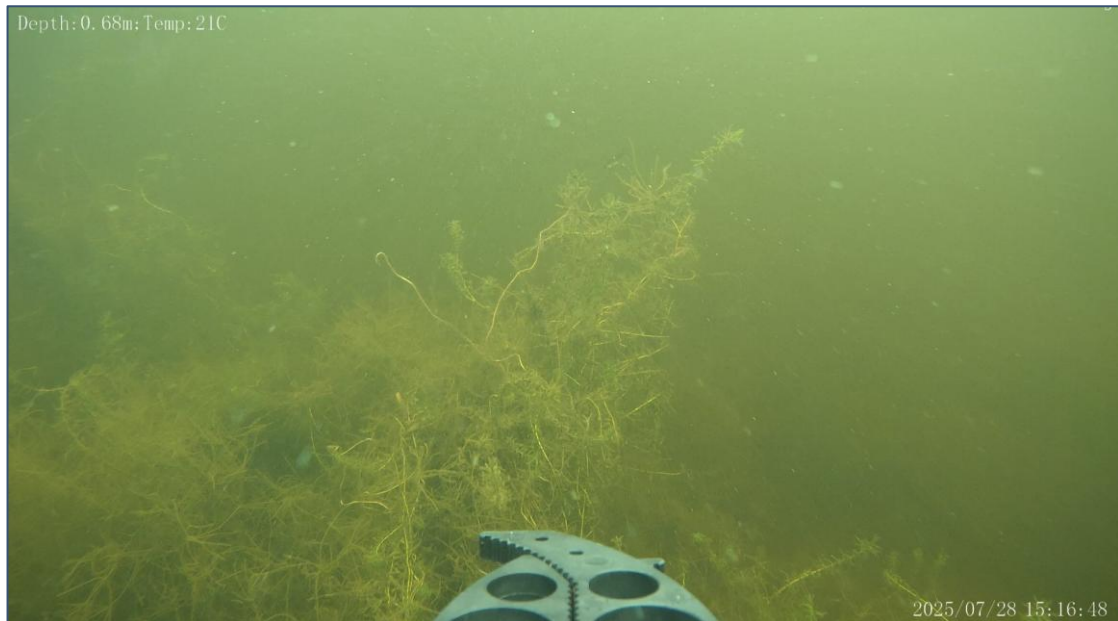
Plate 3-54. A representative photo of *Elodea* sp. entangled throughout aquatic drone transect 9 within the existing marina

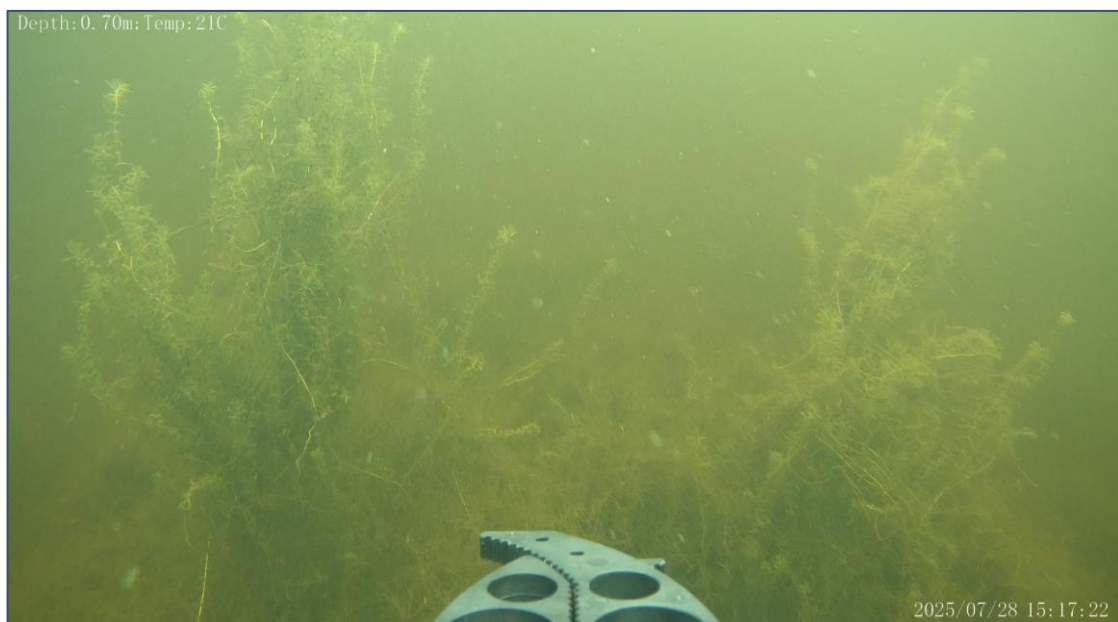
Plate 3-55. A representative photo of *Elodea* sp. observed throughout aquatic drone transect 9

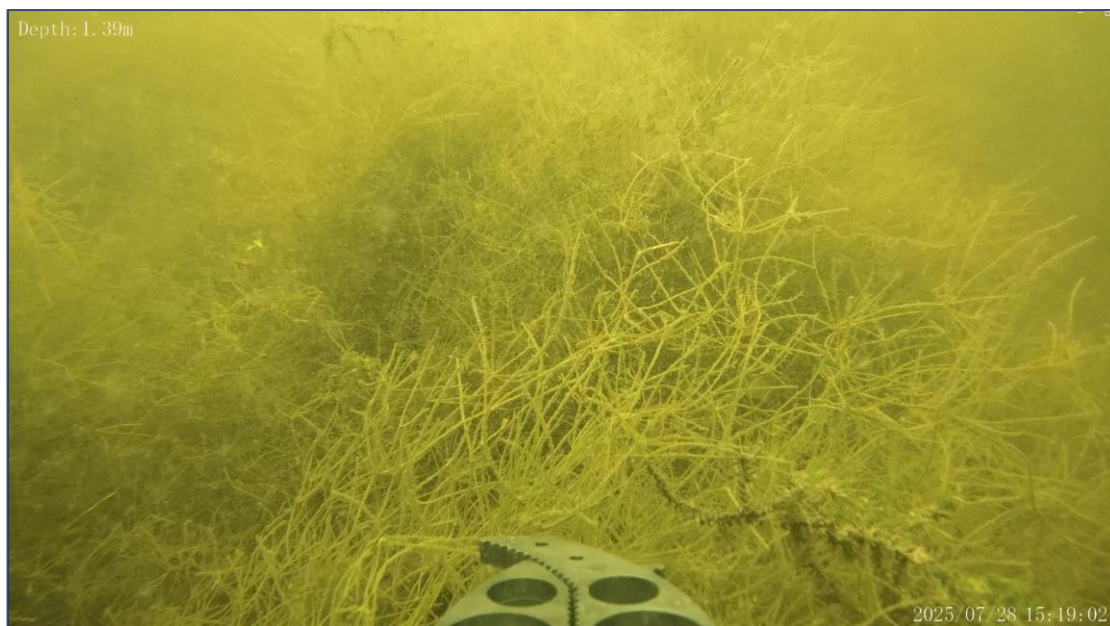
Plate 3-56. A representative photo of the non-native starry stonewort (*Nitellopsis obtusa*) **Dominant** sections of aquatic drone section 9
