Conservation Architect's Report on Rahara Medieval Church, Co. Roscommon.

Prepared by
Michael O'Boyle B.Arch MUBC FRIAI
RIAI Grade 1 Conservation Architect
on behalf of
Roscommon County Council

Date: 19th November 2020

Ref.: P20-033 (01)

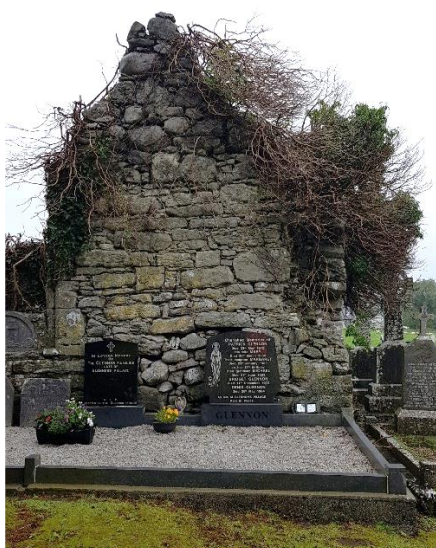
Fig. 5 Exterior face of east gable

The east gable is off-plumb, with the uppermost part of the masonry leaning outwards by at least 300mm. This outward movement in the wall appears to have contributed to the loss of masonry at the north-east corner of the ruin (see a) above). It is not possible to determine from a single inspection whether the movement in the wall is actively deteriorating. The extent of this outward lean is such that the gable must be regarded as unstable and at potential risk of collapse. There are dead ivy branches at the top of the wall, which appear to have been cut off close to the root.

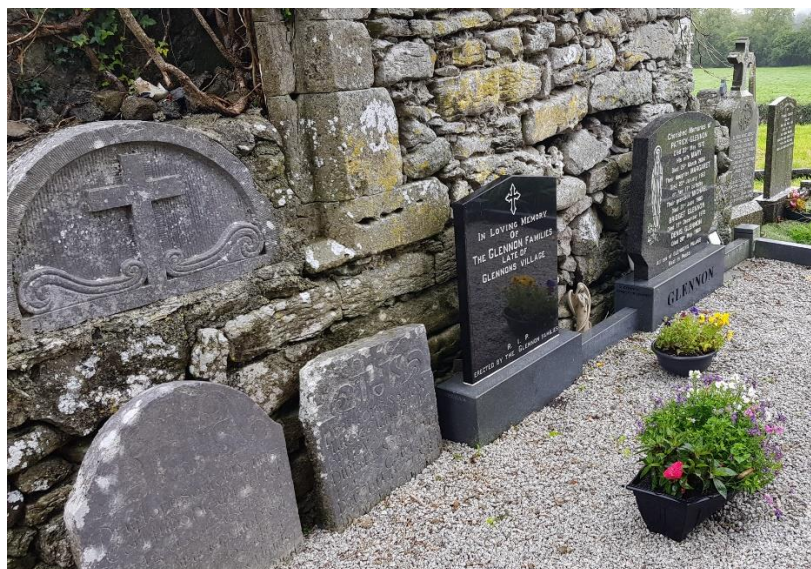
Fig. 6 Detail of cut stone embrasure to lancet window on exterior face of east gable.

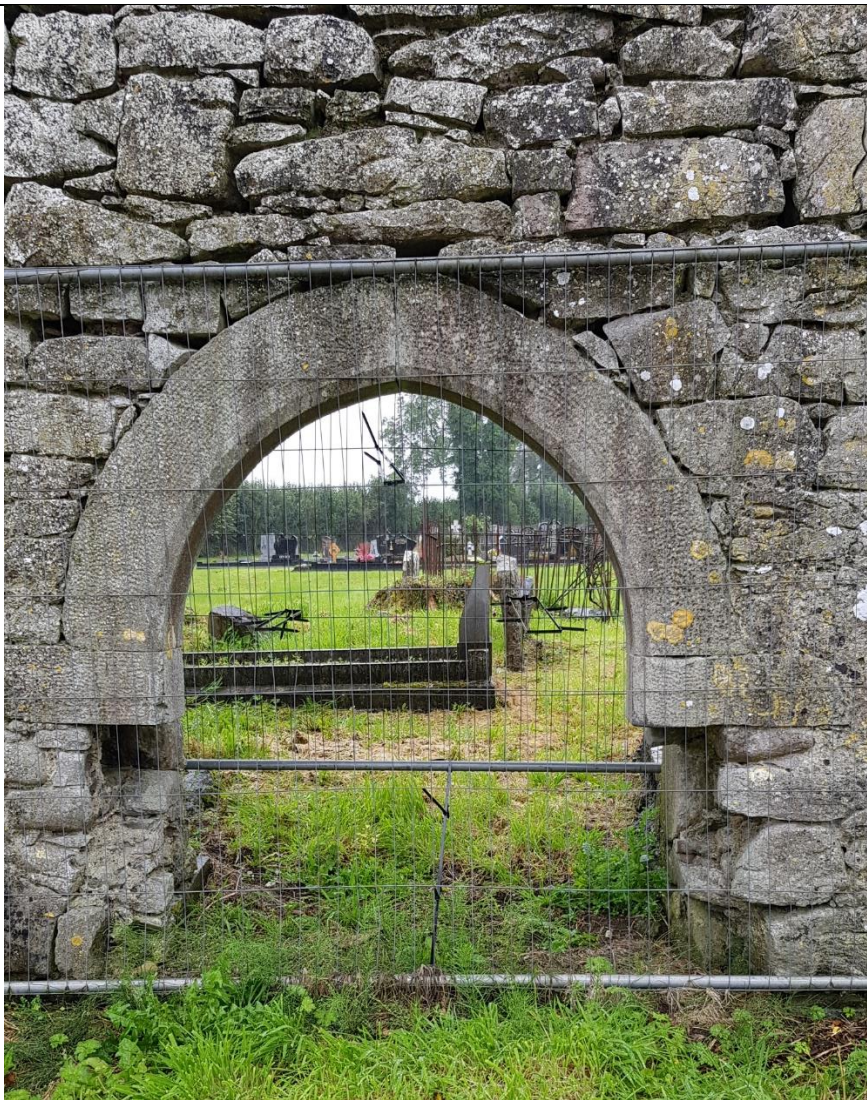
The cut stone surround to the pointed-arch opening on the north external wall is an important survival. The cut stone reveals beneath the arch do not survive. The masonry rubble reveal to the inside of the arch is in poor condition, with missing stone on both sides (*Fig. 14 & 15*). The stone rubble inner arch is not adequately supported. It is possible to see through the wall at the gaps between the stones at the head of the arch. The stone arch is not stable and consolidation is urgently required to the reveals. Protective fencing is in place to prevent public access to the arch.

Fig. A5 Detail of pointed arched opening on exterior face of north wall of church

g) Consolidation and repair of pointed arch opening on north wall

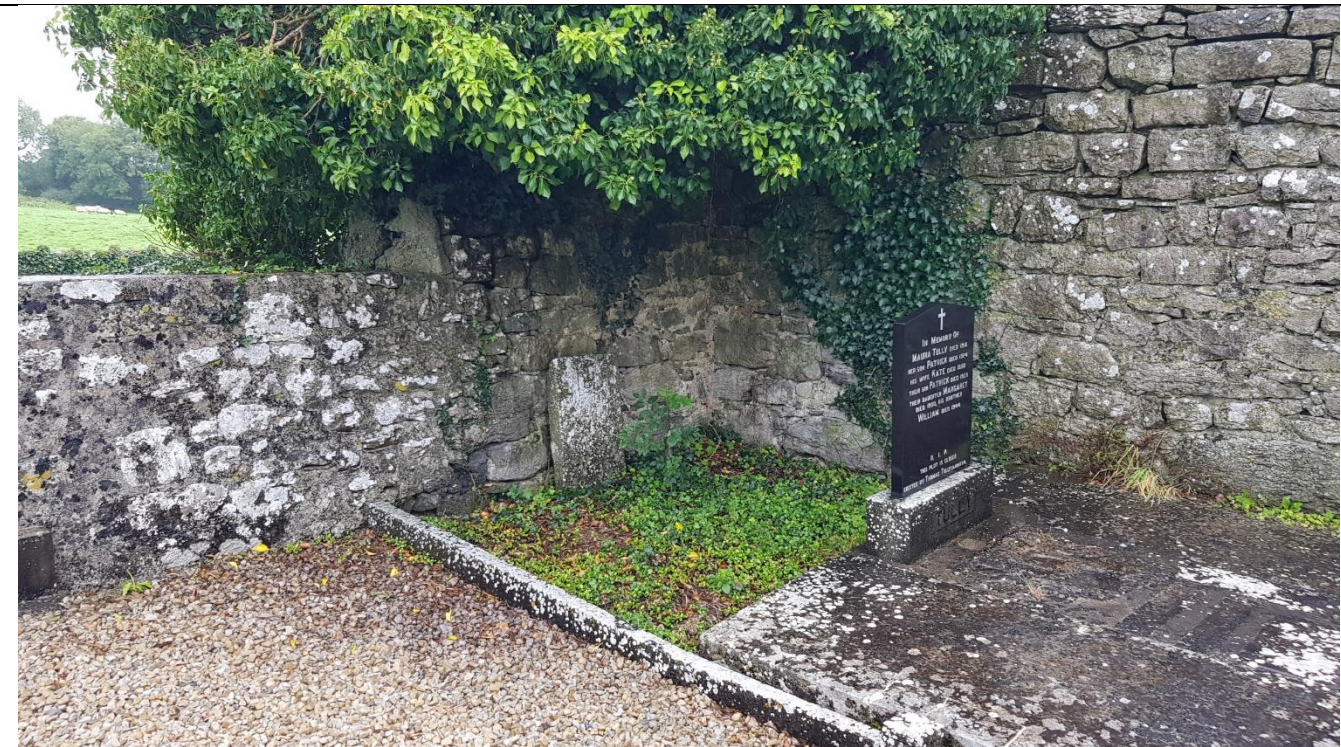
There is a substantial cluster of mature ivy, which completely obscure the interior and exterior face of the wall at the north-west corner (*Fig. 12 & 13*). It was not possible to visually inspect the face of the wall in this corner on the date of inspection and it is not possible to comment on the condition of the stone.

Fig. A8 Interior of church ruin at north-west corner
