**ROSCOMMON COUNTY COUNCIL**

**NOTIFICATION OF DETERMINATION**

Reference Number: DED 912  
Application Received: 1<sup>st</sup> July, 2025  
Name of Applicant: Sean Ned Mulready  
Agent: N/A

# **BUILDING CONDITION ASSESSMENT**

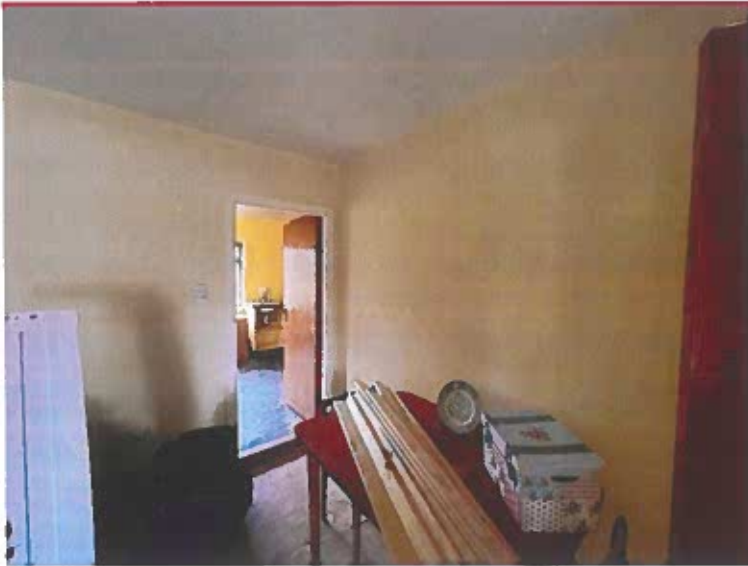
**6.07**

Location Living Room

proofing works required to make

this property habitable.

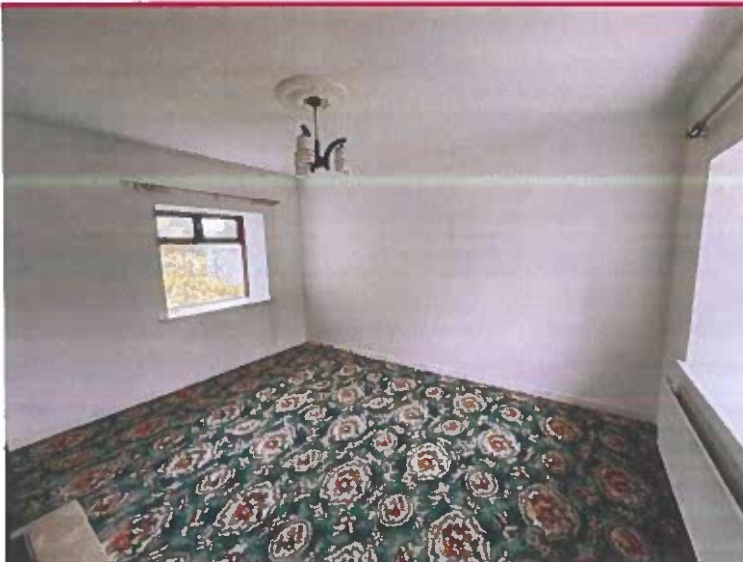
**6.08**

Location Bedroom 1

proofing works required to make

this property habitable.

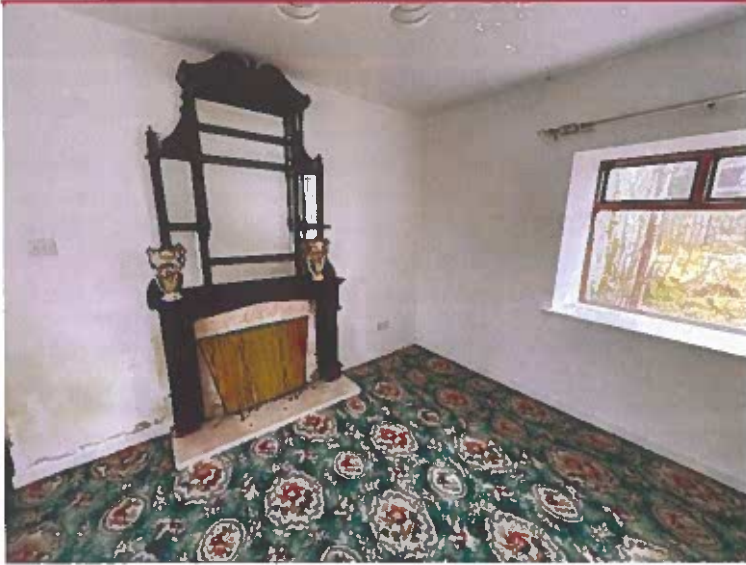
**6.09**

Location Bedroom 1

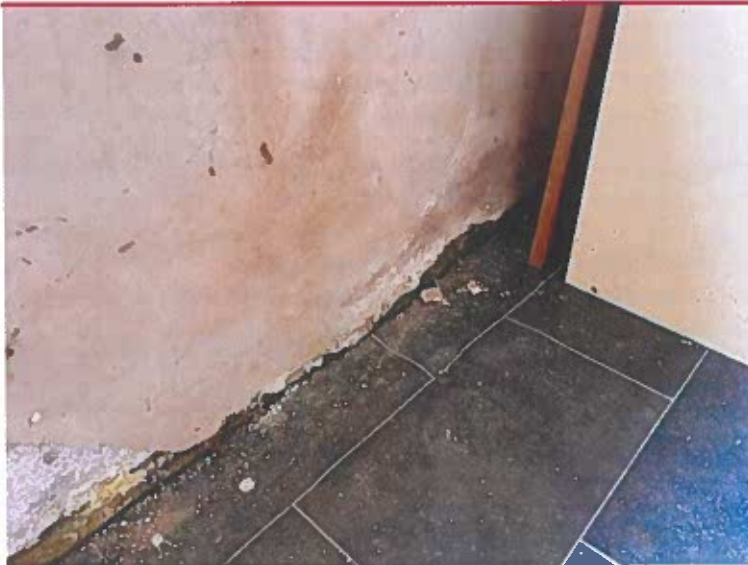
#### 6.17

There is a solid concrete floor with various finishes throughout. There is rising damp, and the floors should be stripped and replaced, it is recommended to add a radon membrane and DPM should be placed below an insulation and screed.

Location Rising Damp

proofing works required to make

this property habitable.

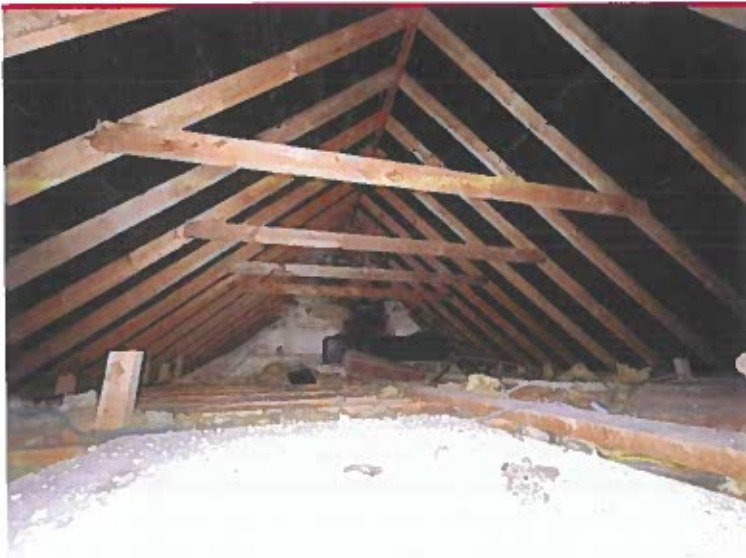
#### 6.18

A detailed inspection of the flues was not possible. It is generally impossible to establish, from a visual inspection, whether fireplaces or flues function satisfactorily or are subject to problems. Factors such as wind strength and direction can create problems. Specialist tests and investigations would be necessary to confirm that problems do not exist under any circumstances. Suspected damage to flue due to soot staining on chimney breast in attic space.

Location Attic Space
